**AIRCRAFT ACCIDENT REPORT AND EXECUTIVE SUMMARY**

<b>Reference:</b>		CA18/2/3/10258	
<b>Aircraft Registration</b>	ZS-IBX	<b>Date of Accident</b>	30 January 2023		<b>Time of Accident</b>	1313Z	
<b>Type of Aircraft</b>	Beechcraft E33 Bonanza			<b>Type of Operation</b>	Private (Part 91)		
<b>Pilot-in-command Licence Type</b>	Private Pilot Licence (PPL)		<b>Age</b>	43	<b>Licence Valid</b>	Yes	
<b>Pilot-in-command Flying Experience</b>	<b>Total Flying Hours</b>		92.6		<b>Hours on Type</b>	30.1	
<b>Last Point of Departure</b>	Private Farm in Steelpoort, Mpumalanga Province						
<b>Next Point of Intended Landing</b>	Nelspruit Aerodrome (FANS), Mpumalanga Province						
<b>Damage to Aircraft</b>	Destroyed						
<b>Location of the accident site with reference to easily defined geographical points (GPS readings if possible)</b>							
Portion 2 Hermannsburg 450 JJ (GPS position: 25°29'55.5" South 030°52'42.5" East), at an elevation of 3510 feet (ft)

**Reference Number** : CA18/2/3/10258  
**Occurrence Category** : Accident (Category 1)  
**Type of Operation** : Private (Part 91)  
**Name of Operator** : Mashishing Building Material (PTY) LTD  
**Aircraft Registration** : ZS-IBX  
**Aircr

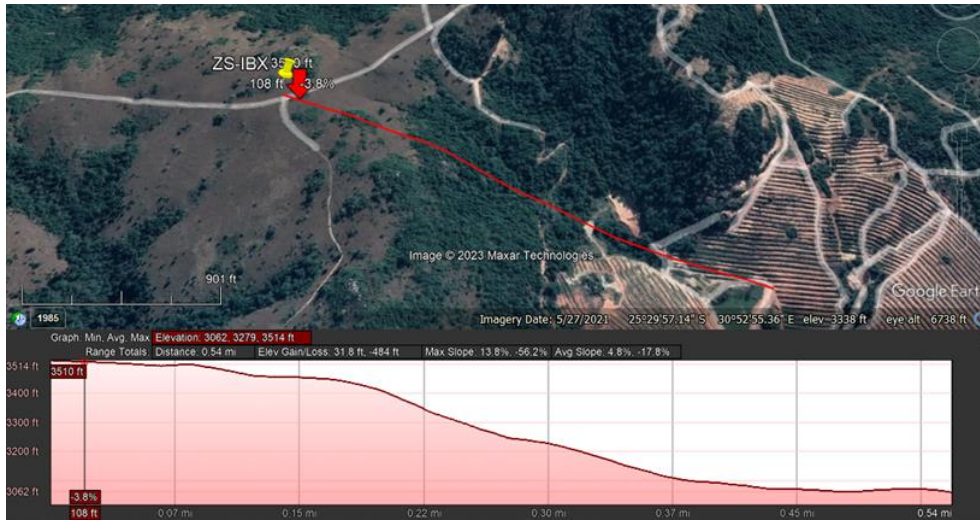
- 1.1.7. Two witnesses, one of whom was a FANS employee, were positioned just outside the aerodrome perimeter fence when they saw the aircraft (from a distance) moments before it disappeared on the side of the mountain. The FANS employee alerted the airport manager who then called and requested ZS-EPO pilot to check on the ZS-IBX aircraft. Later, the ZS-EPO pilot confirmed that the ZS-IBX had crashed. The airport manager informed emergency services who responded to the accident site. One of the two witnesses called the owner of the farm on which ZS-IBX had crashed to request that he shows the first responders how to get to the accident site by road. An emergency helicopter was dispatched to the accident site. The aircraft was found crashed on rising terrain (Figure 2) and the pilot was fatally injured.

Figure 2: Image showing rising terrain at the crash site. (Source: Google Earth)

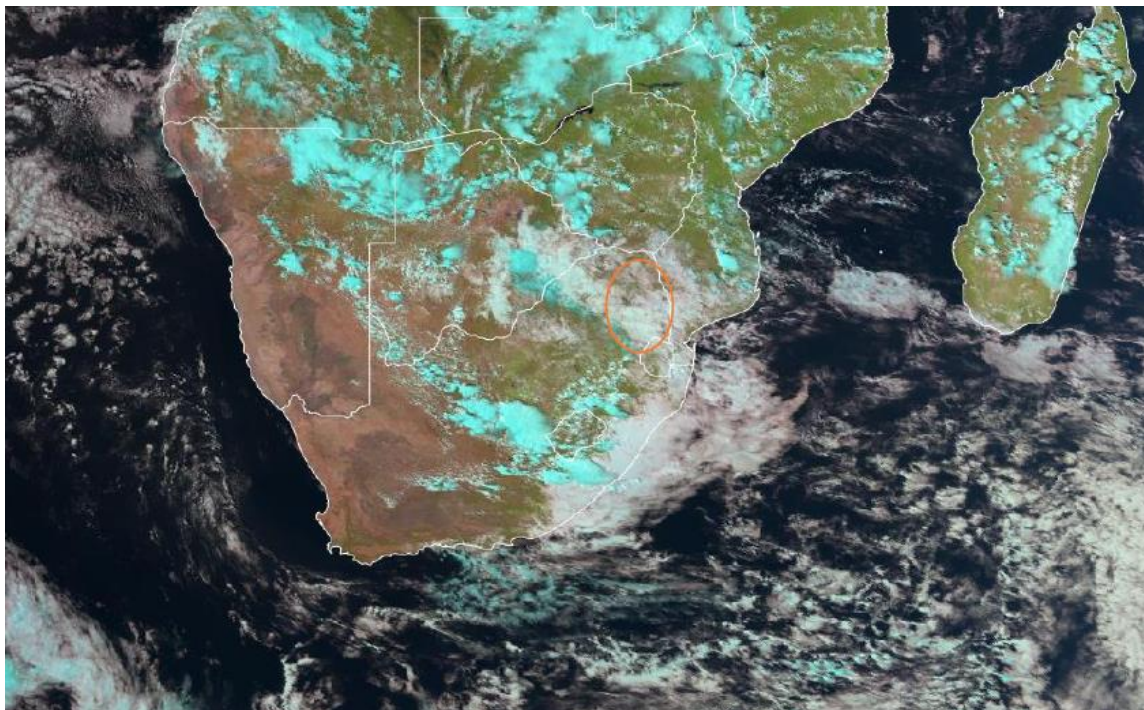
**Figure 5:** The Day Natural Colour (DNC) satellite image valid for 30 January 2023 at 1300Z. The circle depicts the accident area. (Source: SAWS)

The Day Natural Colour (DNC) Red Green Blue (RGB) satellite images of the MeteoSat Second Generation (MSG) above show the presence of low-level clouds over the north-eastern escarpment of South Africa. These low-level clouds were present in the circled area where the accident occurred. There were cumulus clouds embedded by low-level clouds to the west of the accident site. The low-level clouds were extensively covering the accident site as depicted in the satellite image above.

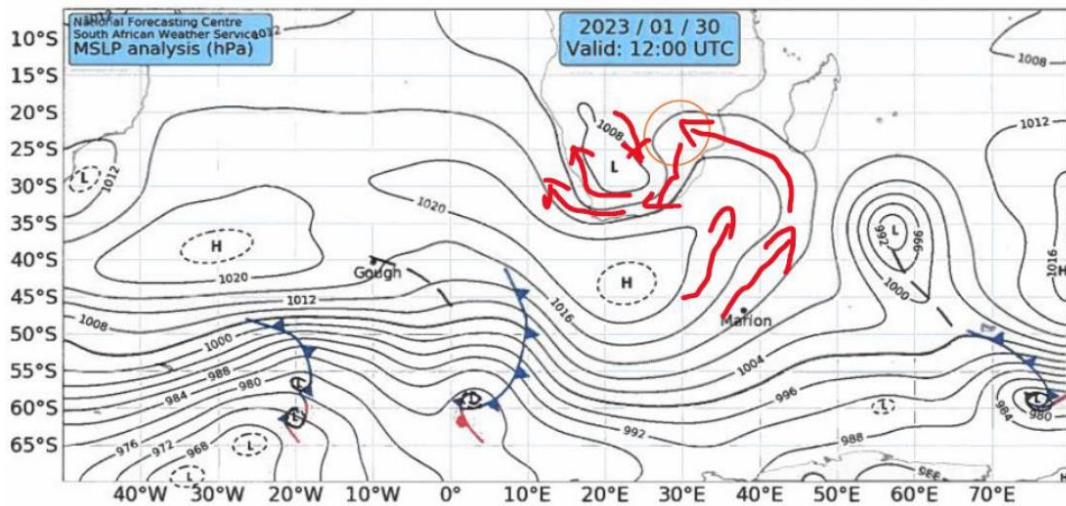
**Figure 6:** Synoptic Chart valid for 1200Z. (Source: SAWS)

1.7.3 The Synoptic Chart at 1200Z above shows a ridging high pressure system supplying moisture over the north-eastern escarpment from the warm Indian Ocean. The anticyclonic circulation result in the cloud cover (low-level clouds) as observed over the south-east coast and its adjacent interior, as well as the north-east escarpment of the country (also observed in Figure 5 satellite images). The geostrophic wind circulation (red arrows) draws moisture from the ocean into the interior (accident area). A surface trough over the western interior of the country favours convective cloud development in the east of the surface trough.

The chart corresponds with cumulus clouds over central to north-eastern escarpment as observed in the satellite image in Figure 5.

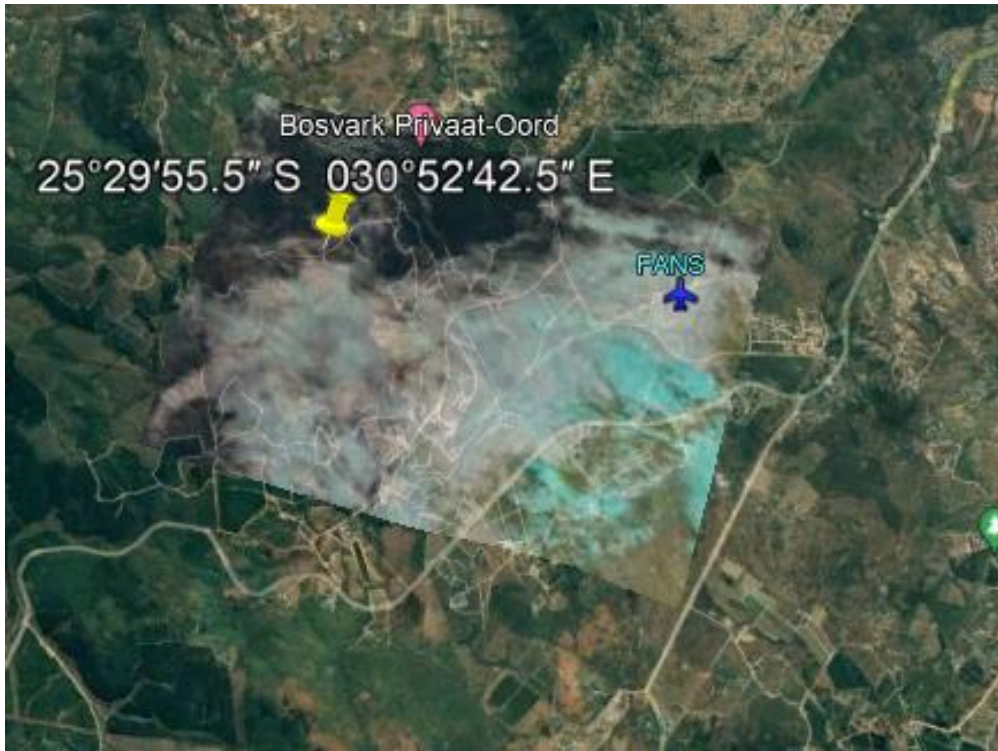
**Figure 12.** Cloud overlay at the accident site and FAKN. (Source: Google Earth)
