**AIRCRAFT ACCIDENT REPORT AND EXECUTIVE SUMMARY**

<b>Reference:</b>	<b>CA18/2/3/10271</b>			
<b>Aircraft Registration</b>	<b>ZS-NSY</b>	<b>Date of Accident</b>	21 February 2023		<b>Time of Accident</b>	0615Z		
<b>Type of Aircraft</b>	Beechcraft BE-76 Duchess			<b>Type of Operation</b>	Training (Part 141)			
<b>Pilot-in-command Licence Type</b>		Commercial Pilot Licence (CPL) Aeroplane	<b>Age</b>	61	<b>Licence Valid</b>	Yes		
<b>Pilot-in-command Flying Experience</b>		<b>Total Flying Hours</b>		2 451.7	<b>Hours on Type</b>	55		
<b>Last Point of Departure</b>		Wonderboom Airport (FAWB), Gauteng Province						
<b>Next Point of Intended Landing</b>		Grand Central Airport (FAGC), Gauteng Province						
<b>Damage to Aircraft</b>		Substantial						
<b>Location of the accident site with reference to easily defined geographical points (GPS readings if possible)</b>								
On Runway 17 at FAGC at Global Positioning System co-ordinates determined to be 25°59'08.06" South 028°08'24.55" East, at an elevation of 5 259 feet

The left-side main landing gear A-frame failed during the landing roll due to a fatigue fracture which initiated from the weld metal bead and progressed to the down-lock m

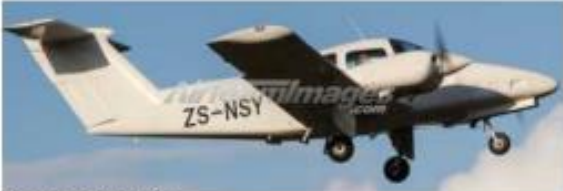
<p>Photo 1: ZS-NSY<sup>1</sup></p>

ITEM:	MAIN LANDING GEAR "A" FRAME, MAIN LANDING GEAR ASSEMBLY, BEECHCRAFT DUCHESS 76, AIRCRAFT NUMBER ZS-NSY	
<p>1. INTRODUCTION &amp; BACKGROUND INFORMATION</p> <p>1.1. The "A" Frame (Photo 2), forming part of the main landing gear assembly of a Beechcraft 76 Duchess, aircraft registration no ZS-NSY (Photo 1), serial No ME-114, was submitted to determine the most probable contributing factor/s towards failure during operation.</p> <p>1.2. The FAA (AD2021-08-26) and the OEM (Beechcraft Textron, SB 32-4156) issued documentation relating to scheduled NDT inspections relating to the MLG "A" Frame.</p>

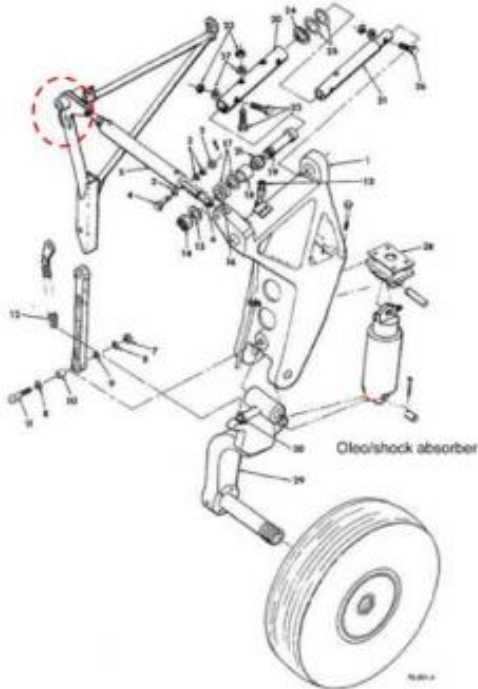
Diagram 1: Beechcraft 76 MLG assembly

The visual inspection revealed a fracture within the tubular section of the MLG "A" frame (Photo 2, Doagrams2 1 and 2, red dashed circles). The fracture initiated within the weld metal area (Diagram 2, green arrow; Photos 3 and 4, red arrows).
