LIMITED OCCURRENCE INVESTIGATION REPORT – FINAL

Reference Number	CA18/2/3/10272					
Classification	Accident	Date	21 February 2023	Time	0620Z	
Type of Operation	Aerial Work Operations – Game Darting (Part 137)					
Location						
Place of Departure	Brisbane Farm near Pomfret, North West Province		Place of Intended Landing	Brisbane Farm near Pomfret, North West Province		
Place of Occurrence	Brisbane Farm near Pomfret in the North West Province					
GPS Co-ordinates	Latitude	25°42'28.10" S	Longitude	023°33'59.51" E	Elevation	3 575 ft
Aircraft Information						
Registration	ZS-RTH					
Make; Model; S/N	Robinson Helicopter Company; R44 Raven II (Serial Number: 10269)					
Damage to Aircraft	Substantial		Total Airframe Hours	2 630.0		
Pilot-in-command						
Licence Type	Private Pilot Licence (PPL)			Gender	Male	Age 64
Licence Valid	Yes	Total Hours on Type	2 412.0	Total Flying Hours	2 412.0	
Total Hours 90 Days	8.8		Total Hours on Type Past 90 Days	8.8

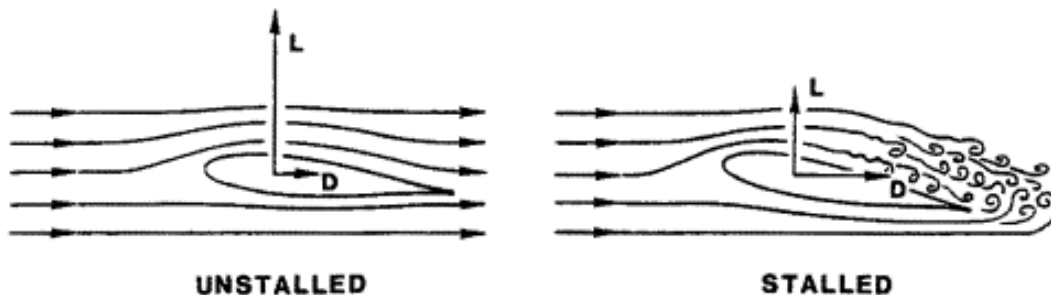
The same thing happens during rotor stall with a helicopter except it occurs due to low rotor RPM instead of low airspeed. As the RPM of the rotor gets lower, the angle-of-attack of the rotor blades must be higher to generate the lift required to support the weight of the helicopter. Even if the collective is not raised by the pilot to provide the higher blade angle, the helicopter will start to descend until the

Wing or rotor blade unstalled and stalled.
