**AIRCRAFT ACCIDENT REPORT AND EXECUTIVE SUMMARY**

| | | | | <b>Reference:</b> | | <b>CA18/2/3/10278</b> | |
| <b>Aircraft Registration</b> | ZS-III | <b>Date of Accident</b> | 2 April 2023 | | <b>Time of Accident</b> | 1950Z | |
| <b>Type of Aircraft</b> | Cessna C310Q | | <b>Type of Operation</b> | | Private (Part 91) | | |

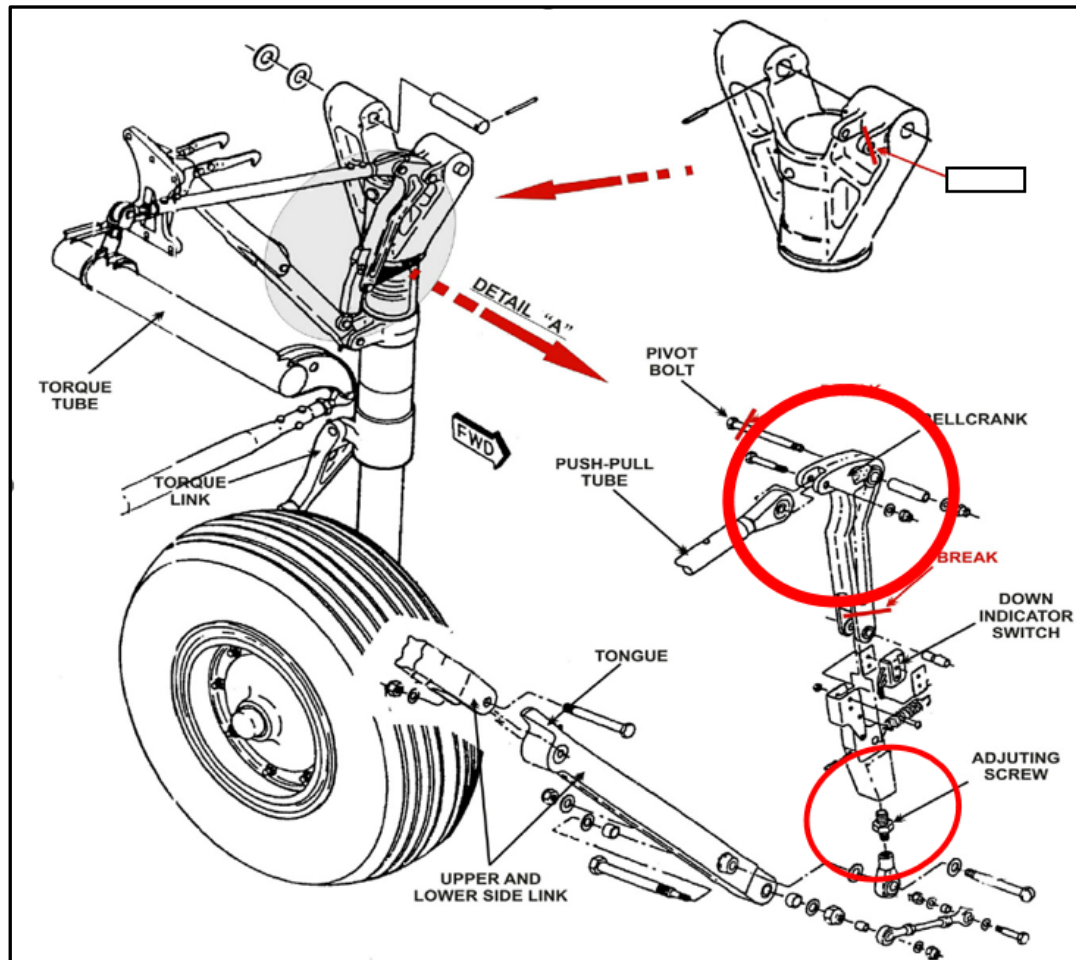
**Diagram 3:** The schematic of the left landing gear push-pull tube and the bottom end fitting with an adjustable screw.

*Diagram 3 shows the left landing gear leg in its extended position. Also shown in the figure is a detailed view of the leg's mechanism with the components most relevant to this accident. Indicated in the red circles highlights the breaks discovered, to be addressed later.*

*Looking at the left leg only (Diagram 3), the operation of the system to retract the gear would require the electrical motor which turns such that the push-pull tube would move towards the leg, pushing the bell-crank, to which it is attached. The push-pull tube makes the bell-crank rotate and push on the pivot bolt, which is located in the truss assembly.*

The push generates torque in the pivot bolt and to retract the gear assembly (leg rotates towards the fuselage). Simultaneously, the rotation of the bell-crank causes its lower arm, the longer of the two, to move the hinged bar located at the end of the arm. This motion has two effects: it overcomes spring pressure to separate the limit switch from the leg, which extinguishes the "gear locked light" and it makes the other end of the bar pull on the over-centre of the lower side link, to which it is attached. This connection is also hinged and goes through the adjusting screw which is attached to the end fitting and the side brace lock link. The pulling on this causes the lower side link to fold upward, allowing the leg to rotate towards the fuselage.

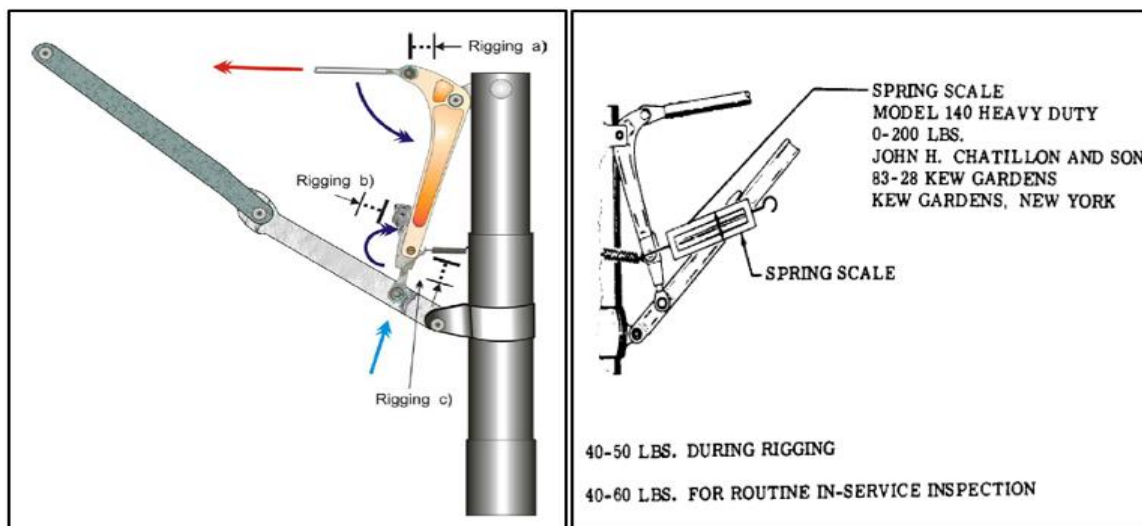
**Illustration 1:** Shows possible adjustments points during rigging.

The movement of the assembly that lowers the landing gear, including the actuating electrical motor, and its cockpit indication, can be adjusted or calibrated in three ways. It also features the generic mechanical adjustments present in any mechanical joint.

- a) The first involves the positioning of the cut-off switches for the electric motor and for the transmission linkages to the push-pull tube, where it joins the actual mechanism of the gear mechanism in the final gear up and locked and gear down and locked position.
- b) Another adjustment located above the gear down and locked switch involves the mechanism's final position. This adjustment is easy to make since the switch itself can be adjusted without affecting the mechanism's other components. Likewise, there

- I. With adjustment a), the cut-off switch for the motor when extending, beyond its appropriate position, tension is placed on the push-pull tube, and therefore on the upper bell-crank arm. If at the same time the length of the lower bell-crank arm is made excessive using adjustment c), this places a compressive load on the lower bell-crank arm. As a result of either or both loads, the pivot bolt is conditioned for a shear fracture at an intermediate angle between the two arms of the bell-crank.

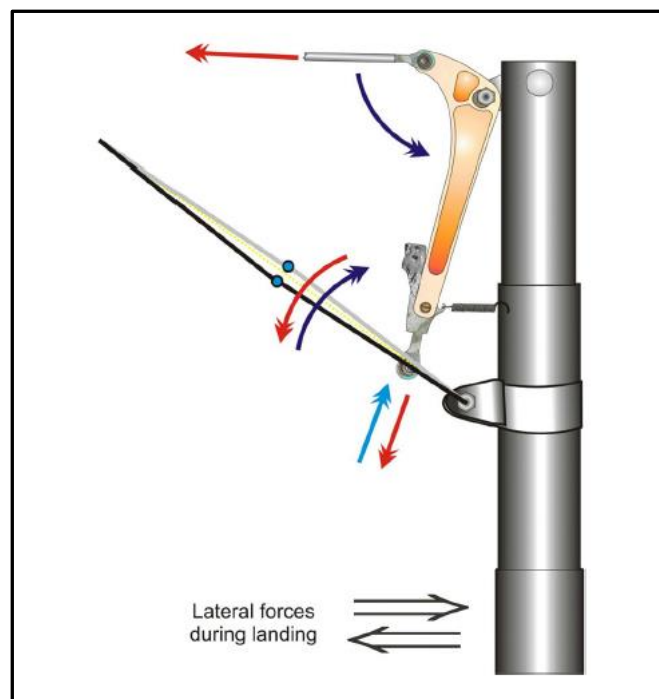
**Illustration 2:** Showing forces on the mechanism.

- II. A setting contrary to that mentioned above for adjustment c) leaves the lower side link or over centre with enough clearance at its mechanical stop to allow for the appearance of an oscillatory motion around a neutral axis as a consequence of lateral loads on the leg. This clearance may result from an adjustment of a) as mentioned in the previous paragraph, which would take the gear down switch (adjustment b) to the stop without a fault indication. This oscillatory motion of the over centre induces loads on the bell-crank, and therefore on the pivot bolt, with results similar to those above and with large absolute values due to the geometry of the mechanism.

The mechanism must be properly adjusted or calibrated if it is to maintain a suitable geometry in all its configurations and adequate load distribution within design criteria, without bending and imparting loads on relatively weak components which were designed to move the
