LIMITED OCCURRENCE INVESTIGATION REPORT – FINAL

Reference Number	CA18/2/3/10283						
Classification	Accident	Date	12 April 2023		Time	0630Z	
Type of Operation	Training (Part 141)						
Location							
Place of Departure	Ballito Airfield, KwaZulu-Natal Province		Place of Intended Landing	Ballito Airfield, KwaZulu-Natal Province			
Place of Occurrence	On Runway 08 at Ballito Airfield, KwaZulu-Natal Province						
GPS Co-ordinates	Latitude	29° 29'20.05"S	Longitude	31°10'40.98."E	Elevation	235 ft	
Aircraft Information							
Registration	ZU-DJR						
Make; Model; S/N	Solo Wings; Windlass Aquilla Trike (Serial Number: WA 1010)						
Damage to Aircraft	Substantial		Total Aircraft Hours	186.6			
Pilot-in-command							
Licence Type	National Pilot Licence (NPL)		Gender	Male		Age	66
Licence Valid	No	Total Hours	149		Total Hours on Type	128.7	
Total Hours 30 Days	6.8		Total Flying on Type Past 90 Days	6.8			
People On-board	1+0	Injuries	0	Fatalities	0	Other (on ground)	0

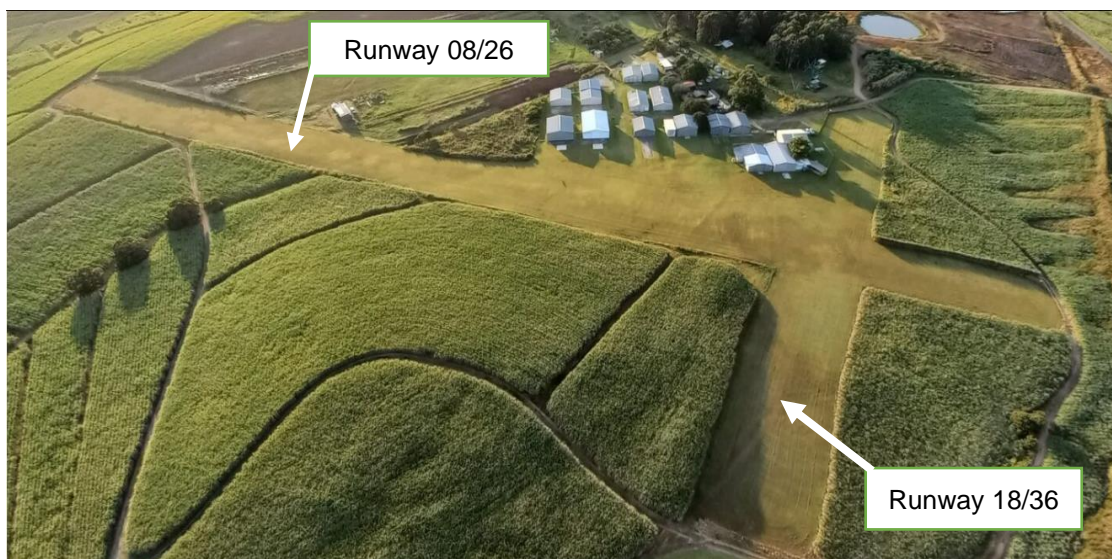
Figure 6: The Ballito Airfield layout. (Source: Google Earth)

- The airfield is privately owned; thus, it is not registered with the Regulator (SACAA).

- On the day of the accident, the grass was dry. The runway surface condition was suitable for use, however, the terrain along the runway edge was unsuitable.
