HELICOPTER ACCIDENT REPORT AND EXECUTIVE SUMMARY

Reference:		CA18/2/3/10288	
Aircraft Registration	ZS-HKC	Date of Accident		19 April 2023		Time of Accident	1145Z
Type of Aircraft	Guimbal Cabri G2			Type of Operation		Training (Part 141)	
Pilot-in-command Licence Type		Commercial Pilot Licence		Age	25	Licence Valid	Yes
Pilot-in-command Flying Experience		Total Flying Hours		432.9		Hours on Type	209.9
Last Point of Departure		Mossel Bay Aerodrome (FAMO), Western Cape Province					
Next Point of Intended Landing		Mossel Bay Aerodrome (FAMO), Western Cape Province					
Damage to Helicopter		Substantial					
Location of the accident site with reference to easily defined geographical points (GPS readings if possible)							
Open field (farmland) approximately 1.6nm west of FAMO (GPS co-ordinates: 34°09'21.10" South 022°01'36.80" East)							
Meteorological Information		Surface wind; 260°/3kt, temperature; 21°C, dew point; 16°C, CAVOK					
Number of People On-board	2 + 0	Number of People Injured	1	Number of People Killed	0	Other (On Ground)	0

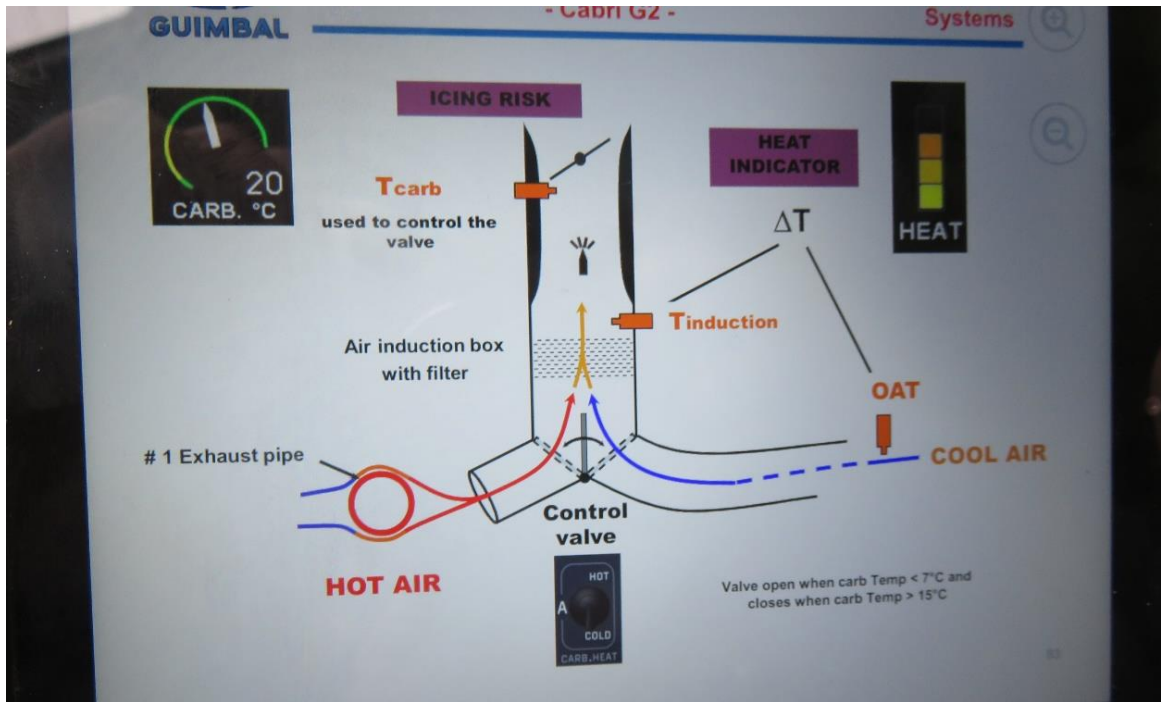
Figure 13: Illustration of the carburettor heating system.

The auto mode was selected when the helicopter was flown. This function does not require pilot's intervention, and the system detects the possibility of carburettor icing when the temperature in the carburettor drops to 7°C and below, it will allow hot air to enter the carburettor by opening a valve that bleeds hot air from the exhaust. Once the carburettor temperature reaches 15°C and above, the valve will close. Figure 13 illustrates the location of the temperature (Tcarb) probe in the carburettor that activates the valve. The valve is located within the air induction box that also contains the air filter.
