LIMITED OCCURRENCE INVESTIGATION REPORT – FINAL

Reference Number	CA18/2/3/10291					
Classification	Accident	Date	23 April 2023	Time	1450Z	
Type of Operation	General Aviation and Operating Flight Rules (Part 91)					
Location						
Place of Departure	Wonderboom Aerodrome (FAWB), Gauteng Province		Place of Intended Landing	Wonderboom Aerodrome (FAWB), Gauteng Province		
Place of Occurrence	Runway 29 at Wonderboom Aerodrome (FAWB), Gauteng Province					
GPS Co-ordinates	Latitude	25°39'7.79" S	Longitude	028°13'16.20" E	Elevation	4 095 ft
Aircraft Information						
Registration	ZS-KJU					
Make; Model; S/N	Rockwell Commander, 112TCA (Serial Number: 13183)					
Damage to Aircraft	Substantial		Total Airframe Hours	2 395.34		
Pilot-in-command						
Licence Type	Private Pilot Licence (PPL)			Gender	Male	Age 54
Licence Valid	Yes	Total Hours on Type	63.04	Total Flying Hours	144.1	
Total Hours 90 Days	3.0		Total Hours on Type Past 90 Days	3.0		
People On-board	1 + 0	Injuries	0	Fatalities	0	Other (on ground) 0

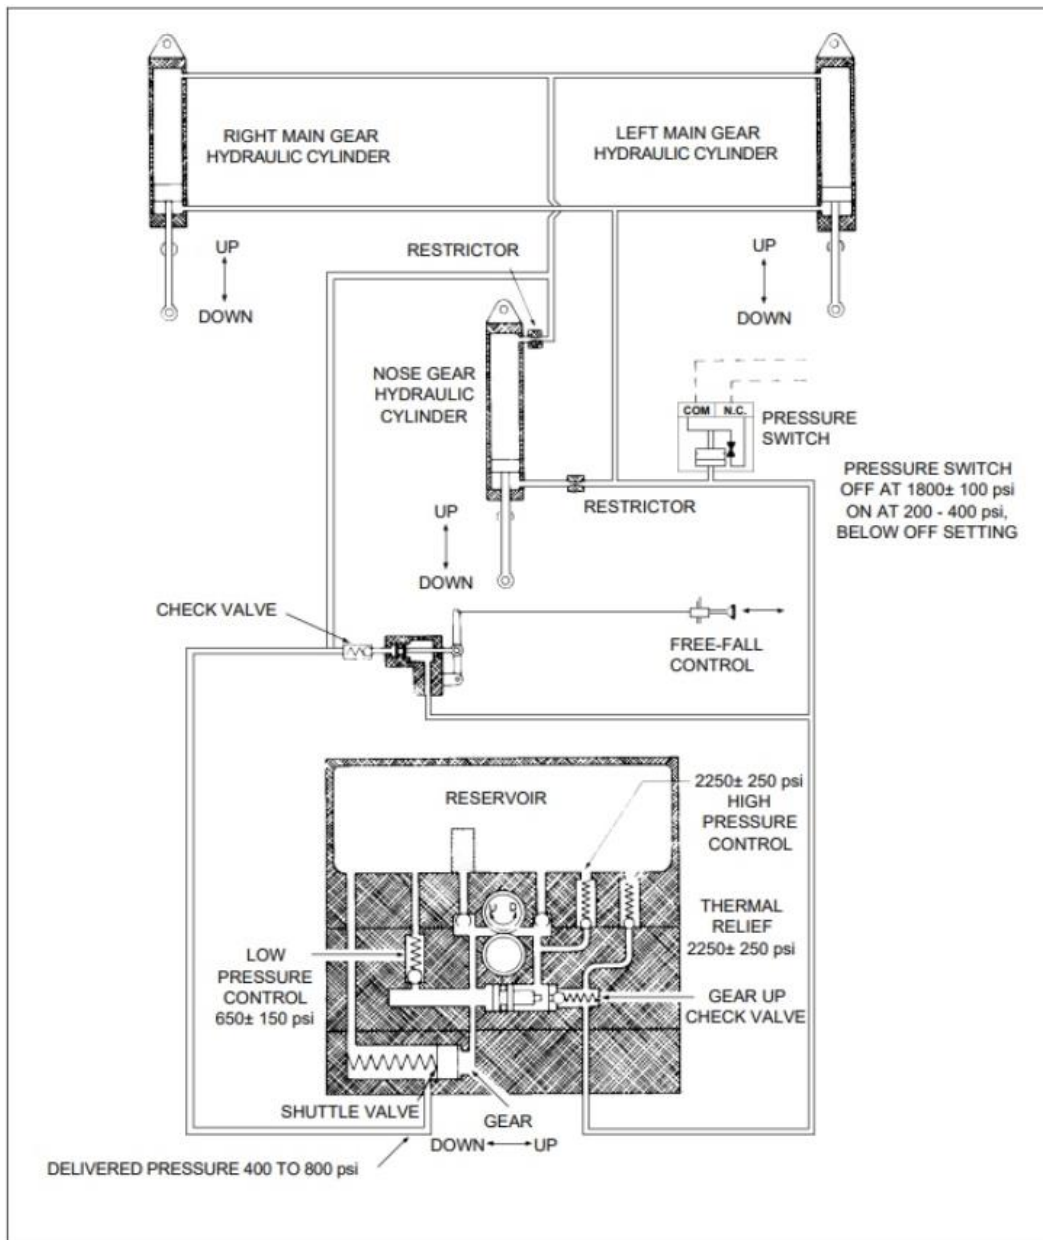
Diagram 1: The aircraft hydraulic system schematic. (Source: AFM)

When the landing gear selector switch is placed in the DOWN position, pressurised hydraulic fluid is directed through the hydraulic manifold to the downside of the actuator cylinders. When all three gears are down and locked (drag brace over centre) the power pack is turned off by a gear pressure switch set at 400 to 800 psi. Hydraulic pressure is maintained in the gear down system by a pilot operated check valve. The emergency dump valve bypasses fluid from the upside of the hydraulic actuators (which form the hydraulic uplock) directly to the reservoir, the gear then drop by gravity, assisted by down springs. When the emergency dump valve is in the down position, the gear will not retract because the pressure is being relieved through the dump valve back to the reservoir and not to the hydraulic cylinders.
