UAS LIMITED OCCURRENCE INVESTIGATION REPORT – FINAL

Reference Number	CA18/2/3/10292						
Classification	Accident	Date	24 April 2023		Time	2045Z	
Type of Operation	Remotely Piloted Aircraft Systems – Surveillance (Part 101)						
Location							
Place of Departure	Syferfontein Mine, Mpumalanga Province		Place of Intended Landing	Syferfontein Mine, Mpumalanga Province			
Place of Occurrence	Syferfontein Mine in Mpumalanga Province						
GPS Co-ordinates	Latitude	26° 24' 36.86" S	Longitude	29° 12' 13.35" E	Elevation	5253 ft	
Aircraft Information							
Registration	ZT-UZY		Class	3A			
Make; Model; S/N	Da-Jiang Innovations (DJI); Mavic 2 Enterprise (Serial Number: MAV0014)						
Damage to Aircraft	Substantial		Total UAS Hours	3743.1			
Pilot-in-command							
Licence Type	Remote Pilot Licence (RPL)		Gender	Male		Age	28
Licence Valid	Yes	Total Hours	332.4		Total Hours on Type	332.4	
Total Hours Past 90 Days	153.5		Total Flying Past 90 Days on Type	153.5			
Injuries	0	Injuries (On Ground)	0	Fatalities (On Ground)	0

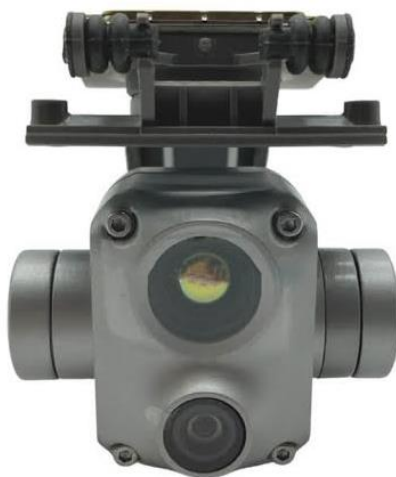
1. When the aircraft is powered on, do not tap or knock the gimbal. To protect the gimbal during take-off, always take-off from open and flat ground.
2. Precision elements in the gimbal may be damaged in a collision or impact, which may cause the gimbal to function abnormally.

- b) The gimbal experiences excessive external force, such as during a collision.
5. DO NOT apply external force to the gimbal after the gimbal is powered on. DO NOT add any extra payload to the gimbal as this may cause the gimbal to function abnormally or even lead to permanent motor damage.

Figure 2: Mavic 2 Enterprise gimbal. (Source: Manufacturer)
