AIRCRAFT ACCIDENT REPORT AND EXECUTIVE SUMMARY

Reference:		CA18/2/3/10337	
Aircraft Registration	ZS-TFH	Date of Accident	21 June 2023		Time of Accident	1436Z	
Type of Aircraft	Air Tractor AT- 802A			Type of Operation		Aerial Works - Firefighting (Part 137)	
Pilot-in-command Licence Type	Commercial Pilot Licence (CPL)		Age	49	Licence Valid	Yes	
Pilot-in-command Flying Experience	Total Flying Hours		3 146.80		Hours on Type	273.2	
Last Point of Departure	Nelspruit Airport (FANS), Mpumalanga Province						
Next Point of Intended Landing	Elandshoogte Airfield near Ngodwana, Mpumalanga Province						
Damage to Aircraft	Destroyed						
Location of the accident site with reference to easily defined geographical points (GPS readings if possible)							
Nooitgedacht Plantation (SAPPI) in Ngodwana at GPS co-ordinates 25°39'33.03" S 030°32'10.01" E at an elevation of 6322 feet (ft)							
Meteorological Information	Wind direction: 080°; wind speed: 2 kts; visibility: 5km; cloud cover: scattered; cloud base: 1 300ft; temperature: 19°C; dew point: 11°C; QNH: 1019

Probable Cause/s and/or Contributory Factors							
The pilot misjudged the climb height required to clear the terrain. This resulte

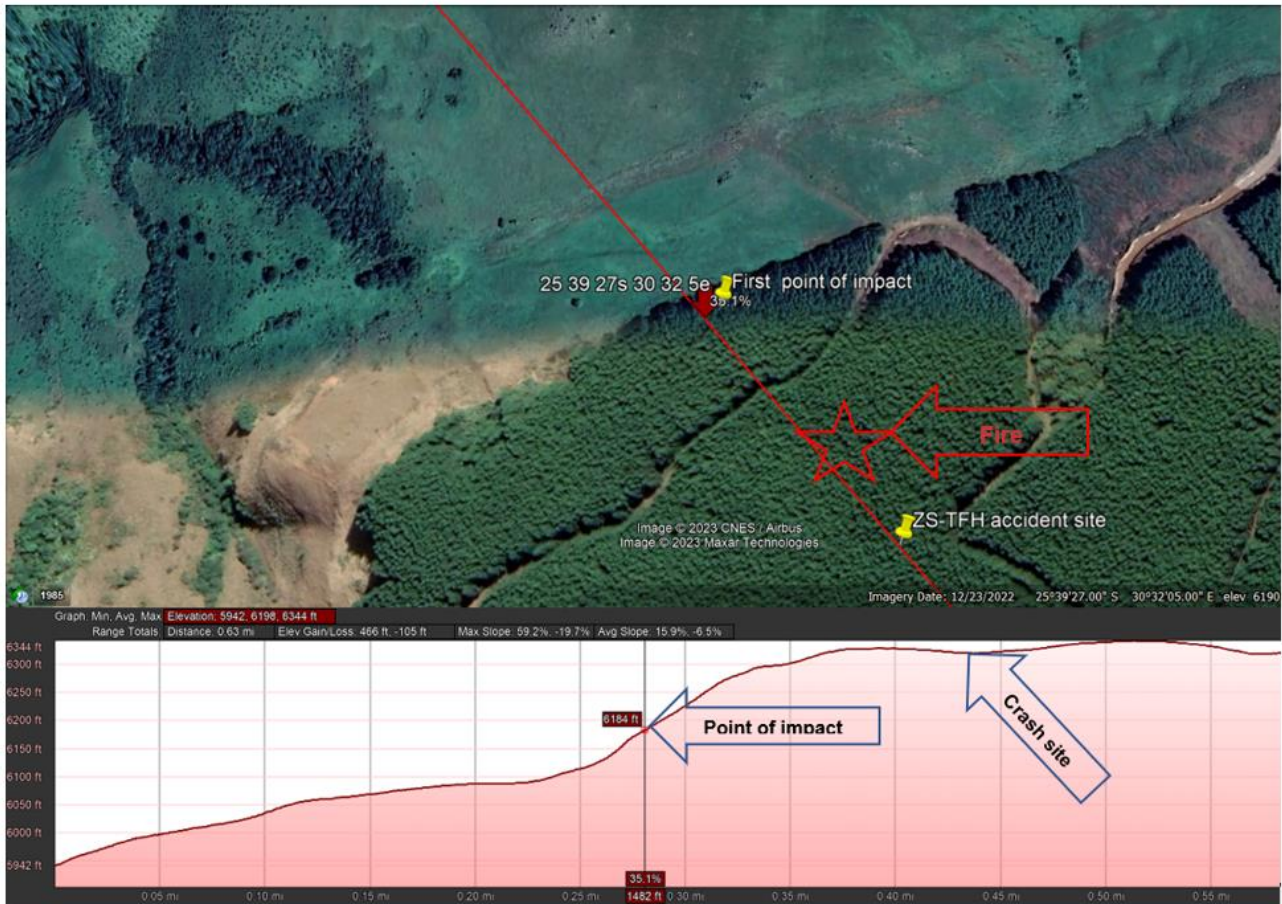
Figure 2: An aerial view (top) and elevation profile (bottom) of the crash site. (Source: Google Earth)

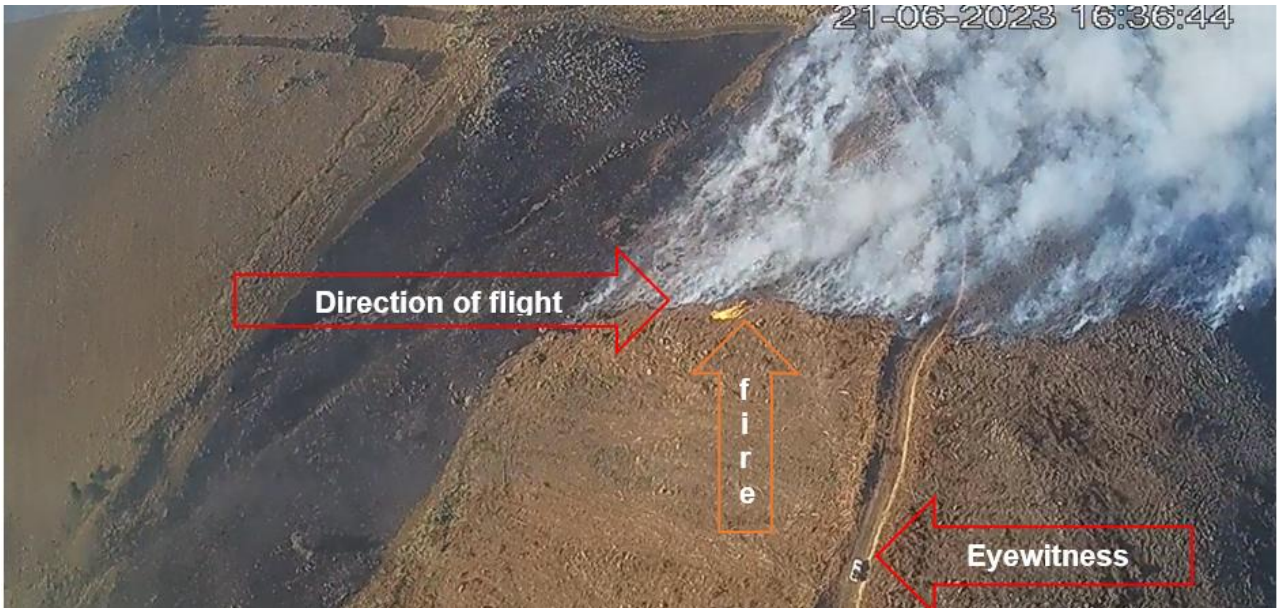
Figure 6: The direction of flight, the area that was on fire (pre-existing) and position of the eyewitness. (Source: Operator)

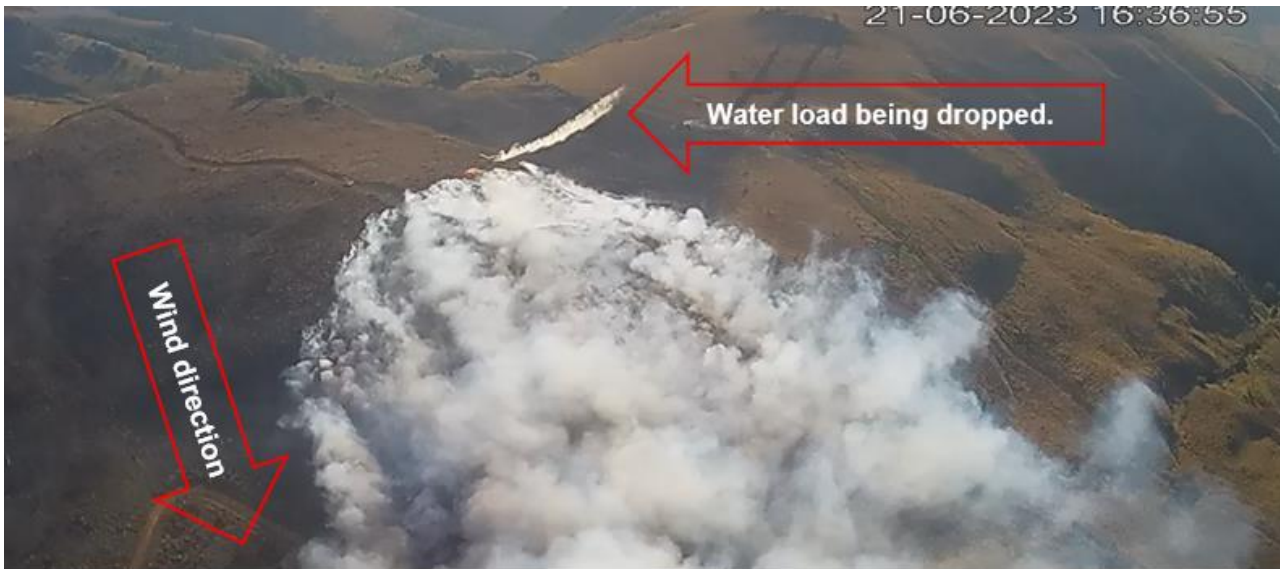
1.12.3 The aircraft was flying perpendicular to the wind direction (see Figure 7 below).

Figure 7: Wind direction at the time ZS-TFH released water on the fire line. (Source: Operator)

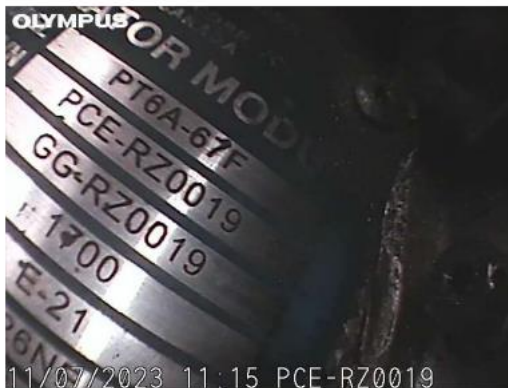
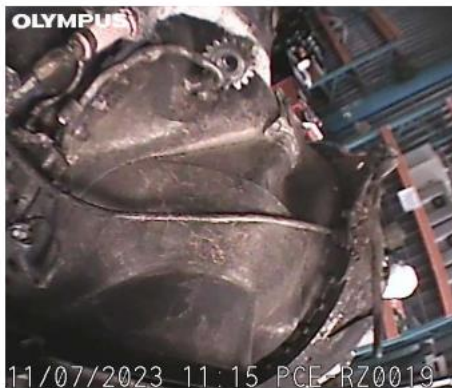
Engine s/n. PCE-RZ0019.

Compressor Section: Access through the inlet housing was used to inspect the inlet housing, 1st stage compressor rotor blades, 1st stage compressor stator and the 2nd stage compressor blades. Compressor inlet housing was found in fair condition with moderate coating deterioration and associated areas of coating loss and dirt build-up observed. 1st stage compressor rotor blades found in fair condition with light to moderate levels of FOD & erosion and with previous blends observed. 1st stage stator and 2nd stage compressor blades found in fair condition with light levels of erosion and FOD./nicks observed. Heavy levels of dirt and debris contamination observed throughout the compressor section.
