UAS LIMITED OCCURRENCE INVESTIGATION REPORT – FINAL

Reference Number	CA18/2/3/10344						
Classification	Accident	Date	4 July 2023		Time	2202Z	
Type of Operation	Remotely Piloted Aircraft System (Part 101)						
Location							
Place of Departure	Panbult near Piet Retief, Mpumalanga Province		Place of Intended Landing	Panbult near Piet Retief, Mpumalanga Province			
Place of Occurrence	Open field in Panbult near Piet Retief, Mpumalanga Province						
GPS Co-ordinates	Latitude	26°49'.38" S	Longitude	30°29'.05" E	Elevation	4 725 feet	
Aircraft Information							
Registration	ZT-XRX		Class	3A			
Make; Model; S/N	Arace Sirin (Serial Number: SIR0038)						
Damage to UAS	Substantial			Total UAS Hours	819.19		
Pilot-in-command							
Licence Type	Remote Pilot Licence (RPL)		Gender	Male	Age	33	
Licence Valid	Yes	Total Hours	282.35		Total Hours on Type	97.45	
Total Hours Past 90 Days	97.45		Total Flying Hours on Type Past 30 Days	35.2			
People Controlling	1	Injuries	0	Fatalities	0	Other (on ground)	0

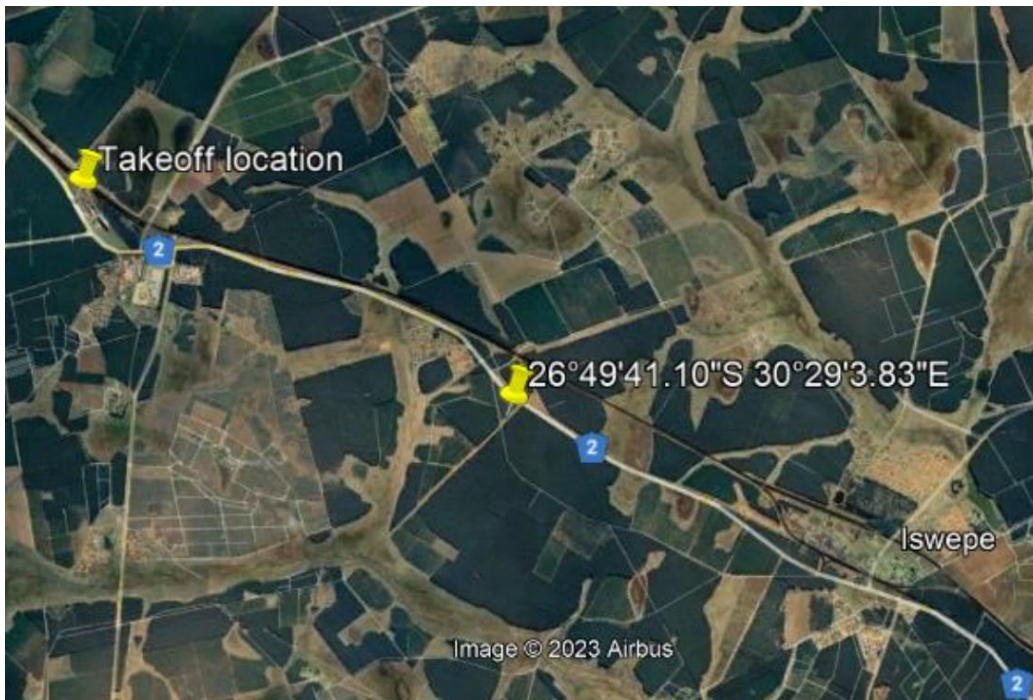
The accident occurred during nighttime at Global Positioning System (GPS) co-ordinates determined to be 26°49'.38" South 30°29'.05" East, at an elevation of 4 725 feet (ft).

Figure 1: The take-off location and the accident site. (Source: Operator)
