## AIRCRAFT ACCIDENT REPORT AND EXECUTIVE SUMMARY

<b>Reference:</b>		CA18/2/3/10346	
<b>Paraglider Registration</b>	N/A	<b>Date of Accident</b>	3 July 2023		<b>Time of Accident</b>	1424Z	
<b>Type of Paraglider</b>	Duet Pro		<b>Type of Operation</b>		Training (Part 141-Subpart 8)		
<b>Pilot-in-command Licence Type</b>	National Pilot Licence (NPL)		<b>Age</b>	22		<b>Licence Valid</b>	Yes
<b>Pilot-in-command Flying Experience</b>	<b>Total Flying Hours</b>		380		<b>Total Hours on Type</b>	380	
<b>Last Point of Departure</b>	Signal Hill in Cape Town, Western Cape Province						
<b>Next Point of Intended Landing</b>	Sea Point Promenade grass area in front of the Winchester Mansions Hotel, Western Cape Province						
<b>Damage to Paraglider</b>	Substantial						
<b>Location of the accident site with reference to easily defined geographical points (GPS readings if possible)</b>							
Atlantic Ocean, approximately 114m from the shoreline at GPS co-ordinates determined to be South 33°54'38.1" East 18°23'26.5" at an elevation of about 65ft

<b>Probable Cause</b>							
Paraglider 1 conducted a manoeuvre which resulted in a collision with Paraglider 2, and Paraglider 1 flight instructor lost

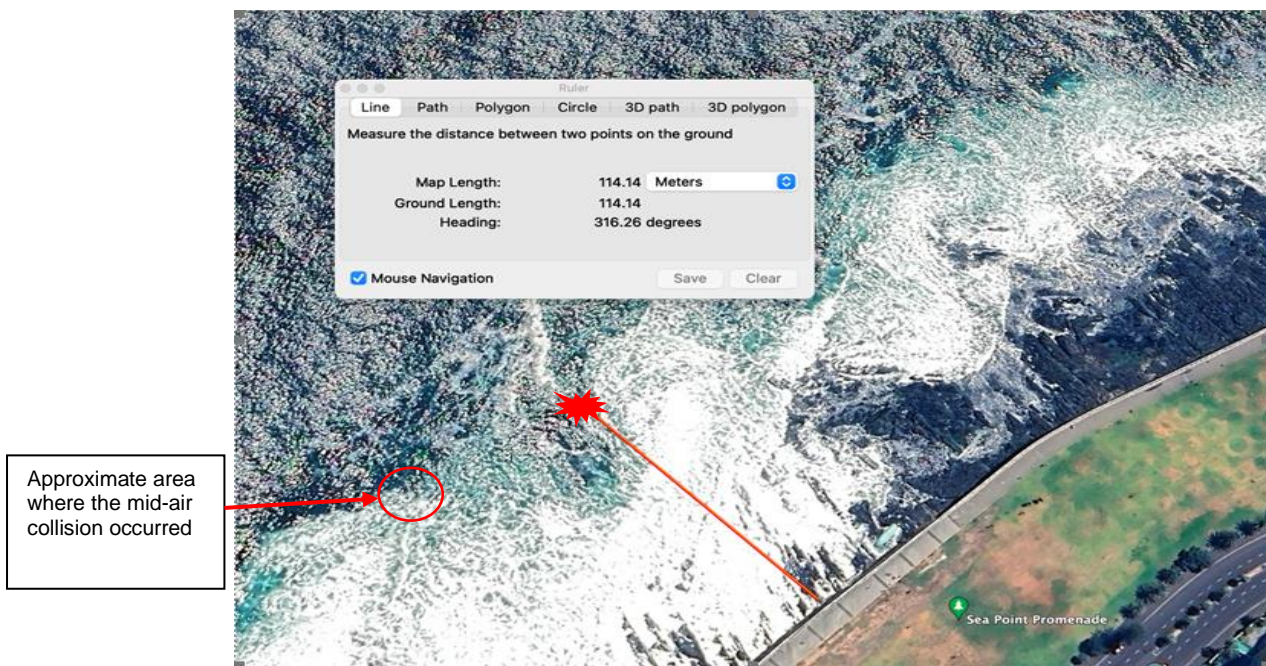
**Figure 10:** The approximate area where the mid-air collision occurred and the crash area which was approximately 114m from the shoreline. (Source: Google Earth)

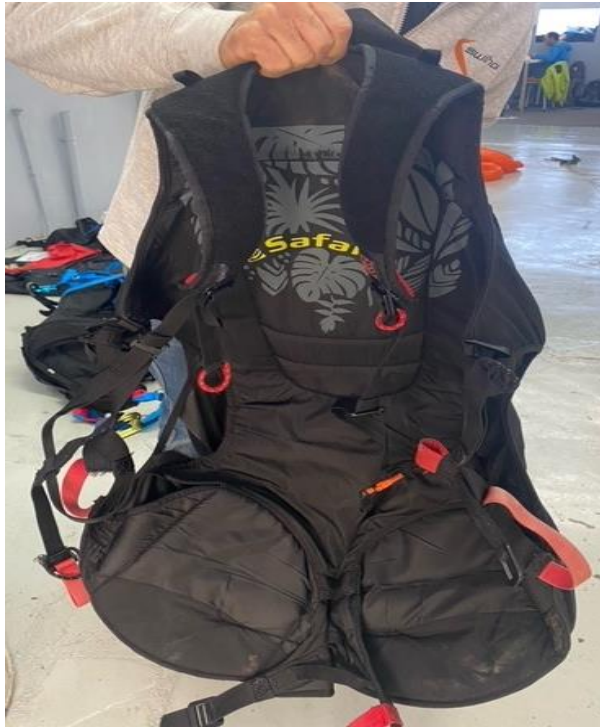
1.16.4 Paraglider 1 flight instructor and student pilot's seats were examined and were found to be intact with the safety harness clips operational. The reserve parachute was also inspected; the reserve strop, which is a connection point between the reserve parachute and the paraglider, had snapped during the accident sequence.

**Figure 13:** The student pilot's seat.

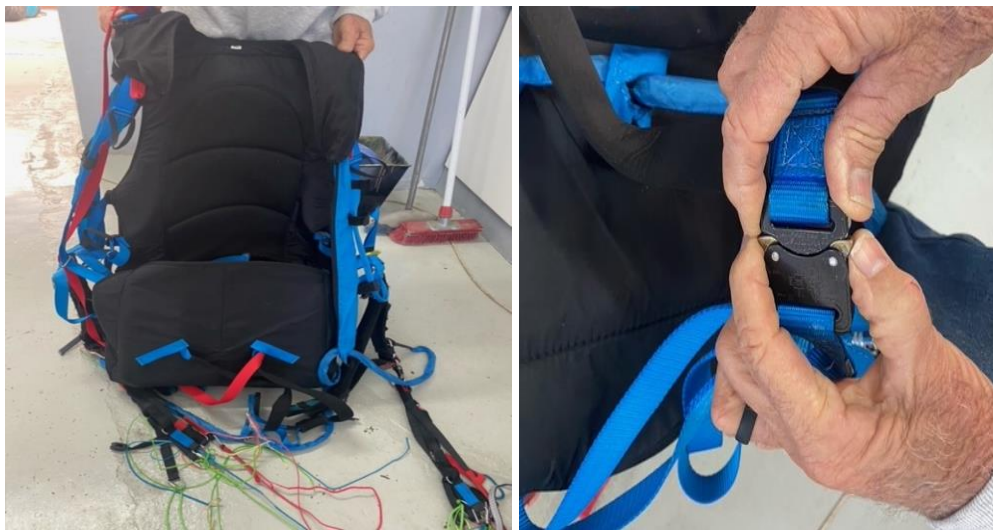
**Figures 14/15:** The flight instructor's seat (left) and its safety buckle/clip in a locked position (right).
