## AIRCRAFT ACCIDENT REPORT AND EXECUTIVE SUMMARY

<b>Reference:</b>		CA18/2/3/10346		
<b>Paraglider Registration</b>	N/A	<b>Date of Accident</b>	3 July 2023		<b>Time of Accident</b>	1424Z		
<b>Type of Paraglider</b>	Duet Pro		<b>Type of Operation</b>		Training (Part 141-Subpart 8)			
<b>Pilot-in-command Licence Type</b>	National Pilot Licence (NPL)		<b>Age</b>	22		<b>Licence Valid</b>	Yes	
<b>Pilot-in-command Flying Experience</b>	<b>Total Flying Hours</b>		380		<b>Total Hours on Type</b>	380		
<b>Last Point of Departure</b>	Signal Hill in Cape Town, Western Cape Province							
<b>Next Point of Intended Landing</b>	Sea Point Promenade grass area in front of the Winchester Mansions Hotel, Western Cape Province							
<b>Damage to Paraglider</b>	Substantial							
<b>Location of the accident site with reference to easily defined geographical points (GPS readings if possible)</b>								
Atlantic Ocean, approximately 114m from the shoreline at GPS co-ordinates determined to be South 33°54'38.1" East 18°23'26.5" at an elevation of about 65ft

**Reference Number** : CA18/2/3/10346  
**Occurrence Category** : Accident (Category 1)  
**Type of Operation** : Training (Part 141)  
**Parag

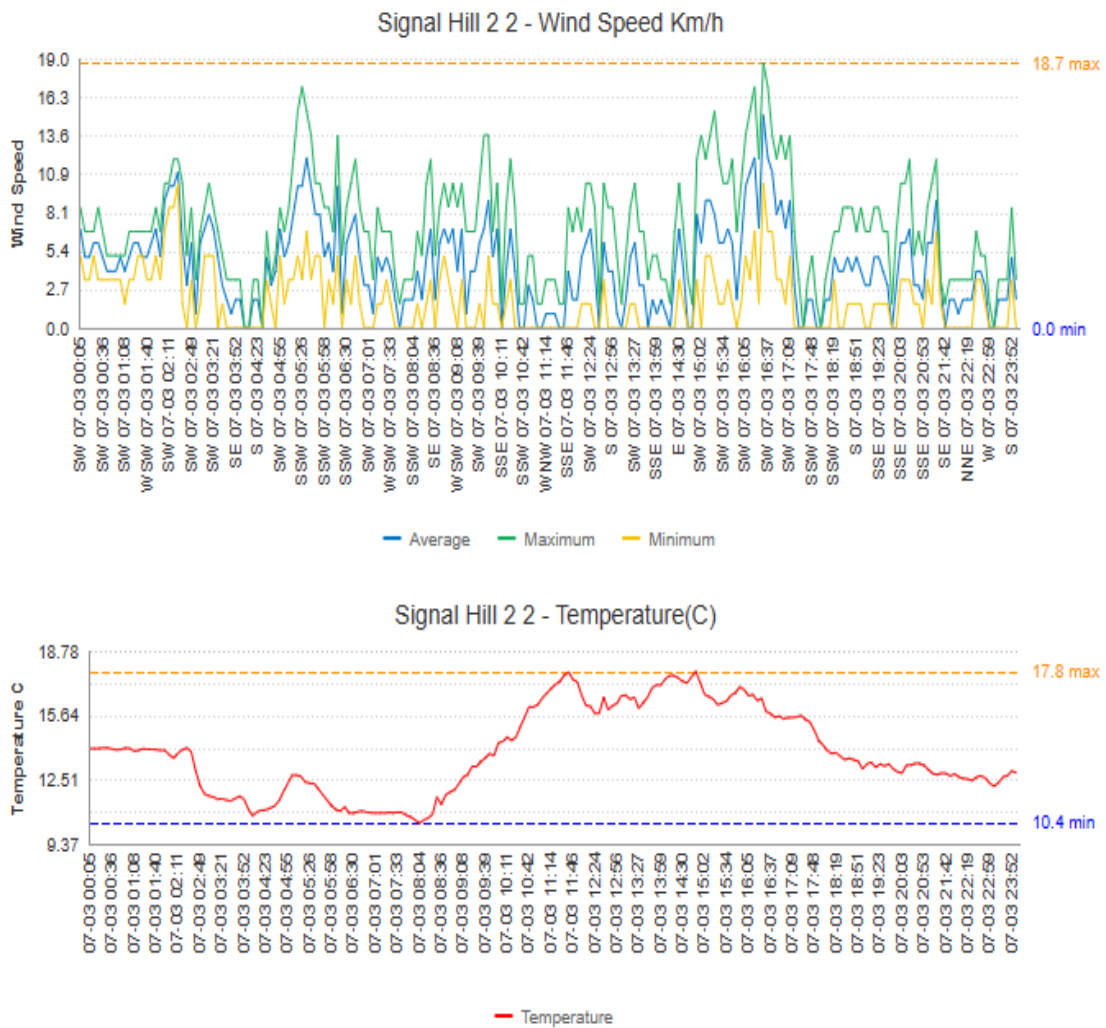
**Figure 5:** The weather information obtained from the Wind Talker at Signal Hill. (Source: SAHPA)

1.7.1 The weather information and graphs below were obtained from the Wind Talker, a local weather station at Signal Hill. This information was made available to the investigation team by SAHPA officials.

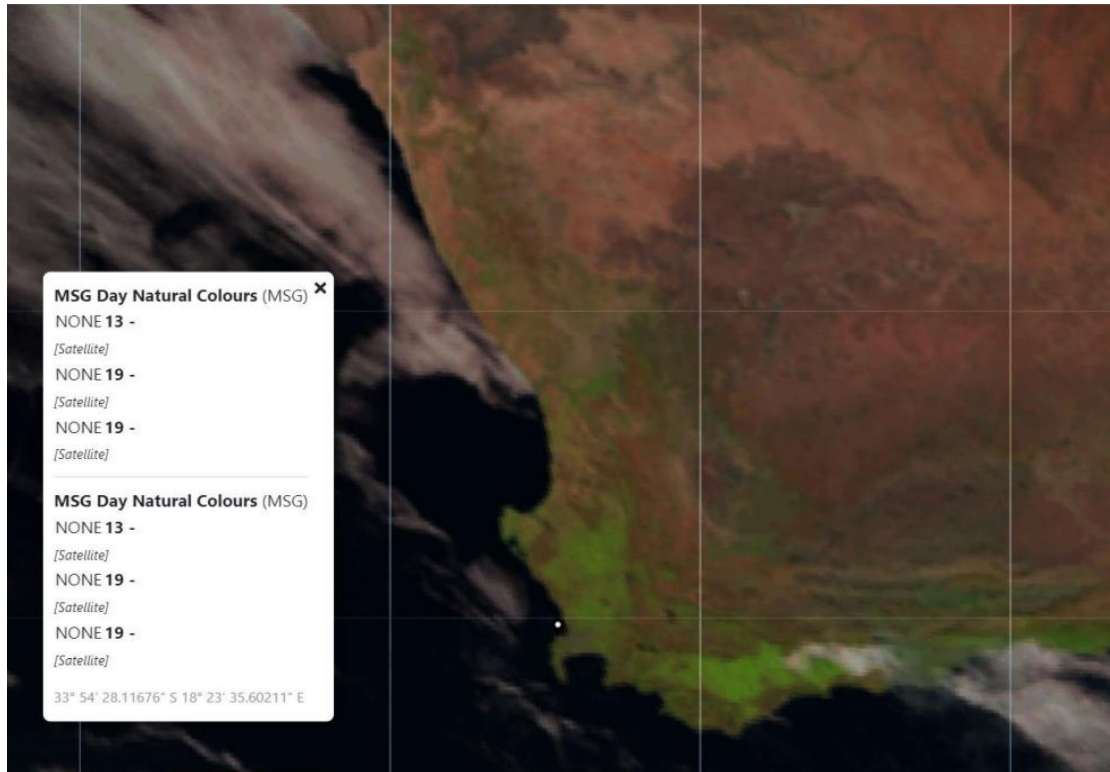
**Figure 6:** The weather forecast indicated no clouds in the vicinity of the accident site (location indicated by the white spot).

Wind Direction	Variable	Wind Speed	03 knots	Visibility	9999m
Temperature	19°C	Cloud Cover	CAVOK	Cloud Base	NIL
Dew Point	12°C	QNH	1014 hPa

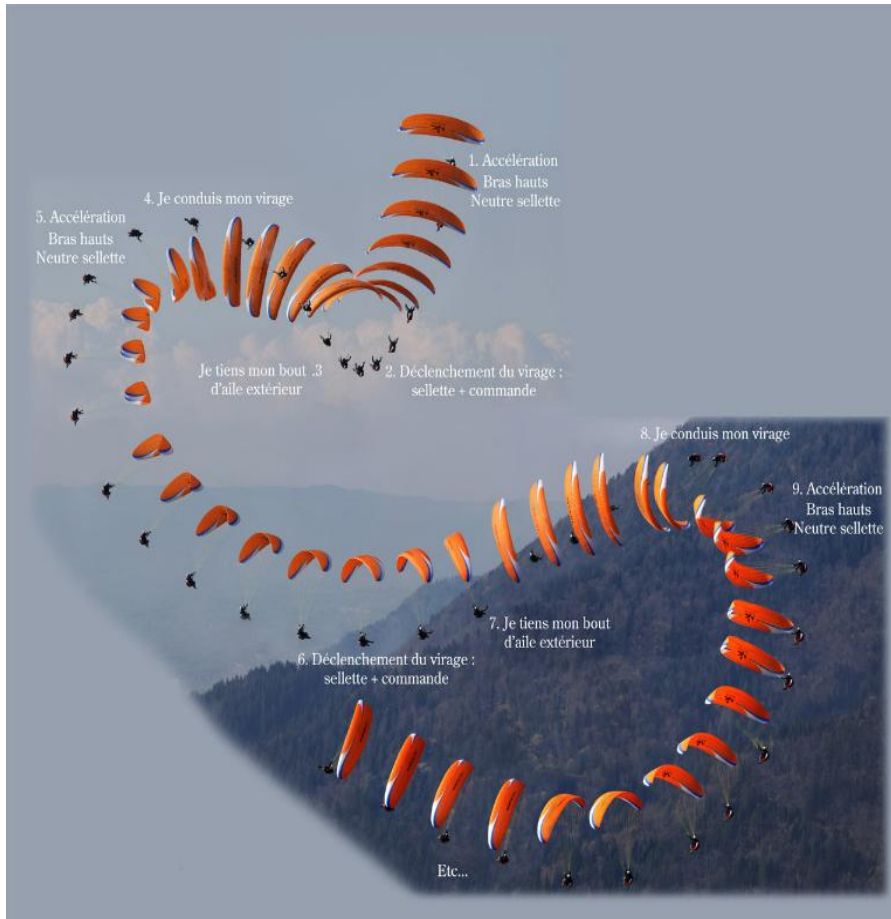
**Figure 16:** An illustration of wing over manoeuvres.

TE 00:24, Paraglider 1 was above the ocean in line with the shore. The flight instructor was observed performing what is referred to as "wing over manoeuvres", although he did not appear to conduct a comprehensive scan of the air space around him before undertaking the manoeuvres.

*If you do not brake (or not enough) the paraglider at the highest point, you can get huge and dynamic collapses on the upper side (big danger of large cravattes, riser twists). At the beginning start the weight shifting just after you pass the highest point and pull the brake before the lowest. By this your wing over will not be so high, but it will be more dynamic and safer. When you feel confident, you can pull it later and later, to increase the amplitude of the turns. Be careful, if you start to brake after the lowest point, the following turn could be very high, but you lose too much energy and there is high risk to get a big collapse on the top of the roll (and then you fall down next to the wing/canopy). However, if you feel it is going to happen (you slow down too much, and the lines starts to lose the tension) pull down the brakes deeply until you start to swing back under the glider (the brake pressure will be very slight) to prevent the collapse or leastwise to moderate the consequences.*

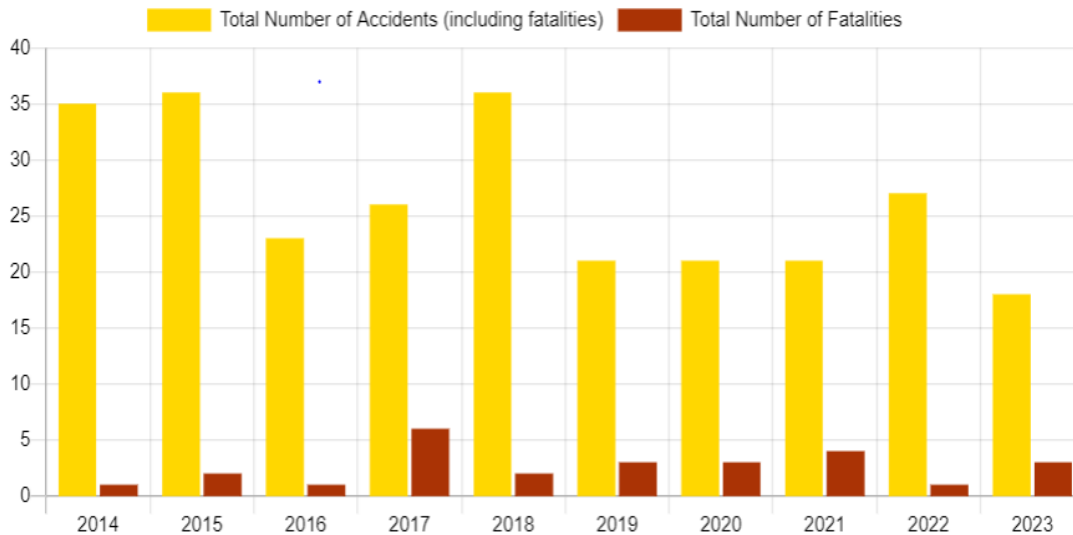
1.18.5.1 The above statistics indicate paraglider accidents that occurred over the past 10 years.
