AIRCRAFT ACCIDENT REPORT AND EXECUTIVE SUMMARY

Reference:		CA18/2/3/10350	
Aircraft Registration	ZS-ARC	Date of Accident	11 July 2023		Time of Accident	0617Z	
Type of Aircraft	Thrush S2R-H80		Type of Operation		Aerial Work - Crop Spraying (Part 137)		
Pilot-in-command Licence Type	Commercial Pilot Licence (CPL)		Age	43	Licence Valid	Yes	
Pilot-in-command Flying Experience	Total Flying Hours		11 044	Hours on Type	9 924.6		
Last Point of Departure	Rosenburg Farm, Malmesbury, near Western Cape Province						
Next Point of Intended Landing	Rosenburg Farm, Malmesbury, near Western Cape Province						
Damage to Aircraft	Substantial						
Location of the accident site with reference to easily defined geographical points (GPS readings if possible)							
Droeivlei Farm, approximately 10km south of Malmesbury at GPS 33°36'59.7" South 018°42'36.8" East, at an elevation of 357 feet (ft)							
Meteorological Information	Wind direction: 360°, wind speed: 2 knots, CAVOK, temperature: 3°C, Dew point 2°C, QNH 1023

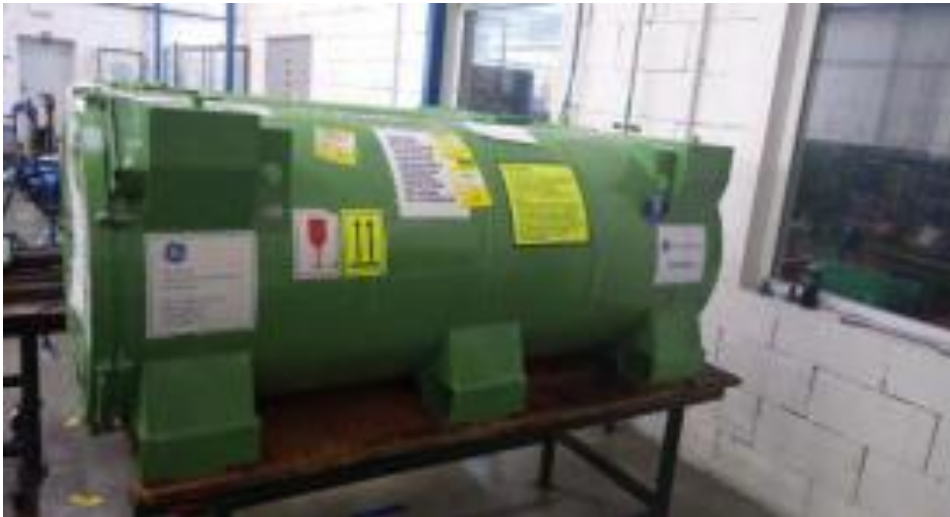
Figure 7: The engine before it was removed from the shipping container. (Source: engine manufacture)

1.16.3 The engine tear-down inspection was conducted from 31 August 2023 to 1 September 2023 in the presence of the operator's accredited representatives, Avia Propeller, as well as the Air Accidents Investigation Institute (AAIL) from the Czech Republic. The engine was in good condition with no visible damage.
