AIRCRAFT ACCIDENT REPORT AND EXECUTIVE SUMMARY

Reference:		CA18/2/3/10351	
Aircraft Registration	ZS-GMD	Date of Accident	15 July 2023	Time of Accident	1030Z		
Type of Aircraft	UFM-13 Lambada		Type of Operation	Private (Part 94)			
Pilot-in-command Licence Type	National Pilot Licence (NPL)		Age	60	Licence Valid	No	
Pilot-in-command Flying Experience	Total Flying Hours		2 708.3	Hours on Type	5.5		
Last Point of Departure	Orient Airfield (FAOI) in Magaliesburg, Gauteng Province						
Next Point of Intended Landing	Orient Airfield (FAOI) in Magaliesburg, Gauteng Province						
Damage to Aircraft	Substantial						
Location of the accident site with reference to easily defined geographical points (GPS readings if possible)							
Approximately 100 metres (m) south-west of Runway 36 at GPS 26°02'42.70" South 027°35'47.66" East, at an elevation of 5 122 feet (ft)							
Meteorological Information	Surface Wind: 260V360 at 9 knots, Visibility: 9999m, Temperature: 13°C, Dew Point: 3°C: QNH 1029 hPa

During a climb, the TMG's attitude reached a high critical angle-of-attack which resulted in a stall from which the pilot could not recover.

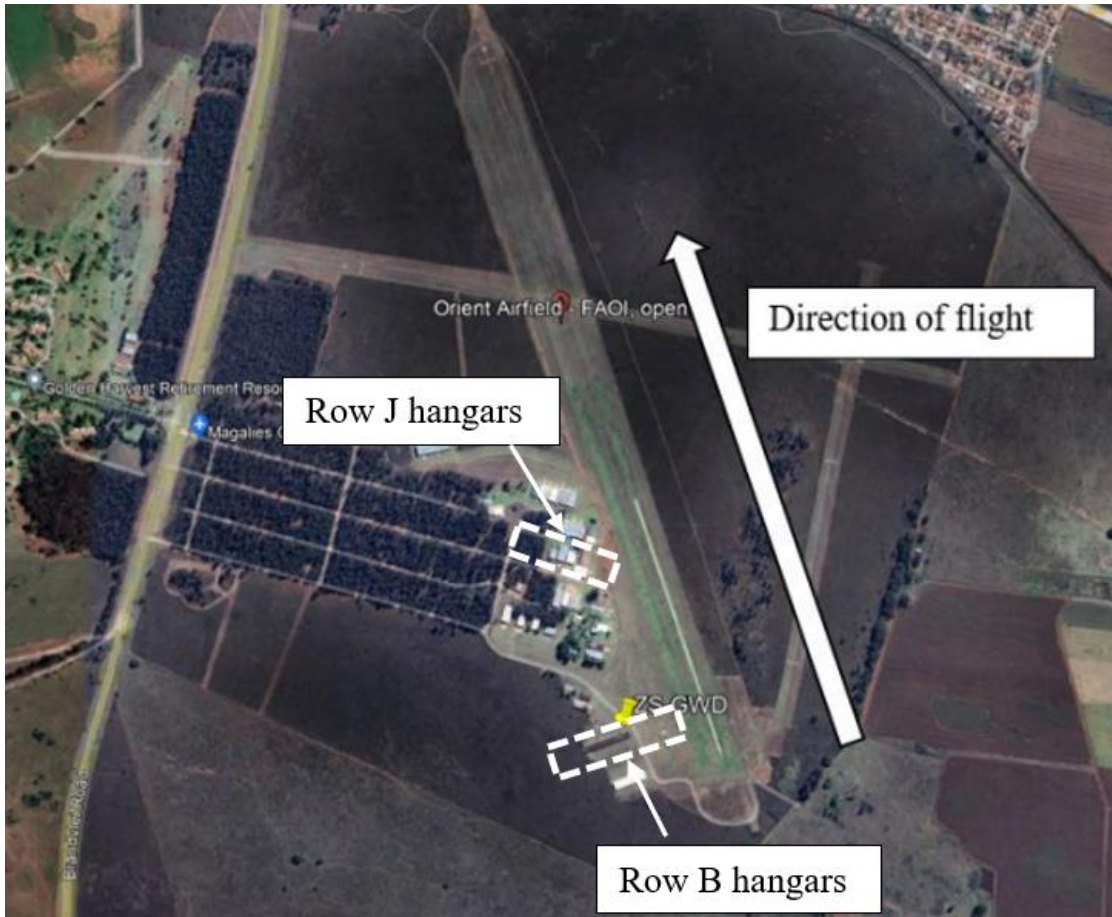
- 1.1.4. The Aeronautical Rescue Coordination Centre (ARCC) was notified of the accident, and they notified the Emergency Medical Services (EMS) at Gauteng Provincial Services, the South African Police Service (SAPS) and the South Africa Search and Rescue (SARZA). The SAPS arrived first at the scene followed by the EMS and SARZA.
- 1.1.5. The TMG accident occurred during the day at FAOI at Global Positioning System (GPS) coordinates determined to be 26°02'42.70" South 027°35'47.66" East, at an elevation of 5 122 feet (ft).

Figure 1: Overview of the accident site. (Source: Google Earth)
