**LIMITED OCCURRENCE INVESTIGATION REPORT – FINAL**

<b>Reference Number</b>	CA18/2/3/10355						
<b>Classification</b>	Accident	<b>Date</b>	27 July 2023			<b>Time</b>	0700Z
<b>Type of Operation</b>	Training (Part 141)						
<b>Location</b>							
Place of Departure	Hoedspruit Civil Aerodrome (FAHT), Limpopo Province			Place of Intended Landing	Hoedspruit Civil Aerodrome (FAHT), Limpopo Province		
Place of Occurrence	15 metres west of Runway (RWY) 35 at Hoedspruit Civil Aerodrome (FAHT)						
GPS Co-ordinates	Latitude	24° 20' 56.37" S	Longitude	030° 56' 48.12" E	Elevation	1 761 ft	
<b>Aircraft Information</b>							
Registration	ZU-IOZ						
Make; Model; S/N	Savannah Aircraft Africa; Savannah S (Serial Number: 18-11-54-0643)						
Damage to Aircraft	Substantial			Total Aircraft Hours	797		
<b>Pilot-in-command</b>							
Licence Type	Student Pilot Licence (SPL)		Gender	Male		Age	22
Licence Valid	Yes	Total Hours	14.5		Total Hours on Type	14.5	
Total Hours 30 Days	14.5		Total Flying on Type Past 90 Days	14.5

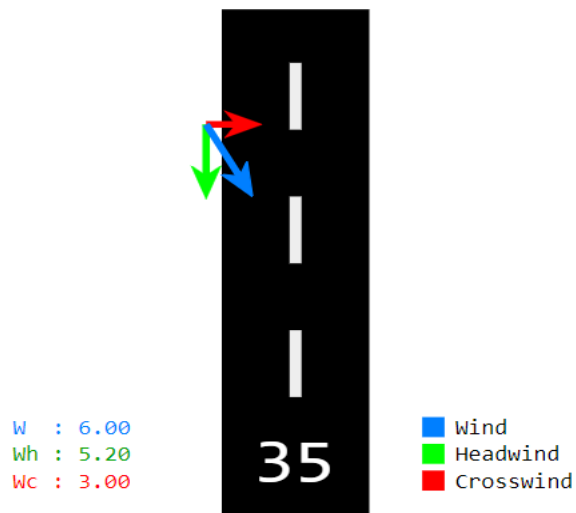
The weather information in the table below was obtained from the South African Weather Service (SAWS) for FAHT on 27 July 2023 at 0700Z. The weather was not a factor in this accident.

**Figure 2:** Crosswind component calculation. (Source: E6BX.com)
