LIMITED OCCURRENCE INVESTIGATION REPORT – FINAL

Reference Number	CA18/2/3/10358						
Classification	Accident	Date	13 August 2023	Time	1325Z		
Type of Operation	Private Flight (Part 91)						
Location							
Place of Departure	Prince Albert Airport (FAPC), Western Cape Province		Place of Intended Landing	Prince Albert Airport (FAPC), Western Cape Province			
Place of Occurrence	Prince Albert Airport (FAPC) Runway 19						
GPS Co-ordinates	Latitude	33°11'20" S	Longitude	022°01'06.74" E	Elevation	1801 feet (ft)	
Aircraft Information							
Registration	ZS-TKP						
Make; Model; S/N	Cessna 177 RG (Serial Number: 177RG-0797)						
Damage to Aircraft	Substantial		Total Aircraft Hours	4379.3			
Pilot-in-command							
Licence Type	Airline Transport Pilot Licence		Gender	Male		Age	45
Licence Valid	Yes	Total Hours	6722		Total Hours on Type	17.1	
Total Hours past 30 Days	0.8		Total Flying Hours on Type Past 90 Days	3.9			
People On-board	1 + 1	Injuries	0	Fatalities	0	Other (on ground)	0

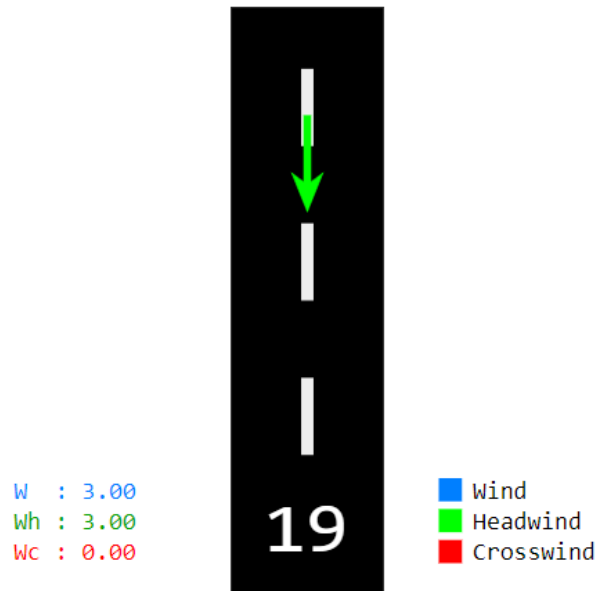
Wind Direction	190°	Wind Speed	3 knots	Visibility	9999
Temperature	22°C	Cloud Cover	CAVOK	Cloud Base	-
Dew Point	-	QNH	-

Figure 3: Wind component. (Source: <https://e6bx.com/wind-components>)
