**LIMITED OCCURRENCE INVESTIGATION REPORT – FINAL**

<b>Reference Number</b>	CA18/2/3/10359						
<b>Classification</b>	Accident	<b>Date</b>	12 August 2023	<b>Time</b>	1440Z		
<b>Type of Operation</b>	Private (Part 94)						
<b>Location</b>							
Place of Departure	Vereeniging Airfield (FAVV), Gauteng Province		Place of Intended Landing	Vereeniging Airfield (FAVV), Gauteng Province			
Place of Occurrence	On the grass next to Runway 21, Vereeniging Airfield (FAVV)						
GPS Co-ordinates	Latitude	26°33.78'S	Longitude	27°57.68'E	Elevation	4 847ft	
<b>Aircraft Information</b>							
Registration	ZU-AKE						
Make; Model; S/N	Piper Aircraft Corporation; PA 22-150 Tri-pacer (Serial Number: 22-6033)						
Damage to Aircraft	Substantial		Total Aircraft Hours	375.33			
<b>Pilot-in-command</b>							
Licence Type	Airline Transport Pilot Licence (ATPL)		Gender	Male		Age	41
Licence Valid	Yes	Total Hours	7134		Total Hours on Type	29.8	
Total Hours 30 Days	7		Total Flying on Type Past 90 Days	28

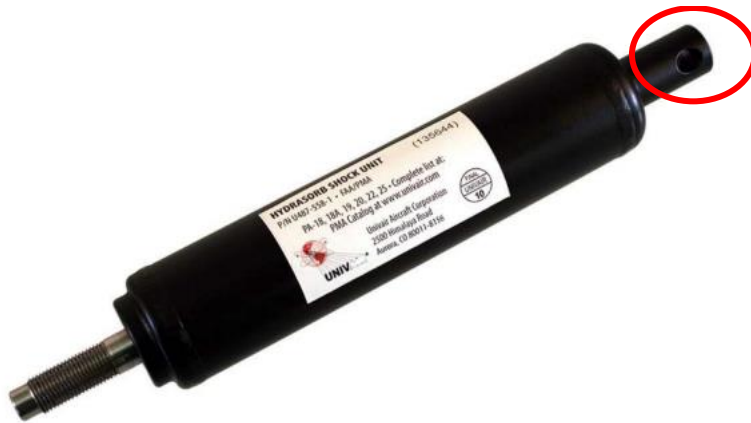
**Figure 7:** New Hydrasorb shock absorber with bottom mounting boss (top right).

When worn out, this sealed unit must be replaced.

The hydraulic units cannot be repaired and must also be replaced when worn.

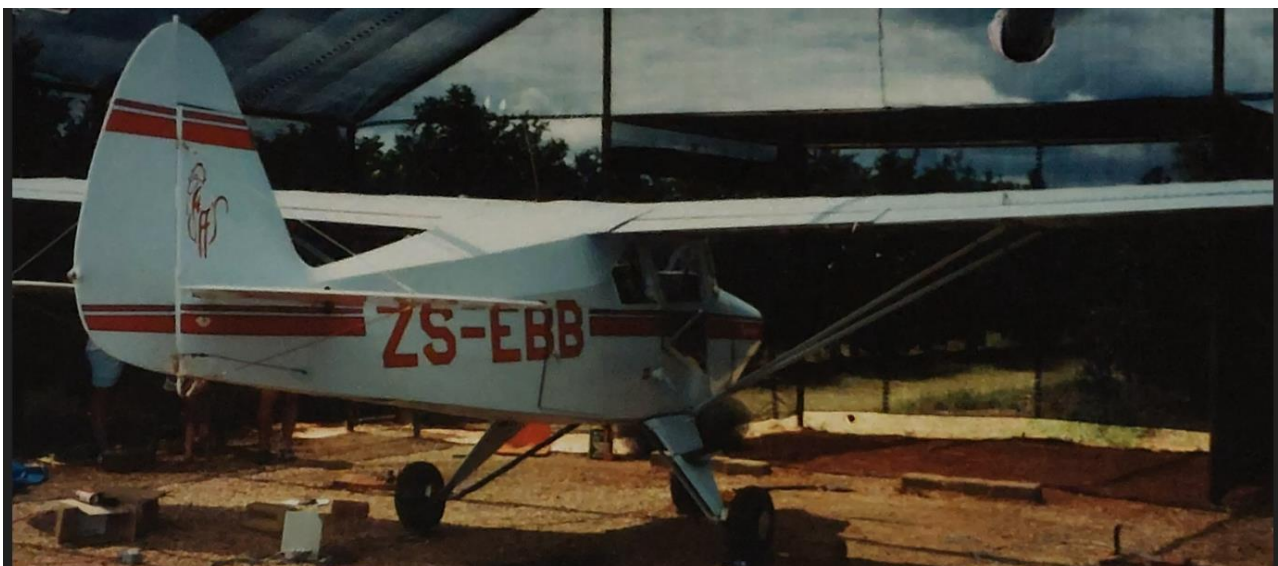
According to available information, the aircraft was initially registered as ZS-EBB Tri-Pacer (nose wheel configuration). On 6 January 2005, it was involved in an accident after it experienced engine failure during a climb, which was followed by an unsuccessful landing at Empangeni Airfield (FAEM). The aircraft was destroyed on impact with the ground; no injuries were reported during this accident.

**Figure 9:** ZS-EBB Tri-Pacer (nose wheel configuration) before modification.

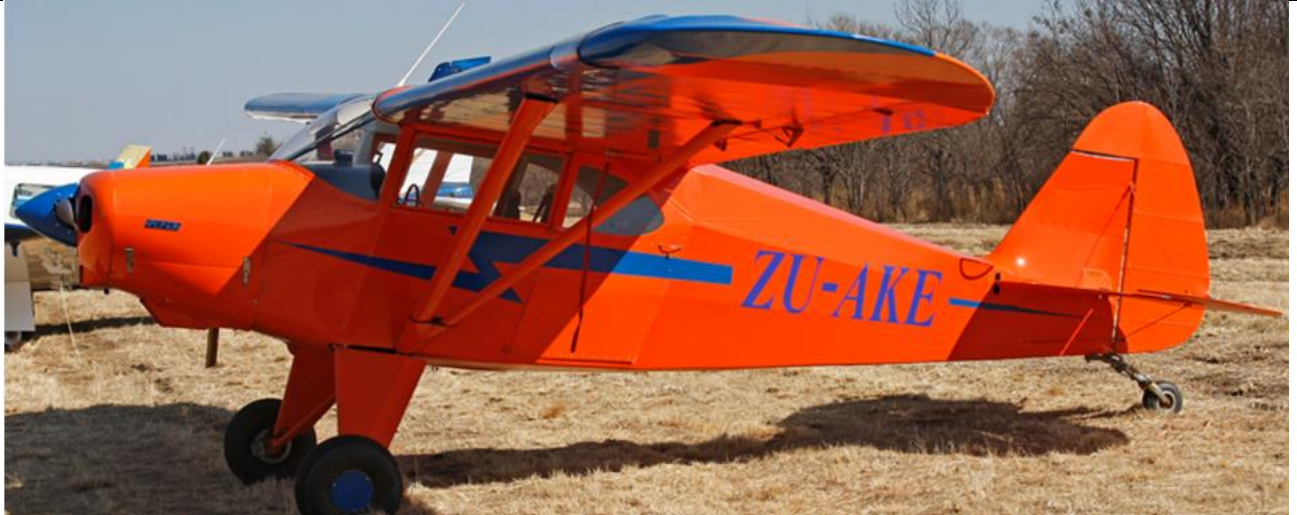
Following this accident, two airframes, namely, ZS-EBB and ZU-AKE Pacer (tail wheel configuration) were merged to create another aircraft. An application for modification was made to convert the aircraft to a tail wheel configuration, and the modification was approved by the Regulator on 23 November 2010. As most parts came from ZU-AKE, the aircraft carried the ZU-AKE Pacer registration.

**Figure 10:** ZU-AKE Pacer (tail wheel configuration) after modification.
