AIRCRAFT ACCIDENT REPORT AND EXECUTIVE SUMMARY

Reference:		CA18/2/3/10361	
Aircraft Registration	ZU-EIB	Date of Accident	29 August 2023		Time of Accident	1055Z	
Type of Aircraft	Tri Cubby			Type of Operation	Private (Part 94)		
Pilot-in-command Licence Type	Private Pilot Licence		Age	66	Licence Valid	Yes	
Pilot-in-command Flying Experience	Total Flying Hours		415.0		Hours on Type	Unknown	
Last Point of Departure	Swellendam Aerodrome (FASX), Western Cape Province						
Next Point of Intended Landing	Worcester Aerodrome (FAWC), Western Cape Province						
Damage to Aircraft	Destroyed						
Location of the accident site with reference to easily defined geographical points (GPS readings if possible)							
Ridgemont Farm near Robertson (GPS position: 33°50'21.64" South 019°46'21.99" East)							
Meteorological Information	Surface wind: 020°/13kt; temperature: 31°C; dew point: 10°C; visibility: CAVOK						
Number of People On-board	1+0	Number of People Injured	0	Number of People Killed	1	Other (On Ground)	0

Reference Number : CA18/2/3/10361
Occurrence Category : Accident (Category 1)
Type of Operation : Private (Part 94)
Name of Operator : Private Flight
Aircraft Registration : ZU-EIB

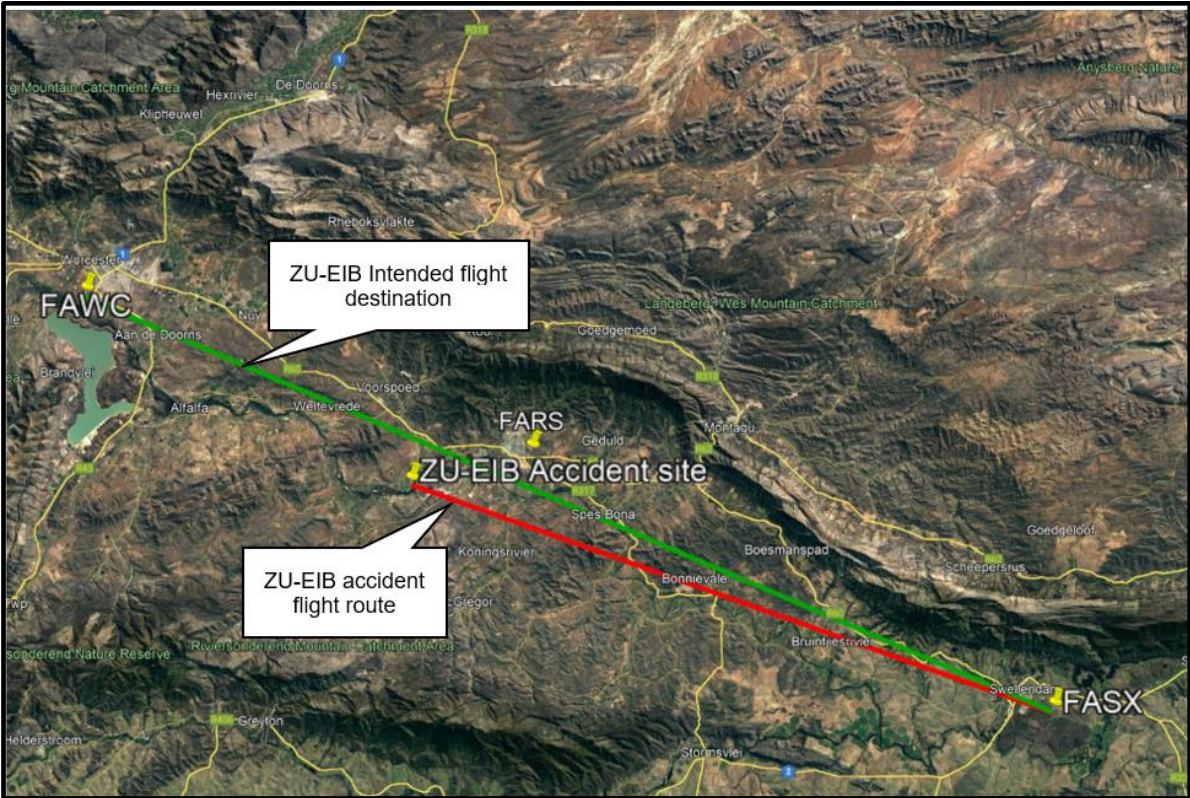
- 1.1.4 The accident occurred during daylight whilst the aircraft was flying from FASX to FAWC at Global Positioning System (GPS) co-ordinate determined to be 33°50'21.64" South 019°46'21.99" East, at an elevation of 580 feet (ft).

Figure 1: The route flown by the aircraft, and the accident site. (Source: Google Earth)

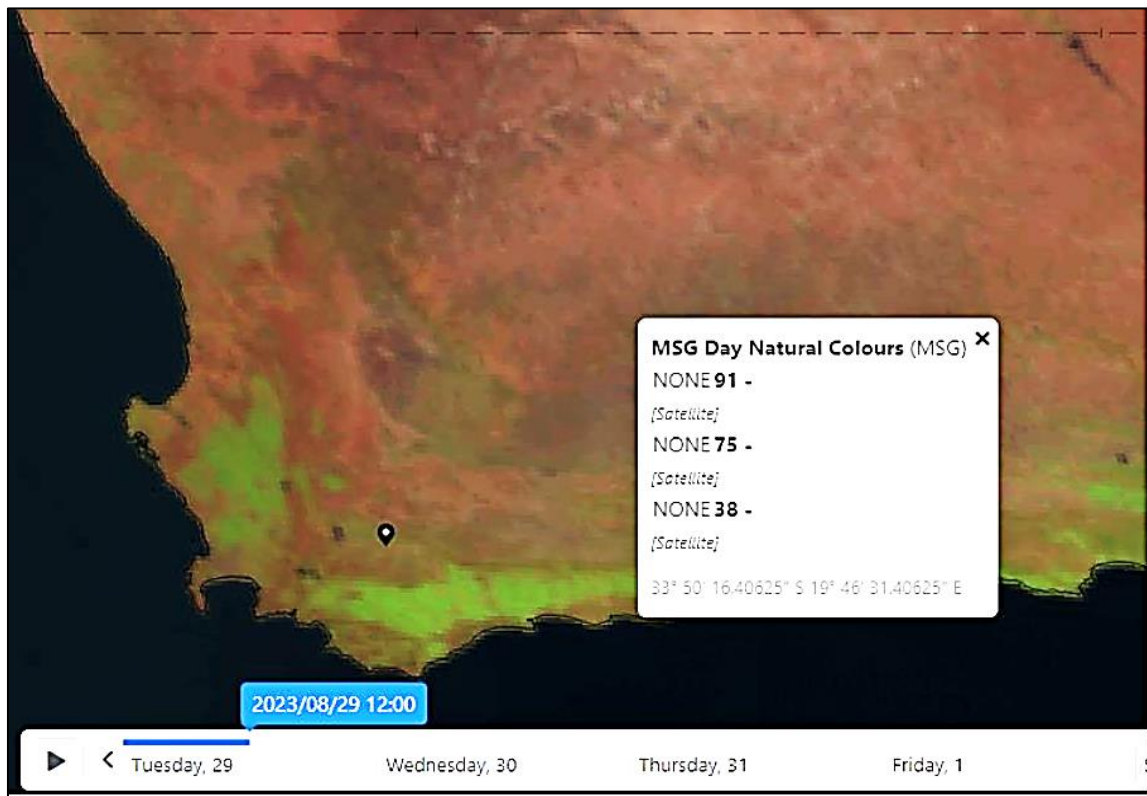
The Day Natural Colours satellite imagery of the MeteoSat Second Generation (MSG) taken at 1200Z on 29 August 2023 indicates no significant clouds (show clear skies) over the area of the accident.

Figure 5: Day Natural Colours satellite imagery at 1200Z on 29 August 2023.

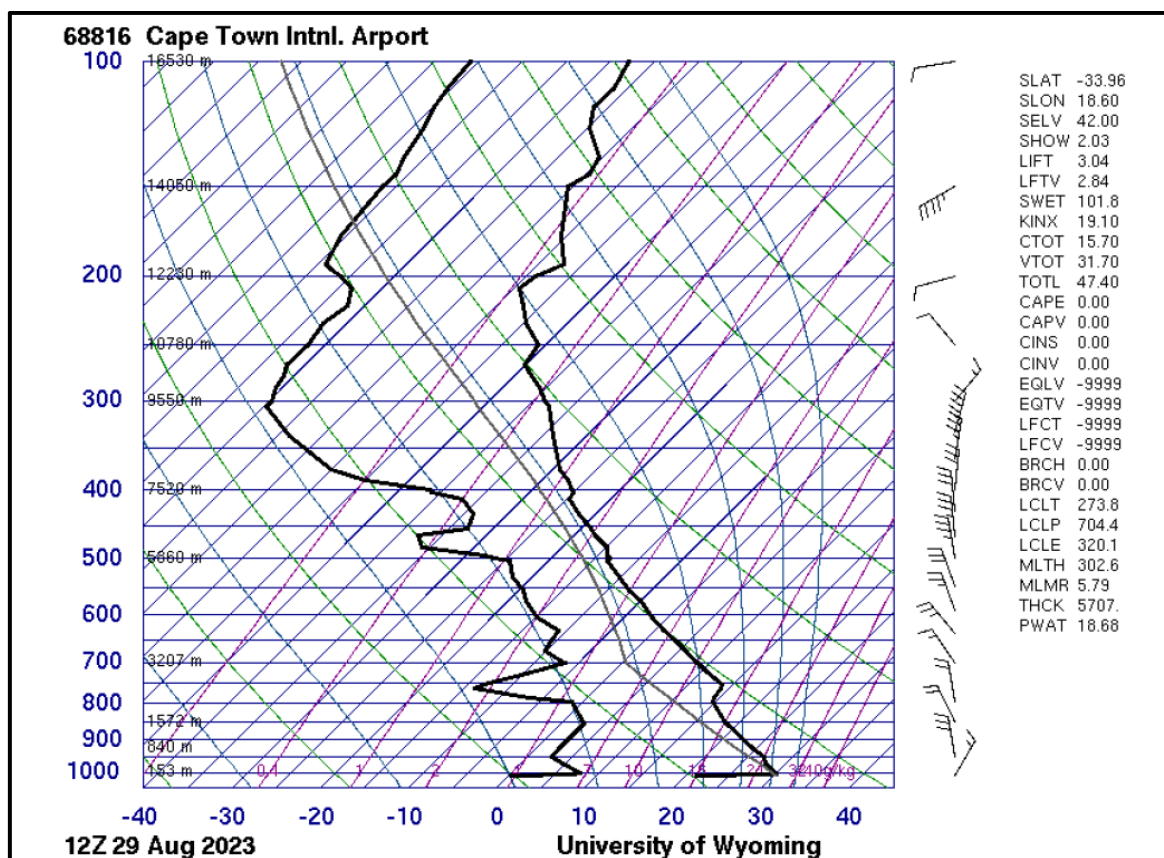
The 1200Z Cape Town (FACT-68816) upper air ascent (see Figure 6) valid for 29 August 2023 shows dry conditions which indicate the absence of significant clouds at low levels. This coincides with the clear conditions on the satellite imagery and the METAR above. The profile also shows an increase of 15kts in wind speed between 1000 hPa and 950 hPa, with wind direction backing with height.

Figure 6: Upper air ascent for FACT on 29 August 2023.

This is an indication of severe low-level turbulence. The presence of low-level inversion in the ascent supports the presence of severe turbulence. In addition, the 15kts north-easterly winds at 153m indicate that there could have been mountain wave turbulence in the north-westerly to south-easterly orientation in the vicinity of the accident site.

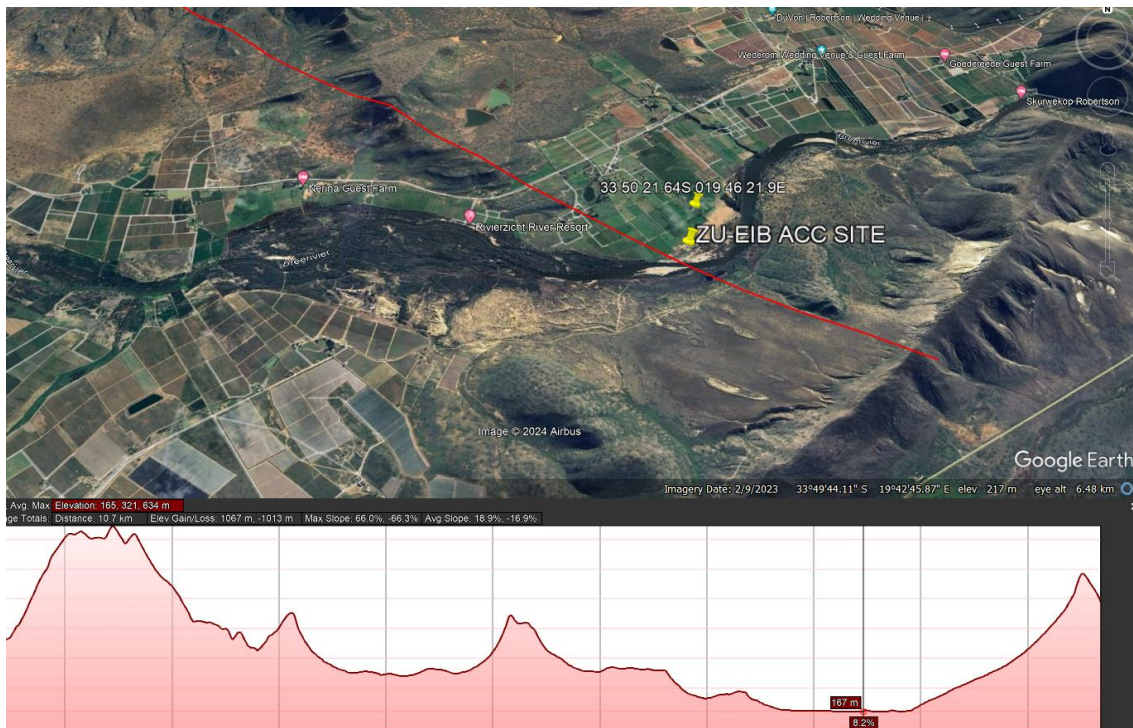
Figure 14: View of the terrain. (Source: Google Map).
