| <b>AIRCRAFT ACCIDENT REPORT AND EXECUTIVE SUMMARY</b> |

| | | | | <b>Reference:</b> | | CA18/2/3/10362 | |
| <b>Aircraft Registration</b> | ZU-IHA | <b>Date of Accident</b> | 2 September 2023 | | <b>Time of Accident</b> | 1618Z | |
| <b>Type of Aircraft</b> | Apollo T | | <b>Type of Operation</b> | | Private (Part 105) | | |

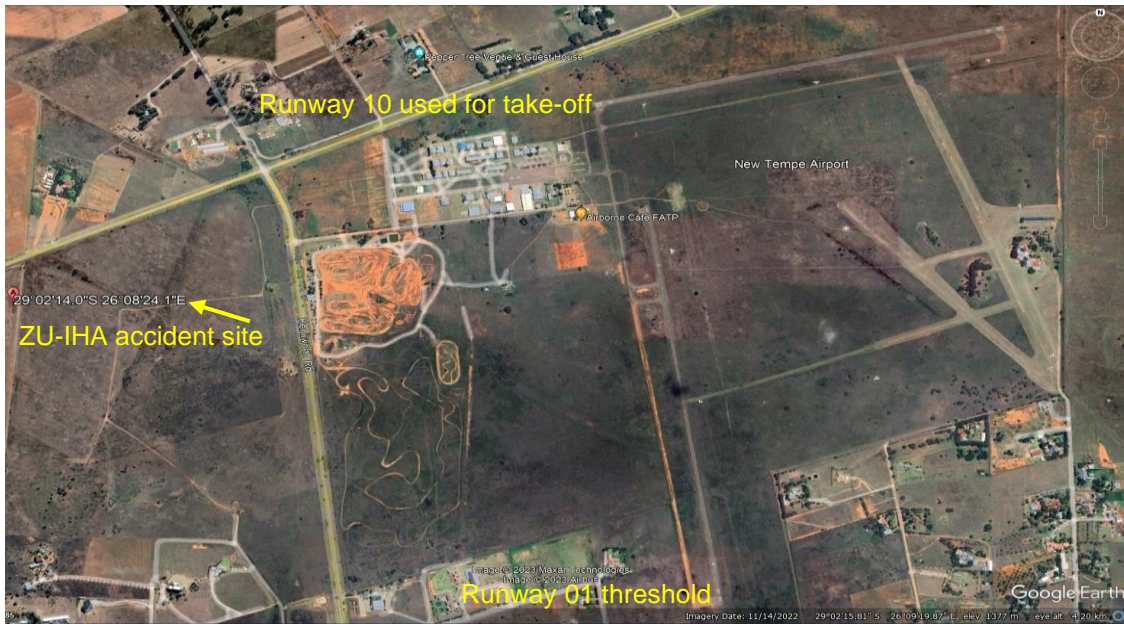
1.1.4. The accident occurred during daylight at Global Positioning System (GPS) co-ordinates determined to be 29° 02' 14.06" South 26° 08' 24.1" East, at about 4 526 feet (ft) above mean sea level (AMSL).

Figure 1: View of the accident site and the runway used for take-off. (Source: Google Earth Maps)
