**LIMITED OCCURRENCE INVESTIGATION REPORT – FINAL**

<b>Reference Number</b>	CA18/2/3/10365						
<b>Classification</b>	Accident	<b>Date</b>	15 September 2023	<b>Time</b>	1537Z		
<b>Type of Operation</b>	Training (Part 141)						
<b>Location</b>							
Place of Departure	Pietermaritzburg Aerodrome (FAPM) KwaZulu-Natal Province		Place of Intended Landing	Pietermaritzburg Aerodrome (FAPM) KwaZulu-Natal Province			
Place of Occurrence	Runway (RWY) 16 at Pietermaritzburg Aerodrome (FAPM)						
GPS Co-ordinates	Latitude	28° 43' 48" S	Longitude	032° 04' 48" E	Elevation	2 372 ft	
<b>Aircraft Information</b>							
Registration	ZU-JAR						
Make; Model; S/N	Sling 2 (Serial Number: 156)						
Damage to Aircraft	Substantial			Total Aircraft Hours	637.5		
<b>Pilot-in-command</b>							
Licence Type	Student Pilot Licence (SPL)		Gender	Female		Age	19
Licence Valid	Yes	Total Hours	24.8		Total Hours on Type	24.8	
Total Hours 30 Days	3.6		Total Flying on Type Past 90 Days	16.1

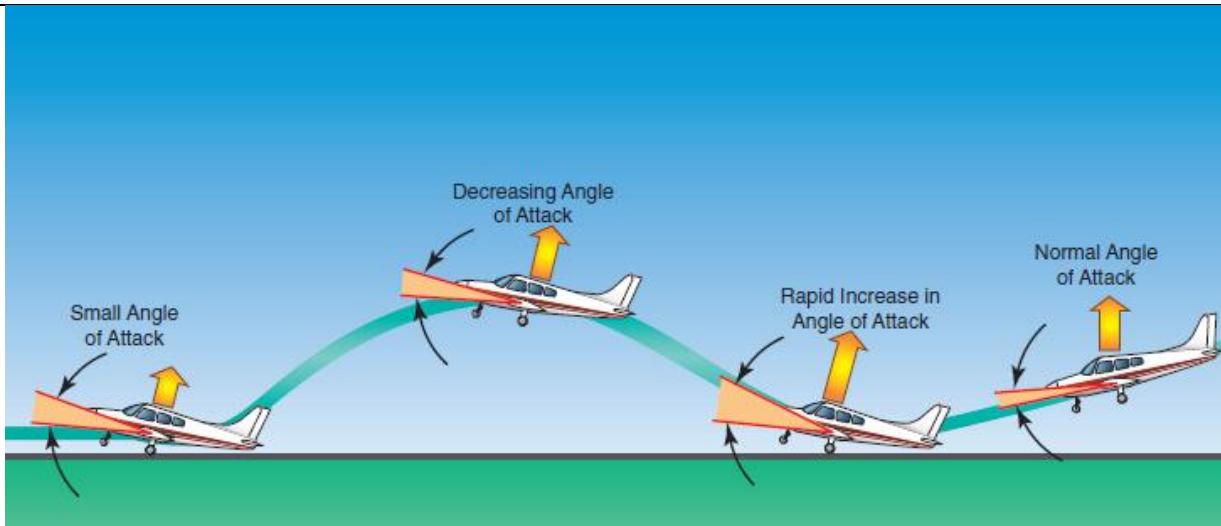
**Illustration 1:** The graphics illustrate the bounce sequence. (Source: Source: FAA- Airplane Flying Handbook, Chapter 8)
