LIMITED OCCURRENCE INVESTIGATION REPORT – FINAL

Reference Number	CA18/2/3/10370						
Classification	Accident	Date	30 September 2023	Time	1525Z		
Type of Operation	Commercial (Part 127)						
Location							
Place of Departure	One United Sports Ground in Pine Ridge, Mpumalanga Province		Place of Intended Landing	Burgersfort, Limpopo Province			
Place of Occurrence	On Gazania Street in Pine Ridge Suburb, Emalahleni, approximately 1 nautical mile (nm) north of FAWI, Mpumalanga province						
GPS Co-ordinates	Latitude	25°48'57.38" S	Longitude	029°11'.46.36" E	Elevation	4 908 feet	
Aircraft Information							
Registration	ZS-RXY						
Make; Model; S/N	Robinson Helicopter Company R44; Raven II (Serial Number: 10910)						
Damage to Aircraft	Substantial			Total Aircraft Hours	2 428.4		
Pilot-in-command							
Licence Type	Commercial Pilot Licence (CPL)		Gender	Male		Age	61
Licence Valid	Yes	Total Hours	1 657.2		Total Hours on Type	1 405.1	
Total Hours 90 Days	15.3		Total Flying on Type Past 30 Days		15.3

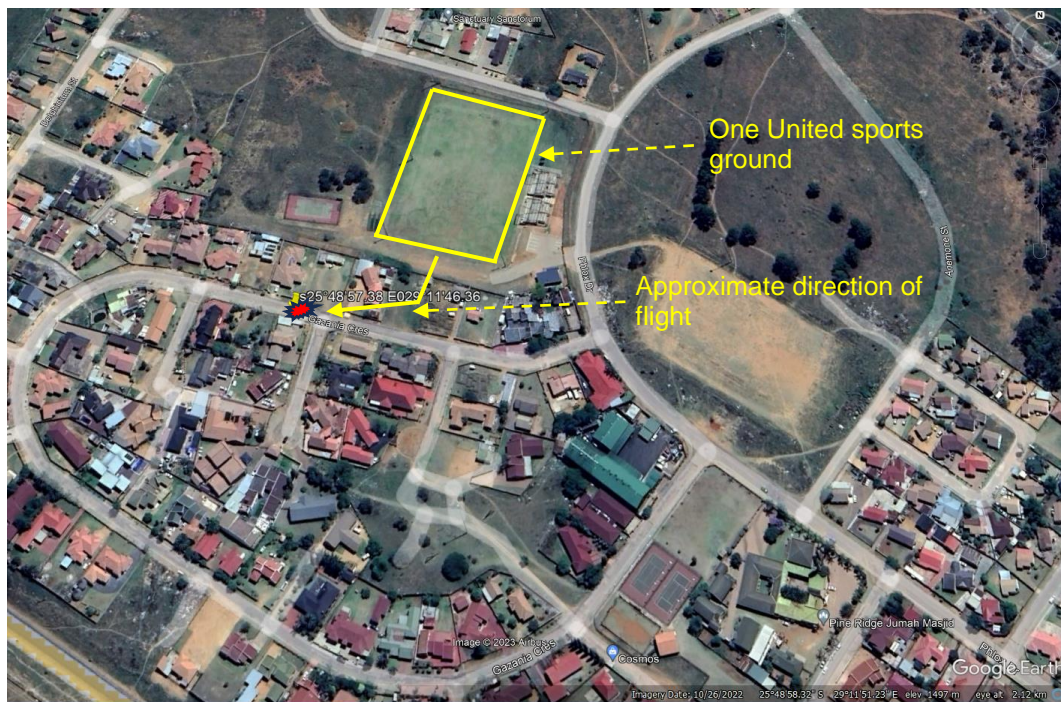
The accident occurred during daylight on a public road at Global Positioning System (GPS) coordinates determined to be 25°48'57.38" South 029°11'46.36" East, at an elevation of 4 908 ft.

Figure 1: Aerial view of the take-off and the accident site. (Source: Google Earth Maps)

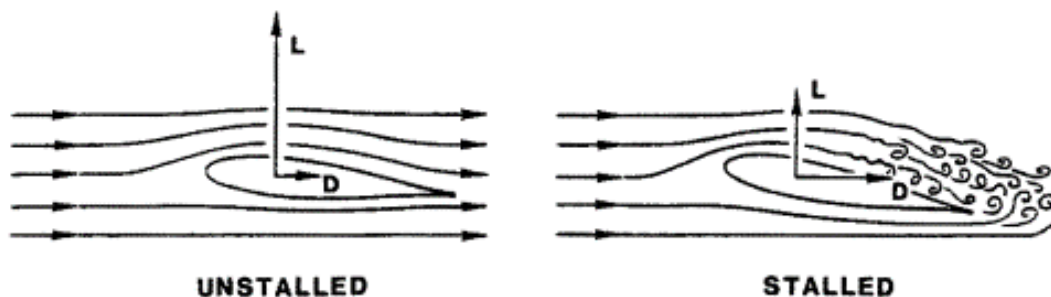
The same thing happens during rotor stall with a helicopter except it occurs due to low rotor RPM instead of low airspeed. As the RPM of the rotor gets lower, the angle-of-attack of the rotor blades must be higher to generate the lift required to support the weight of the helicopter. Even if the collective is not raised by the pilot to provide the higher blade angle, the helicopter will start to descend until the

Wing or rotor blade unstalled and stalled.
