AIRCRAFT ACCIDENT REPORT AND EXECUTIVE SUMMARY

Reference:	CA18/2/3/10375		
Aircraft Registration	ZS-JTW	Date of Accident	11 October 2023		Time of Accident	0430Z	
Type of Aircraft	Piper Pawnee PA-25-260		Type of Operation		Training (Part 141)		
Pilot-in-command Licence Type	Commercial Pilot Licence (CPL)		Age	22	Licence Valid	Yes	
Pilot-in-command Flying Experience	Total Flying Hours		286.6	Hours on Type	20.1		
Last Point of Departure	Kroonstad Airfield (FAKS), Free State Province						
Next Point of Intended Landing	Kroonstad Airfield (FAKS), Free State Province						
Damage to Aircraft	Destroyed						
Location of the accident site with reference to easily defined geographical points (GPS readings if possible)							
On an open field at GPS co-ordinates 27° 40' 15.66" South 027°19' 30" East, elevation 4 582 feet							
Meteorological Information	Surface wind: 020°/ 5 kt; temperature: 19°C; dew point: 12°C; CAVOK						
Number of People On-board	1 + 0	Number of People Injured	0	Number of People Killed	1	Other (On Ground)	0

Synopsis

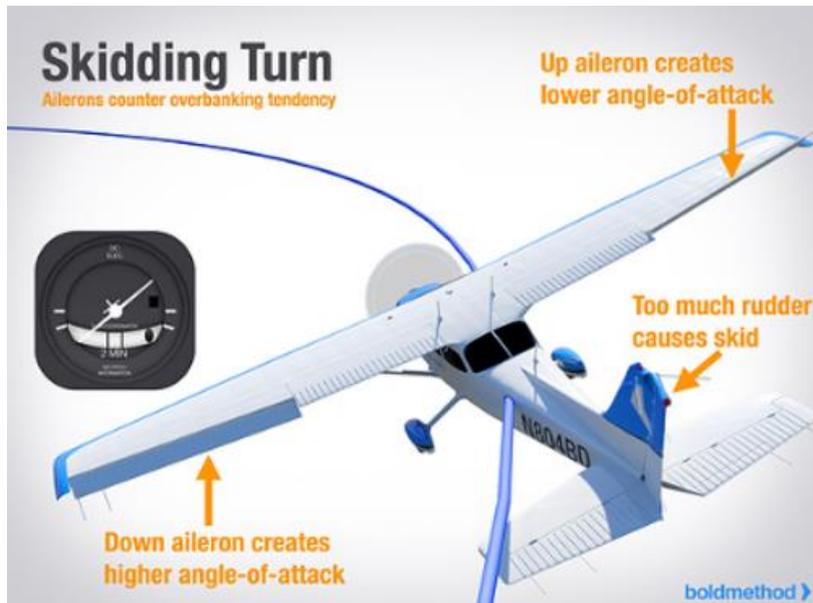
The aerodynamic effects of the uncoordinated, cross-control stall can surprise the unwary pilot because this stall can occur with very little warning and can be deadly if it occurs close to the ground. The nose may pitch down, the bank angle may suddenly change, and the airplane may continue to roll to an inverted orientation, which is usually the beginning of a spin. It is therefore essential for the pilot to follow the stall recovery procedure by reducing the angle-of-attack (AOA) until the stall warning has been eliminated, then roll wings level using ailerons, and coordinate with rudder inputs before the airplane enters a spiral or spin. A cross-control stall occurs when the critical AOA is exceeded with aileron pressure applied in one direction and rudder pressure in the opposite direction, causing uncoordinated flight. A skidding cross-control stall is most likely to occur in the traffic pattern during a poorly planned and executed base-to-final approach turn. There may be an unrecognized tailwind component and higher groundspeed on the base leg, which causes the pilot to turn late or with inadequate bank. The airplane overshoots the runway centreline, and the pilot attempts to correct by increasing the bank angle, increasing back elevator pressure, and applying excess rudder in the direction of the turn (i.e., inside or bottom rudder pressure) to bring the nose around further to align it with the runway. The difference in lift between the inside and outside wing will increase, resulting in an unwanted increase in bank angle. At the same time, the nose of the airplane slices downward through the horizon. The natural reaction to this may be for the pilot to pull back on the elevator control, increasing the AOA toward critical. Should a stall be encountered with these inputs, the airplane may rapidly enter a spin.

Figure 9: Pilot’s reaction during a left turn – skidding turn. (Source: <https://forums.flightsimulator.com>)
