LIMITED OCCURRENCE INVESTIGATION REPORT – FINAL

Reference Number	CA18/2/3/10379						
Classification	Accident	Date	14 October 2023	Time	1445Z		
Type of Operation	Private (Part 91)						
Location							
Place of Departure	Dwarsfontein Farm near Lephhalale, Limpopo Province		Place of Intended Landing	Dwarsfontein Farm near Lephhalale, Limpopo Province			
Place of Occurrence	Dwarsfontein Farm, Limpopo Province						
GPS Co-ordinates	Latitude	23°47'52.51" S	Longitude	027°51'37.89" E	Elevation	3 486 ft	
Aircraft Information							
Registration	ZT-RLP						
Make; Model; S/N	Robinson Helicopter; R44 Raven II (Serial Number: 13921)						
Damage to Aircraft	Substantial		Total Airframe Hours	383.1			
Pilot-in-command							
Licence Type	Private Pilot Licence		Gender	Male		Age	64
Licence Valid	No	Total Hours	1 253.8		Total Hours on Type	Unknown	
Total Hours 90 Days	50.8		Total Flying Hours on Type Past 90 Days		50.8		
People On-board	1 + 2	Injuries	0	Fatalities	0	Other (on ground)	0

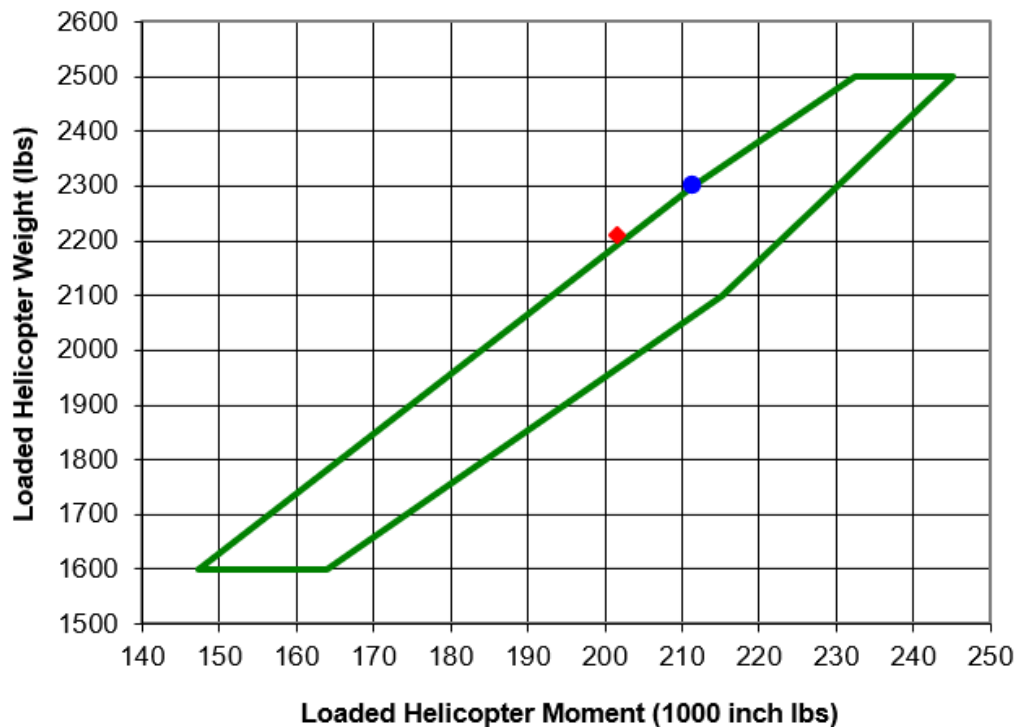
Chart Area **CG Moment vs. Gross Weight Envelope**

Centre of Gravity (CG) (Source: FAA-H-8083-1)

The pilot should ensure that the helicopter is properly balanced and within its centre of gravity limitations, so that minimal cyclic input is required during hovering flight, except for any wind corrections. Since the fuselage acts as a pendulum suspended from the rotor, changing the CG changes the angle at which the aircraft hangs from the rotor mast, the helicopter hangs horizontally; if the CG is too far forward of the mast, the helicopter hangs with its nose tilted down; if the CG is too far aft of the mast, the nose tilts up (see Figure 6).
