AIRCRAFT ACCIDENT REPORT AND EXECUTIVE SUMMARY

Reference:	CA18/2/3/10381		
Aircraft Registration	ZU-MWG	Date of Accident	26 October 2023		Time of Accident	1517Z	
Type of Aircraft	Speed Canard (SC01 B-160) Veteran		Type of Operation		Private (Part 94)		
Pilot-in-command Licence Type		Private Pilot Licence (PPL)	Age	76	Licence Valid	Yes	
Pilot-in-command Flying Experience		Total Flying Hours		3 416.9	Hours on Type	Unknown	
Last Point of Departure		Rand Airport (FAGM), Germiston, Gauteng Province					
Next Point of Intended Landing		Zandspruit Aero Estate Private Airstrip, Hoedspruit, Limpopo Province					
Damage to Aircraft		Destroyed					
Location of the accident site with reference to easily defined geographical points (GPS readings if possible)							
Zandspruit Aero Estate private airstrip in Hoedspruit (GPS position: 24°22'01" South 030°55'25.93" East) at an elevation of 1700 feet (ft)							
Meteorological Information		Surface wind: 210°/07 kts; temperature: 19.2°C; dew point: 0.8°C; Visibility: CAVOK

Reference Number : CA18/2/3/10258
Occurrence Category : Accident (Category 1)
Type of Operation : Private (Part 94)
Name of Operator : Marcel Theodor Anthonius Johannes Nijdam
A

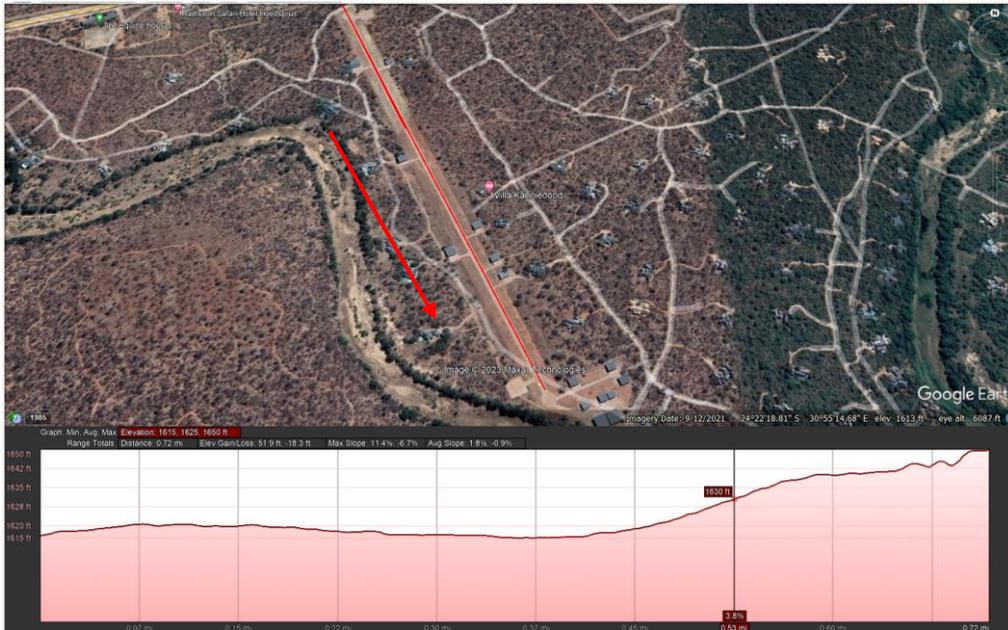
- 1.1.4. The accident occurred during daylight on the left side of Runway 35 at the Global Positioning System (GPS) co-ordinates determined to be 24°22'22.2" South 030°55'55.5" East, at an elevation of 1 700 feet (ft).

Figure 1: Aerial view of the runway and elevation profile. The red arrow indicates the direction of landing.
 (Source: Google Earth)

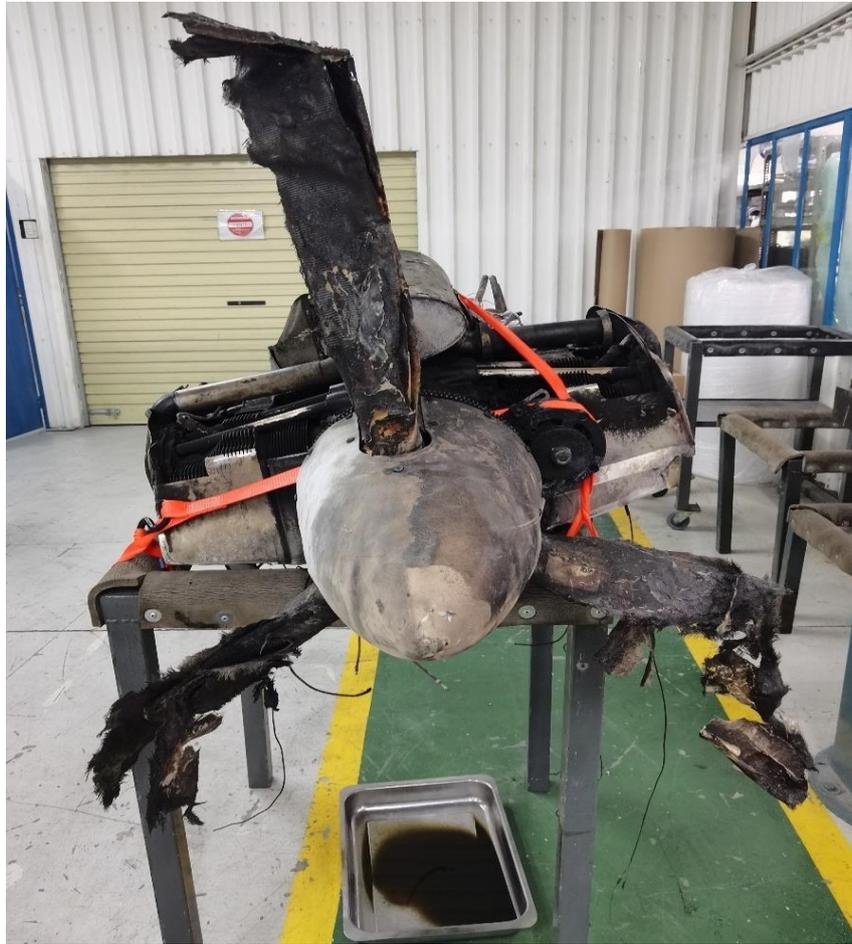
1.16.1 There was a strong smell of fuel at the accident site. However, there was no fuel available for testing. The engine and the propeller were recovered from the accident site and transported to the SACAA-approved engine overhaul facility in Wonderboom Airport (FAWB), Gauteng province, where they were subjected to a teardown inspection in the presence of the investigating team.

Figure 7: The engine and the propeller on a stand.

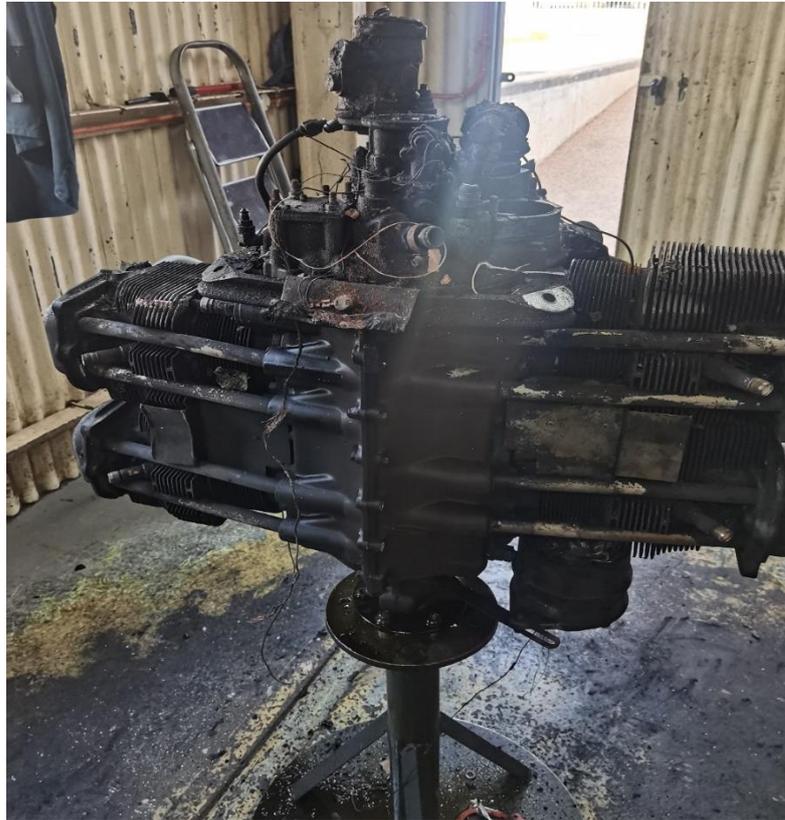
1.16.3 The engine, a Lycoming O-320-D1A, was subjected to a teardown inspection. The crankcase and the oil sump were found in good condition.

Figure 11: The engine on the engine stand before it was dismantled.
