LIMITED OCCURRENCE INVESTIGATION REPORT – FINAL

Reference Number	CA18/2/3/10384						
Classification	Accident	Date	4 November 2023			Time	1145Z
Type of Operation	Private (Part 91)						
Location							
Place of Departure	Lydenburg Airfield (FALL), Mpumalanga Province		Place of Intended Landing			Lydenburg Airfield (FALL), Mpumalanga Province	
Place of Occurrence	Runway 04, Lydenburg Airfield (FALL) Mpumalanga Province						
GPS Co-ordinates	Latitude	25°6'76" South (S)	Longitude	030°24'63" East (E)	Elevation	4 880 feet	
Aircraft Information							
Registration	ZS-DOB						
Make; Model; S/N	Beech Aircraft Corporation; G35 Bonanza (Serial Number: D-4654)						
Damage to Aircraft	Substantial			Total Aircraft Hours	8225.54		
Pilot-in-command							
Licence Type	Private Pilot Licence (PPL)		Gender	Male		Age	50
Licence Valid	Yes	Total Hours	405		Total Hours on Type	145.6	
Total Hours 30 Days	9		Total Flying on Type Past 90 Days			42	
People On-board	1+3	Injuries	0	Fatalities	0	Other (on ground)	0

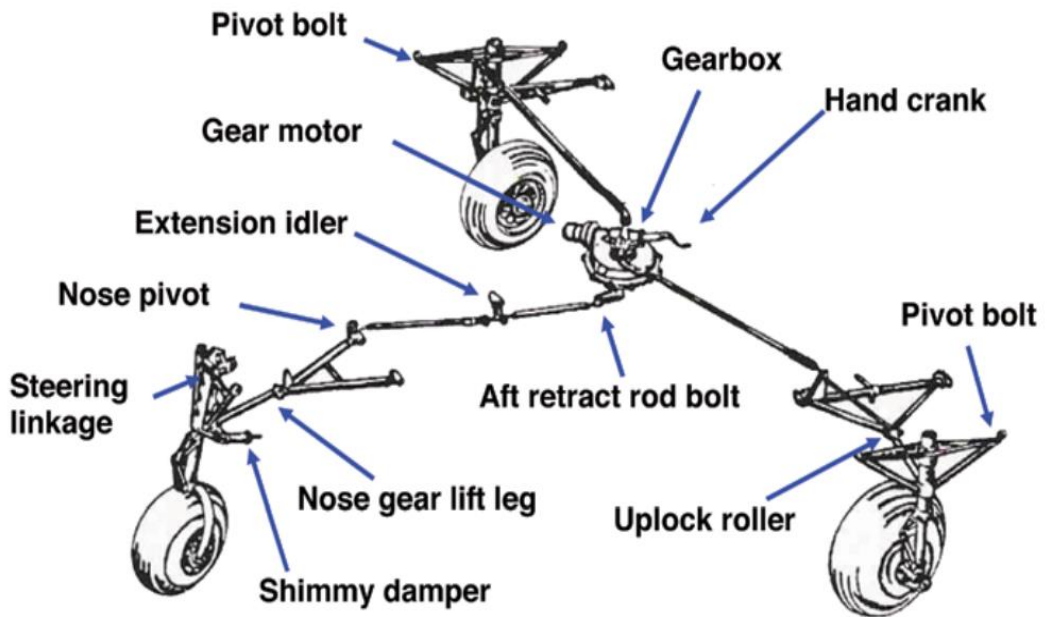
Illustration 1: The landing gear system schematic.

The landing gears may be electrically retracted and extended, and in an emergency may be lowered manually. The landing gear motor circuit consists of the landing gear control switch, limit switches, safety switch, motor and circuit breaker. The push button for resetting the landing gear motor circuit breaker is located in the right hand subpanel.

When the landing gear control switch is placed in the "UP" position, the circuit is completed to the safety switch on the right hand landing gear. If the safety switch has been actuated to complete the circuit to the up winding of the landing gear motor, as would be the case if the airplane were airborne or supported on jacks, the landing gear motor will run until the landing is fully retracted and the up limit switch is actuated, breaking the circuit to the landing gear motor. When the reversing switch is placed in the "DOWN" position, the circuit is completed to the down winding of the landing gear motor and the motor will operate until the landing gear has been fully extended and the down limit switch actuated, breaking the circuit to the landing gear motor.
