LIMITED OCCURRENCE INVESTIGATION REPORT – FINAL

Reference Number	CA18/2/3/10396						
Classification	Accident	Date	2 December 2023		Time	0722Z	
Type of Operation	Private (Part 141)						
Location							
Place of Departure	Klerksdorp Airfield (FAKD), Gauteng Province		Place of Intended Landing		Klerksdorp Airfield (FAKD), Gauteng Province		
Place of Occurrence	Private farm, 7 nautical miles from Klerksdorp Airfield (FAKD)						
GPS Co-ordinates	Latitude	26°45'57.6"S	Longitude	26°39'42.2"E	Elevation	4 444ft	
Aircraft Information							
Registration	ZS-ESW						
Make; Model; S/N	Piper Aircraft Corporation; PA 28-140 Cherokee (Serial Number: 28-22004)						
Damage to Aircraft	Substantial		Total Aircraft Hours	6434.5			
Pilot-in-command							
Licence Type	Commercial Pilot Licence (CPL)		Gender	Female		Age	24
Licence Valid	Yes	Total Hours	364		Total Hours on Type	202	
Total Hours 30 Days	0.5		Total Flying on Type Past 90 Days	5.5			
People On-board	2+0	Injuries	0	Fatalities	0	Other (on ground)	0

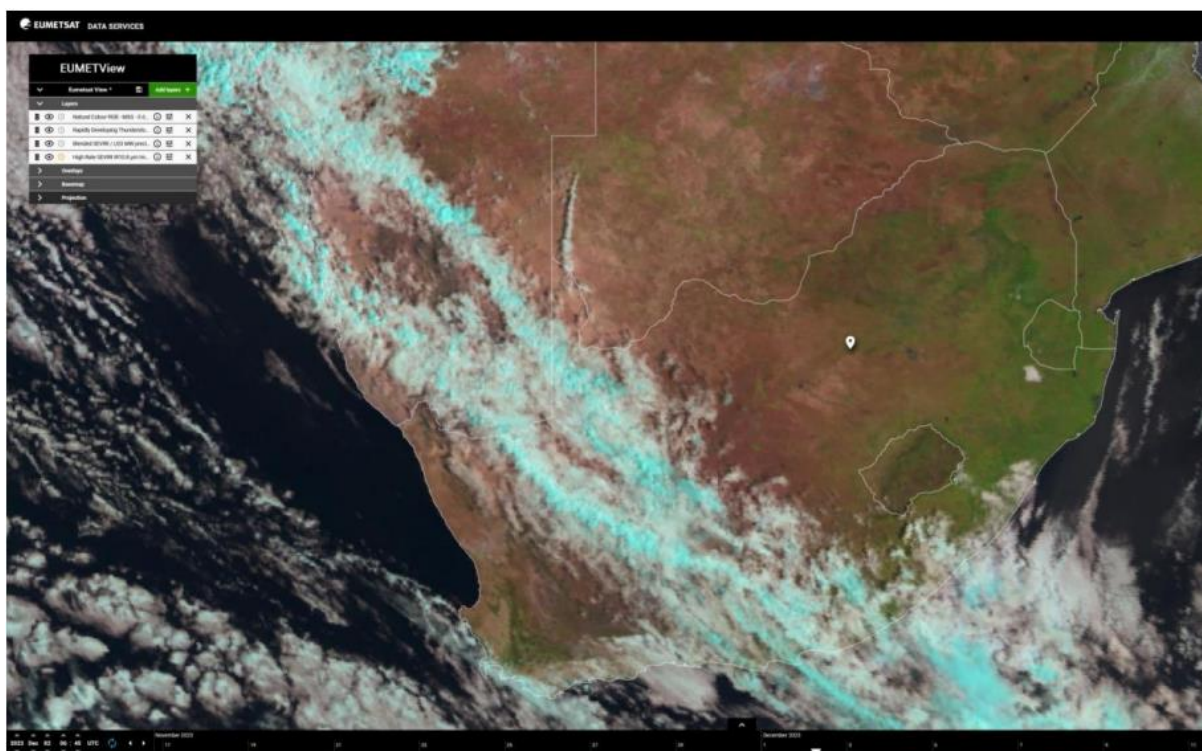
The Day Natural Colour RGB (DNC) satellite images of the MeteoSat Second Generation (MSG) show no presence of clouds over FAKD prior (Figure 5 at 0645Z), during (at 0700Z) and post the time of the accident (at 0715Z).

The area of concern is indicated by a white location pin on the satellite image. As such, visual meteorological conditions (VMC) prevailed before, during and after the accident.

Figure 4: Day Natural Colour satellite image valid for 0715Z on 2 December 2023. (Copyright MSG)

There was no indication of significant weather that may have contributed to the accident as far as observations and model data is presented in this report. Surface wind was light to moderate, which may suggest little to no low-level turbulence over the area and during the time of the accident. In addition, VMC conditions prevailed at the time the accident occurred.

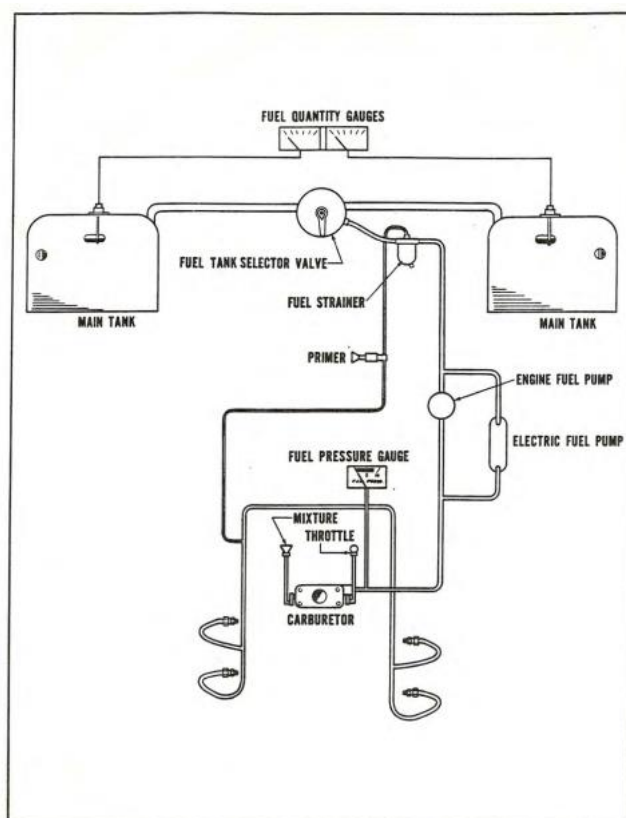
The fuel strainer is equipped with a quick drain and is located on the front lower left corner of the fire wall. This strainer should be drained during preflight to check for water or sediment and proper fuel (a special bottle is furnished for this operation). To drain the lines from the tanks, the tank selector valve must be switched to each tank in turn, with the electric pump on, and the gascolator drain valve opened. Each tank has an individual quick drain located at the bottom, inboard, rear corner. Fuel quantity and pressure are indicated on gauges located in the engine gauge cluster on the left of the side of the instrument panel.

Diagram 1: Fuel system schematic. (Source: PA28-140 POH)
