LIMITED OCCURRENCE INVESTIGATION REPORT – FINAL

Reference Number	CA18/2/3/10399						
Classification	Accident	Date	9 December 2023	Time	0730Z		
Type of Operation	Private (Part 94)						
Location							
Place of Departure	Yorkville Airstrip in Kamberg, KwaZulu-Natal Province		Place of Intended Landing	Farm near Ladysmith, KwaZulu-Natal Province			
Place of Occurrence	Hill side, Nottingham, KwaZulu-Natal Province						
GPS Co-ordinates	Latitude	29°27'41.21" S	Longitude	029°52'59.87" E	Elevation	5 632 feet (ft)	
Aircraft Information							
Registration	ZU-IVW						
Make; Model; S/N	Savanna S (Serial Number: 21-06-54-0792)						
Damage to Aircraft	Substantial		Total Aircraft Hours	210			
Pilot-in-command							
Licence Type	National Pilot Licence (NPL)		Gender	Male	Age	64	
Licence Valid	Yes	Total Hours	903.7	Total Hours on Type	457		
Total Hours Past 30 Days	13		Total Flying Hours on Type Past 90 Days	37			
People On-board	1 + 1	Injuries	2	Fatalities	0	Other (on ground)	0

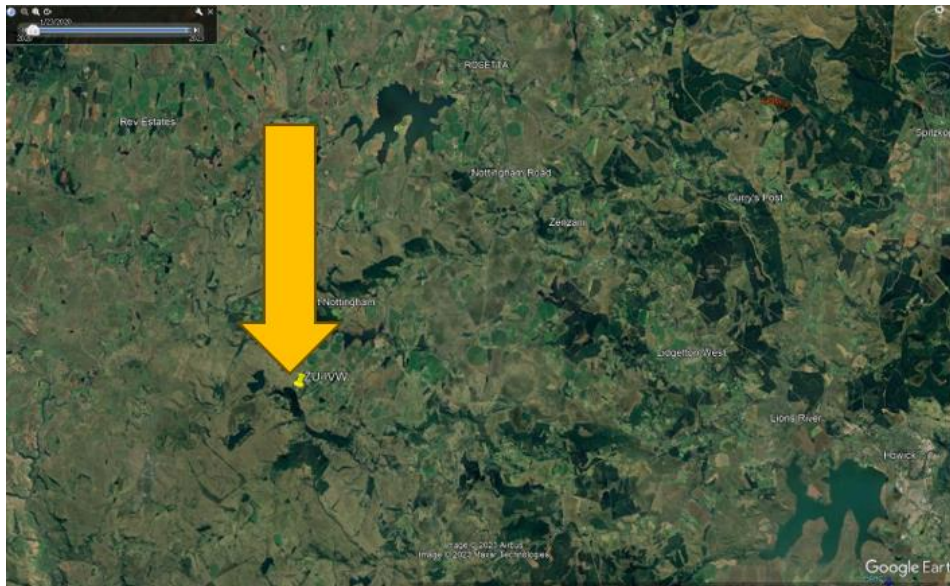
of the mountain approximately 19.19 nautical miles south-east of the departure airstrip (Pin number 3, Figure 2).

Figure 1: The yellow arrow and pin depict the accident site. (Source: Google Earth)

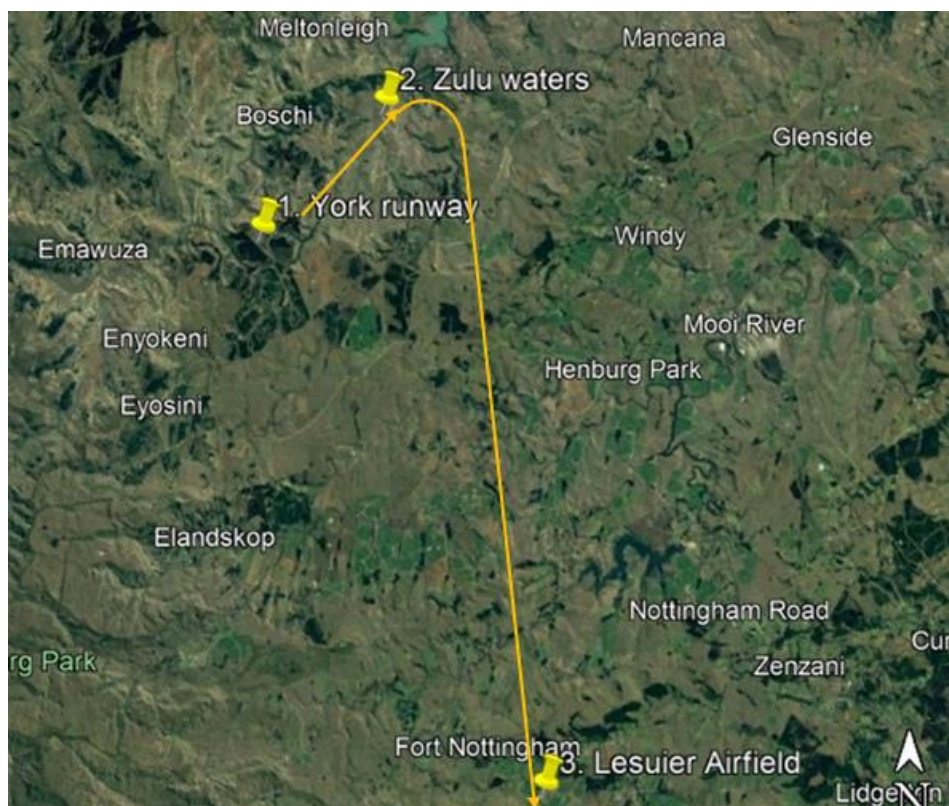
Figure 2: The route flown by the pilot. (Source: Google Earth)

8. The pilot lost his track after flying into poor weather conditions; he turned the aircraft to the right in an attempt to make a turn back and flew into the side of the mountain.
Probable Cause
The pilot inadvertently flew from VMC into IMC and became disoriented; in an attempt to get out of the IMC conditions, he flew the aircraft into the side of the mountain.
Contributing Factor(s)
<ul style="list-style-type: none"> • Failure to obtain the weather report for en route and destination weather conditions. • Lack of flight planning.
Safety Action(s)
None.
Safety Message
In the interest of safety and to prevent injury or damage to property, pilots are advised to ensure that they obtain weather information of their en route and destinations weather conditions, as well as plan accordingly.
About this Report
<p><i>The decision to conduct a limited investigation is based on factors including whether the cause is known and the evidence supporting the cause is clear, the level of safety benefit likely to be obtained from an investigation and that will determine the scope of an investigation. For this occurrence, a limited investigation has been conducted, and the Accident and Incident Investigations Division (AIID) has relied on the information submitted by the affected person/s and organisation/s to compile this limited report. The report has been compiled using information supplied in the initial notification, as well as from follow-up desk top enquiries to bring awareness of potential safety issues to the industry in respect of this occurrence, as well as safety action/s that the industry might want to consider in preventing a recurrence of a similar occurrence.</i></p> <p><i>All times given in this report are Co-ordinated Universal Time (UTC) and will be denoted by (Z). South African Standard Time is UTC plus 2 hours.</i></p>
