**LIMITED OCCURRENCE INVESTIGATION REPORT – FINAL**

<b>Reference Number</b>	CA18/2/3/10405						
<b>Classification</b>	Accident	<b>Date</b>	27 December 2023	<b>Time</b>	0720Z		
<b>Type of Operation</b>	Private (Part 94)						
<b>Location</b>							
Place of Departure	Morningstar Aerodrome, Western Cape Province			Place of Intended Landing	Craigcor Private Airstrip, Western Cape Province		
Place of Occurrence	Runway 20 at Craigcor Private Airstrip, 33 nautical miles north-east of FACT						
GPS Co-ordinates	Latitude	33° 29'31.67" S	Longitude	018° 57'46.89" E	Elevation	306 feet	
<b>Aircraft Information</b>							
Registration	ZU-ITJ						
Make; Model; S/N	Rans Aircraft; S-21 (Serial Number: 05190048)						
Damage to Aircraft	Substantial			Total Aircraft Hours	176.4		
<b>Pilot-in-command</b>							
Licence Type	Private Pilot Licence (PPL) A		Gender	Male		Age	67
Licence Valid	Yes	Total Hours	1 199.3		Total Hours on Type	176.4	
Total Hours 30 Days	12.3		Total Flying on Type Past 90 Days	12.3

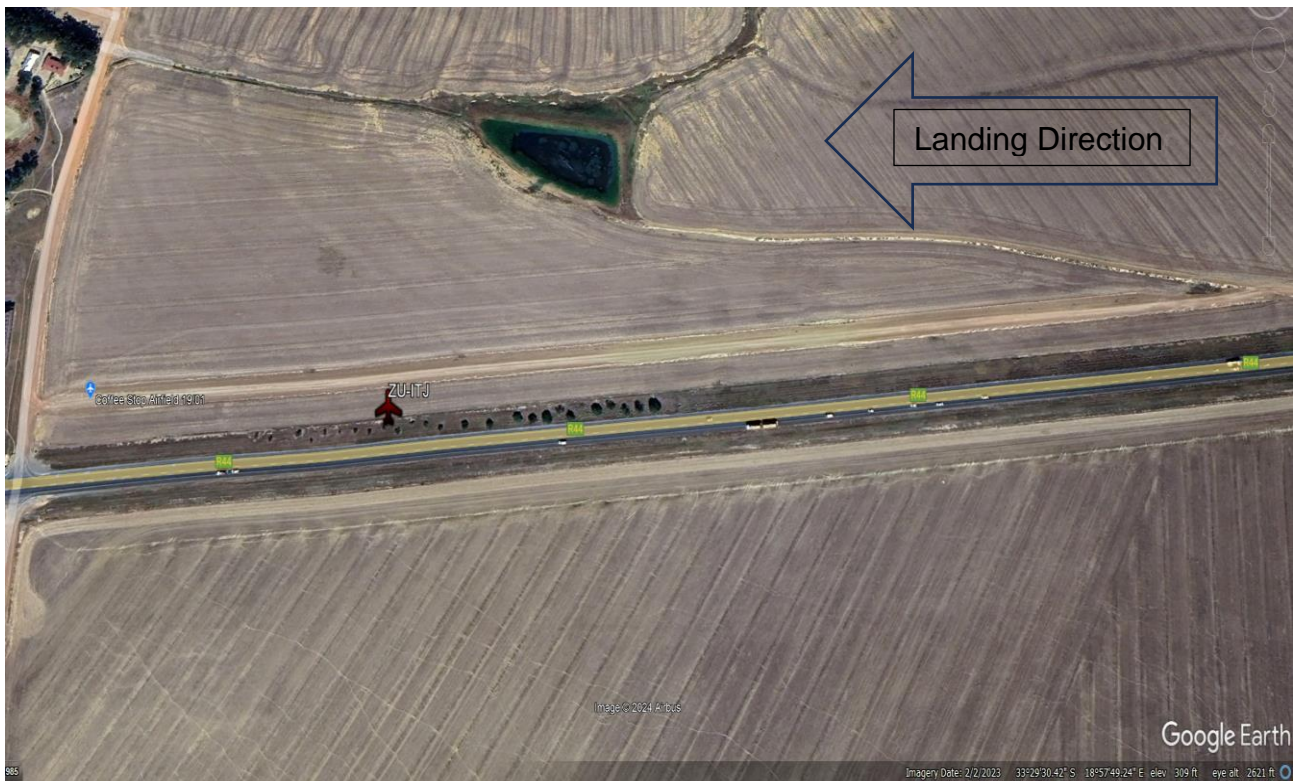
The accident occurred during day light at Global Positioning System (GPS) co-ordinates determined to be 33° 29'31.67" South 018° 57'46.89" East at an elevation of 306 ft.

**Figure 1:** A view of the accident site. (Source: Google Earth)
