**AIRCRAFT ACCIDENT REPORT AND EXECUTIVE SUMMARY**

<b>Reference:</b>		CA18/2/3/10414	
<b>Aircraft Registration</b>	ZS-LUW	<b>Date of Accident</b>	27 January 2024		<b>Time of Accident</b>	0600Z	
<b>Type of Aircraft</b>	Ayres S2R-T34 Turbo Thrush		<b>Type of Operation</b>		Private (Part 91)		
<b>Pilot-in-command Licence Type</b>	Commercial Pilot Licence (CPL)		<b>Age</b>	66		<b>Licence Valid</b>	Yes
<b>Pilot-in-command Flying Experience</b>	<b>Total Flying Hours</b>		3 717.2	<b>Total Hours on Type</b>		1 210	
<b>Last Point of Departure</b>	Bethlehem Aerodrome (FABM), Free State Province						
<b>Next Point of Intended Landing</b>	Kruger Mpumalanga International Airport (FAKN), Mpumalanga Province						
<b>Damage to Aircraft</b>	Destroyed						
<b>Location of the accident site with reference to easily defined geographical points (GPS readings if possible)</b>							
Southern side of Ermelo Airfield (FAEO) at Global Positioning System (GPS) co-ordinates determined to be South 26°29'46.0" East 029°59'04.0" at an elevation of approximately 5 800 feet (ft)

**Reference Number** : CA18/2/3/10414  
**Occurrence Category** : Category 1  
**Operator Name** : Osmond Aerial Spray (Pty) Ltd  
*

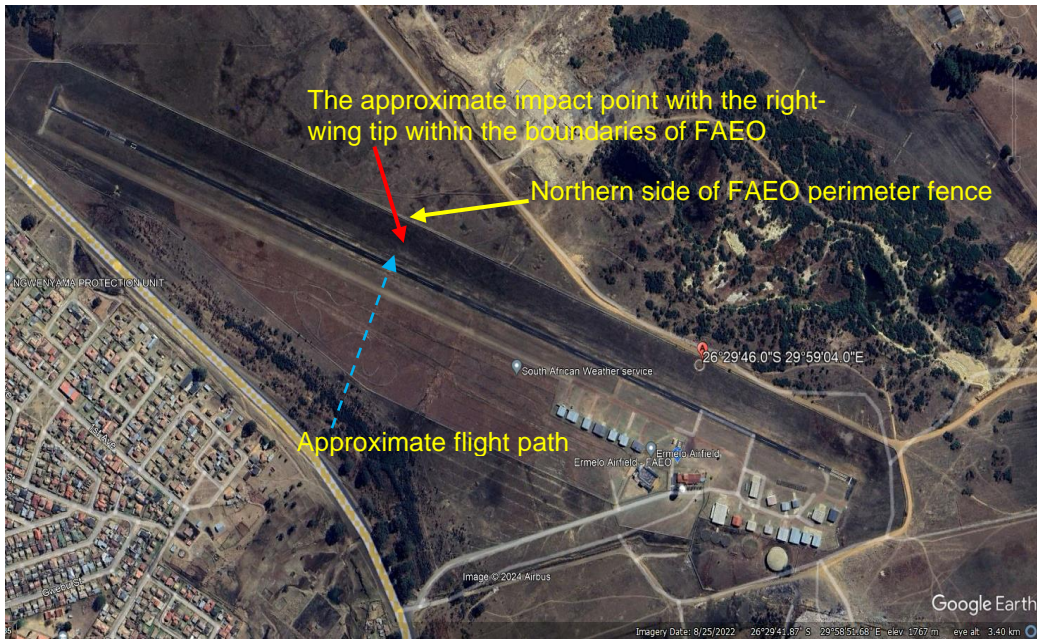
- 1.1.5. The accident occurred in the morning on FAEO grounds (southern side) at GPS co-ordinates determined to be South 26°29'46.0" East 029°59'04.0" at an elevation of approximately 5 800 feet (ft).

**Figure 2:** Aerial view of FAEO shows the approximate flight path and point of impact. (Source: Google Earth)
