AIRCRAFT ACCIDENT REPORT AND EXECUTIVE SUMMARY

Reference:		CA18/2/3/10415	
Aircraft Registration	ZS-FON	Date of Accident	29 January 2024		Time of Accident	1135Z	
Type of Aircraft	Beechcraft King Air C90A		Type of Operation		Private Flight (Part 91)		
Pilot-in-command Licence Type	Airline Transport Pilot Licence (ATPL)		Age	42	Licence Valid	Yes	
Pilot-in-command Flying Experience	Total Flying Hours		8 478.6		Hours on Type	246.7	
Last Point of Departure	Lanseria International Aerodrome (FALA), Gauteng Province						
Next Point of Intended Landing	Bona-Bona Game Lodge Airfield, North West Province						
Damage to Aircraft	Substantial						
Location of the accident site with reference to easily defined geographical points (GPS readings if possible)							
Runway 17 at Bona-Bona Lodge Airfield (GPS co-ordinates: 27°01'18.40" South 026°13'16.52" East) at an elevation 4 760 feet (ft)							
Meteorological Information	Surface wind: 170°/10kts; temperature: 31°C; visibility: 9999m

Probable Cause/s and/ or Contributory Factors							
A fracture on the front face rib caused the failure of the left main wheel outer bearing which led to the wheel separating from the axle during the landing ro

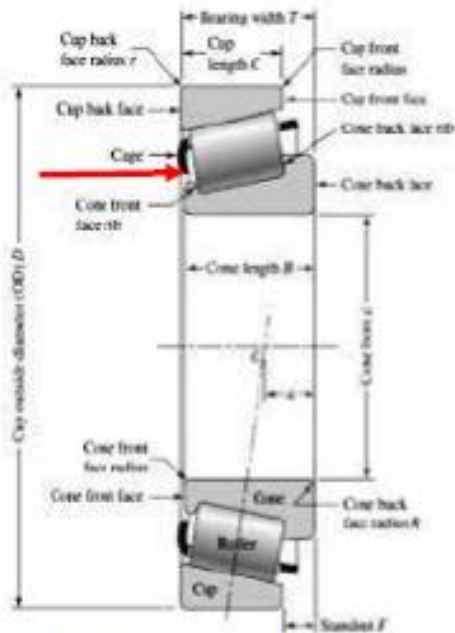
Diagram 2: Cone roller bearing nomenclature

- *The visual inspection of the outer cone-bearing inner ring revealed a fracture within the cone front face rib as shown above in Figure 9. (Photos 3 red dashed circle; Diagram 2 red arrow). Discolouration on the fracture surface (Photo 4, yellow dashed circle) suggests fracture initiation before final failure.*
