AIRCRAFT ACCIDENT REPORT AND EXECUTIVE SUMMARY

Reference:		CA18/2/3/10417	
Aircraft Registration	ZS-IRW	Date of Accident	6 February 2024		Time of Accident	0948Z	
Type of Aircraft	Grumman G-164A		Type of Operation		Agricultural (Part 137)		
Pilot-in-command Licence Type	Commercial Pilot Licence (CPL)		Age	31	Licence Valid	Yes	
Pilot-in-command Flying Experience	Total Flying Hours		922.2		Hours on Type	360.6	
Last Point of Departure	Klippan Private Airstrip, Mpumalanga Province						
Next Point of Intended Landing	Middelburg Aerodrome (FAMB), Mpumalanga Province						
Damage to Aircraft	Substantial						
Location of the accident site with reference to easily defined geographical points (GPS readings if possible)							
South of Wonderfontein Colliery at GPS position 25°52'14.29" South 029°53'43.90" East, at an elevation of 5 732 feet							
Meteorological Information	Surface wind: 280°/2kts; temperature: 26°C; dew point: 15°C; CAVOK						
Number of People On-board	1 + 0	Number of People Injured	0	Number of People Killed	0	Other (On the Ground)	0

Occurrence Details

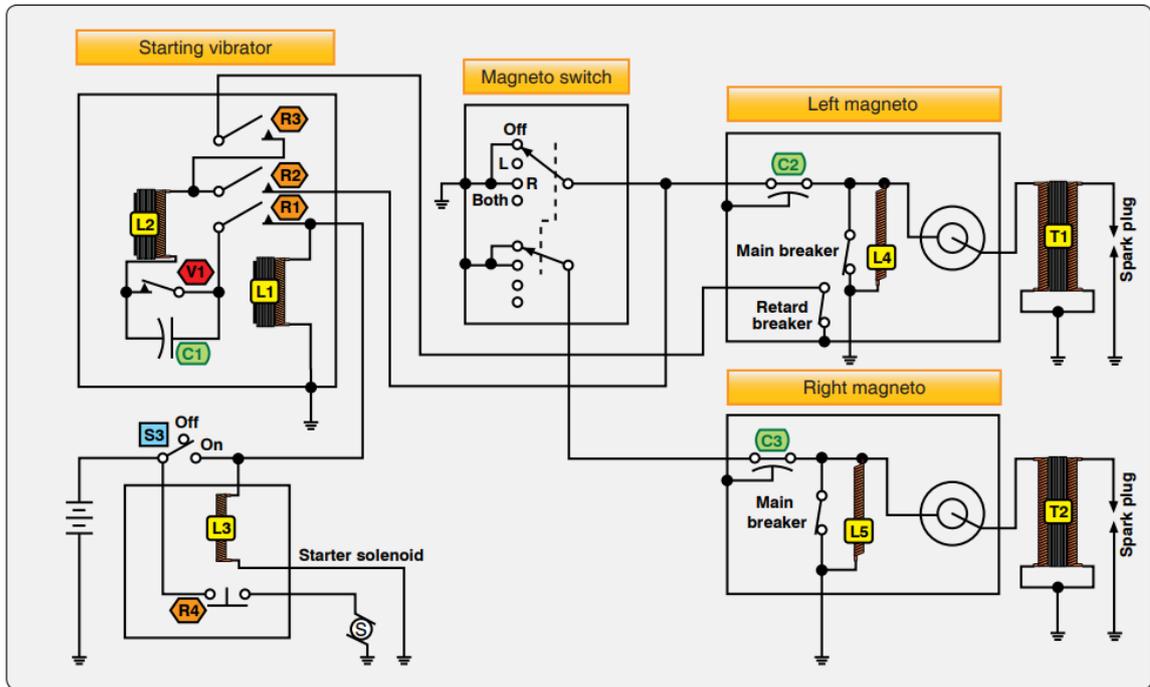
Diagram 1: Schematic of the magneto and ignition system.

This causes a complete engine shutdown, as there is no spark to ignite the fuel-air mixture in the cylinders

Failure modes include internal wear, electrical arcing, debris build-up, and grounding issues, which can lead to malfunction. Regular maintenance and pre-flight testing are crucial to ensure reliable operation.

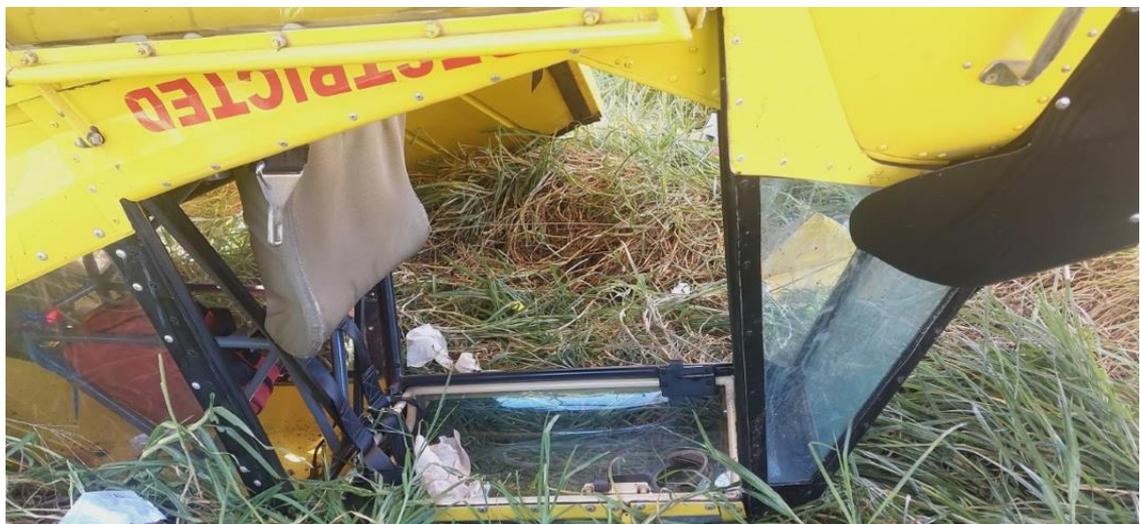
Figure 8: A view of the cockpit as it came to rest in an inverted attitude.

1.12.1. The instrument panel was found intact and had no signs of damage. The magneto switch was in the OFF position.

1.15.1. The accident was considered survivable as there was no damage to the cockpit and cabin areas that would have caused serious injury to the pilot. The pilot had his safety harness on and it did not fail during the accident sequence.

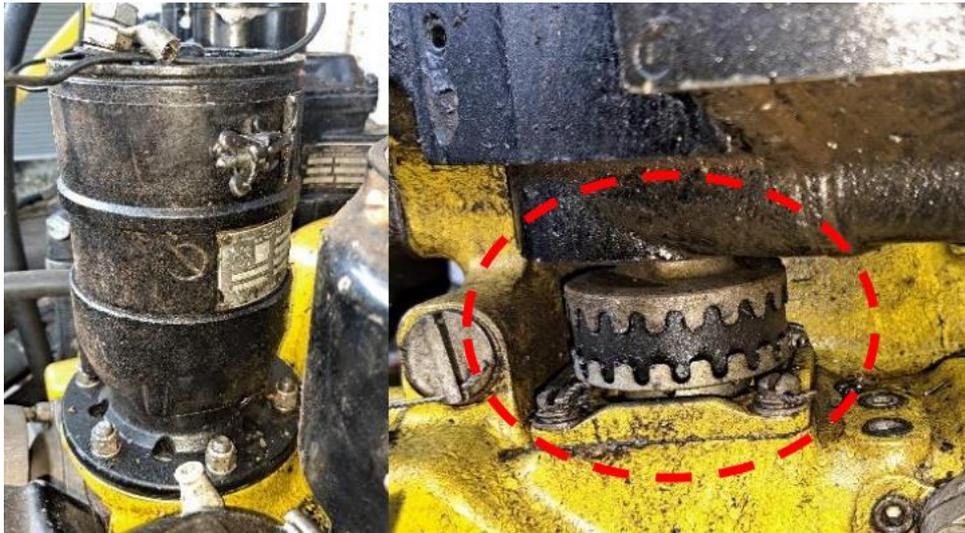
Photo 4: Accessories conditions (digital).

During the rotation test, continuity was confirmed between the accessory gearbox drives and the 2x magnetos (Photo 4, red dashed circle), starter motor and the generator assemblies.
