AIRCRAFT ACCIDENT REPORT AND EXECUTIVE SUMMARY

Reference:		CA18/2/3/10419		
Helicopter Registration		ZS-RLS	Date of Accident		15 February 2024		Time of Accident	1820Z
Type of Helicopter		Bell 407			Type of Operation		Training (Part 141)	
Pilot-in-command Licence Type		Commercial Pilot Licence		Age	39	Licence Valid	Yes	
Pilot-in-command Flying Experience		Total Flying Hours		2 609.4		Hours on Type	157.2	
Last Point of Departure		Ultimate Heliport, Midrand, Gauteng Province						
Next Point of Intended Landing		Ultimate Heliport, Midrand, Gauteng Province						
Damage to Helicopter		Substantial						
Location of the accident site with reference to easily defined geographical points (GPS readings if possible)								
On Runway 35 at Grand Central Aerodrome (GPS co-ordinates: 25°59'19.96" South 028°08'40.20" East) at an elevation of 5 337 feet (ft)								
Meteorological Information		Surface wind: 300°/10 kt; temperature: 24°C; dew point: 17°C

Reference Number : CA18/2/3/10419
Occurrence Category : Accident (Category 1)
Type of Operation : Training (Part 141)
Name of Operator : National Airways Corporation (NAC)
Helicopter Registration : ZS-RLS
Aircraft Make and Model : Bell 407
Nati

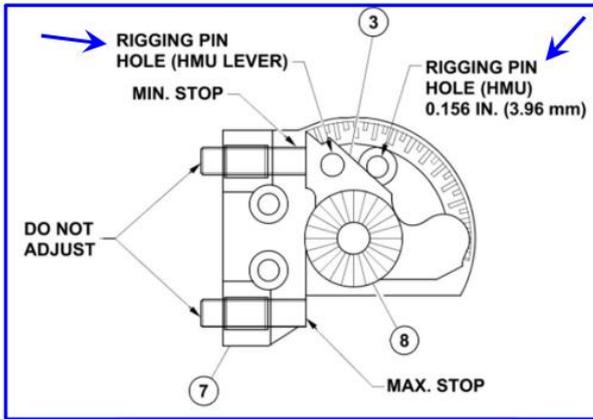
Figure 12: Bell illustration HMU rigging.

- IV. The throttle linkage rigging to the HMU was misaligned by 5° to the lower side. Damage sustained during the accident was not sufficient to alter the throttle to the HMU rigging.
