LIMITED OCCURRENCE INVESTIGATION REPORT – FINAL

Reference Number	CA18/2/3/10423						
Classification	Accident	Date	20 February 2024	Time	1420Z		
Type of Operation	Training Flight (Part 141)						
Location							
Place of Departure	Grand Central Airport (FAGC), Gauteng Province		Place of Intended Landing	Grand Central Airport (FAGC), Gauteng Province			
Place of Occurrence	Grand Central Airport (FAGC), Gauteng Province						
GPS Co-ordinates	Latitude	25°42'16"S	Longitude	27°49'33"E	Elevation	4 065 feet	
Aircraft Information							
Registration	ZS-LPM						
Make; Model; S/N	Piper; PA 34-220T (Serial Number: 34-8133133)						
Damage to Aircraft	Substantial		Total Aircraft Hours	5 430.1			
Pilot-in-command							
Licence Type	Airline Transport Pilot Licence (ATPL), Aeroplane		Gender	Male	Age	32	
Licence Valid	Yes	Total Hours	4 938.9		Total Hours on Type	37.3	
Total Hours 30 Days	24.5		Total Flying on Type Past 90 Days		3.1		
People On-board	2 + 0	Injuries	0	Fatalities	0	Other (on ground)	0

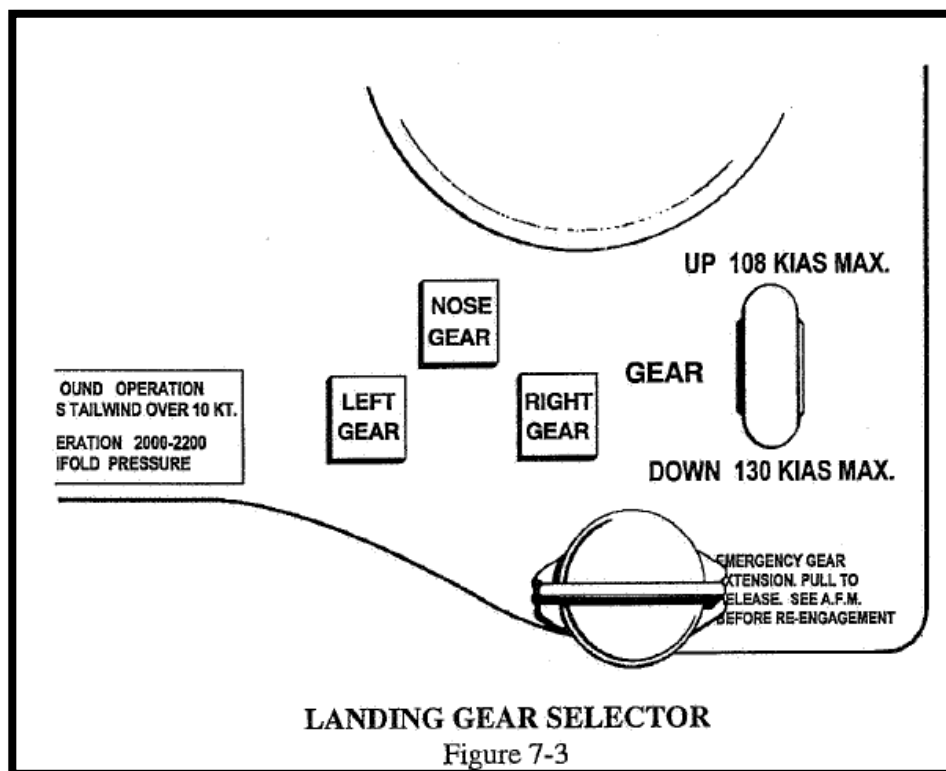
The landing gear is designed to extend even in the event of hydraulic failure. Since the gear is held in the retracted position by hydraulic pressure, should the hydraulic system fail for any reason, gravity will allow the gear to extend. When the landing gear is retracted, the main wheels retract inboard into the wings and the nose wheel retracts forward into the nose section. Aerodynamic loads and springs assist in gear extension and in locking the gear in the down position. During gear extension, once the nose has started toward the down position, the airstream pushes against it and assists in moving it to the downlocked position. After the gears are down and the downlock hooks engage, springs maintain force on each hook to keep it locked until it is released by hydraulic pressure.
