AIRCRAFT ACCIDENT REPORT AND EXECUTIVE SUMMARY

Reference:		CA18/2/3/10424	
Aircraft Registration	ZS-FJU	Date of Accident	21 February 2024		Time of Accident	1450Z	
Type of Aircraft	Cessna 172K		Type of Operation		Training (Part 141)		
Pilot-in-command Licence Type	Commercial Pilot Licence (CPL) A		Age	31	Licence Valid	Yes	
Pilot-in-command Flying Experience	Total Flying Hours		366		Hours on Type	266	
Last Point of Departure	Rand Airport (FAGM), Gauteng Province						
Next Point of Intended Landing	Baragwanath Aerodrome (FASY), Gauteng Province						
Damage to Aircraft	Destroyed						
Location of the accident site with reference to easily defined geographical points (GPS readings if possible)							
Approximately 211 metres (m) to the left of Runway 13 threshold at GPS co-ordinates 26°20'41.61"S 27°46'25.59"E elevation 5 124 feet (ft)							
Meteorological Information	Surface Wind 290° at 09kts; Visibility 9999m; Cloud Cover Nil; Temperature 29°C Dew Point 13°C; QNH 1019

Probable Cause							
The flight instructor and the student pilot lost control of the aircraft after a wingover manoeuvre during circuit training.							
Contributory Factor							
Disregard of HASELL checklist.

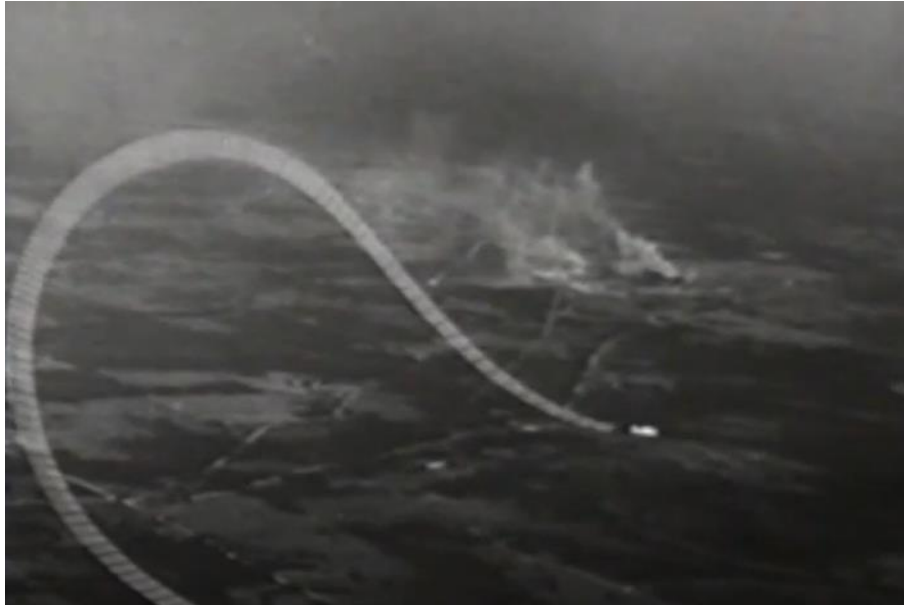
Figure 9: Picture taken from a still video illustrating a chandelle or wing over.

- 2.2.9 The above sequence of events is similar to a wingover depicted in Figure 9 which portrays how the wingover is executed (the smoke trail shows the manoeuvre). The accident aircraft engaged the manoeuvre a metre above ground level and climbed to an unspecified height to perform a wingover. The point of impact is 210m from the edge of the runway which makes the flight path similar to Figure 9, except that the aircraft in Figure 9 is high, and the pilot was able to recover.
