**AIRCRAFT ACCIDENT REPORT AND EXECUTIVE SUMMARY**

<b>Reference:</b>		CA18/2/3/10426	
<b>Aircraft Registration</b>	ZU-IBN	<b>Date of Accident</b>	24 February 2024		<b>Time of Accident</b>	0714Z	
<b>Type of Aircraft</b>	L39C Albatros		<b>Type of Operation</b>		Type (Part 94)		
<b>Pilot-in-command Licence Type</b>	Private Pilot Licence		<b>Age</b>	64	<b>Licence Valid</b>	Yes	
<b>Pilot-in-command Flying Experience</b>	<b>Total Flying Hours</b>		776.70		<b>Hours on Type</b>	71.6	
<b>Last Point of Departure</b>	Middleburg Airfield (FAMD), Mpumalanga Province						
<b>Next Point of Intended Landing</b>	Middleburg Airfield (FAMD), Mpumalanga Province						
<b>Damage to Aircraft</b>	Substantial						
<b>Location of the accident site with reference to easily defined geographical points (GPS readings if possible)</b>							
FAMB field at Global Positioning System (GPS) co-ordinates determined to be (S °40' 58", E 029° 26' 13.9"), at a field elevation of 4886 feet (ft)

**Reference Number** : CA18/2/3/10426  
**Occurrence Category** : Category 3  
**Type of Operation** : Private (Part) 94  
**Name of Operator** : Lovett R N  
**Aircraft Registration** : ZU-IBN  
**Aircraft Make and Model** :

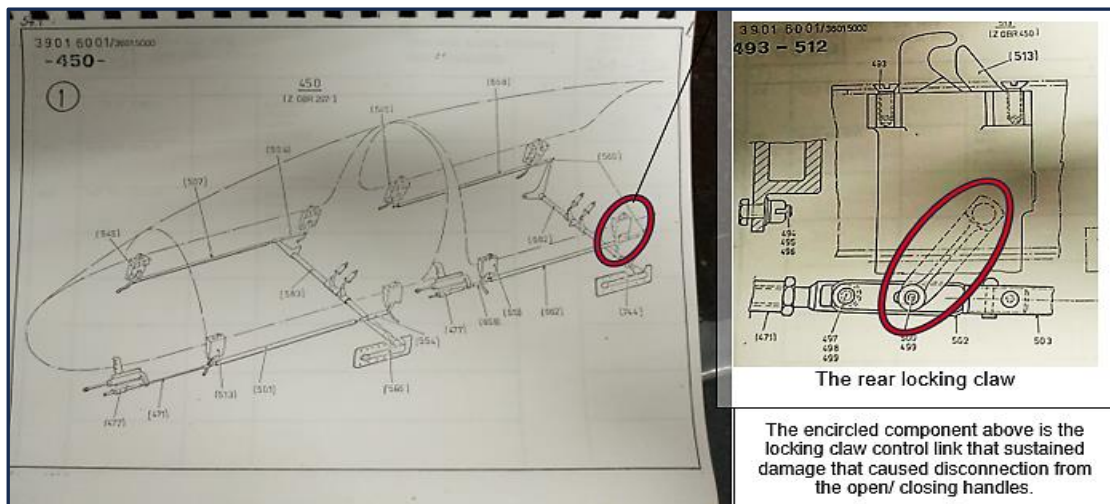
**Figure 9:** Canopy locking mechanism schematics. (Illustrated Part Catalogue)

*The rear cockpit latches (right front and rear) and the left-side front latch claw were found in good condition, and they operated as expected. However, the rear left latch claw had jammed in closed position and had scratch marks near it.*

*Subsequent inspection and tests revealed that the rear right latch claw was not jammed but one of its control links that connect to the canopy locking handle had failed; it moved freely by hand. Additionally, there was a gap between the latch claws when they were in the locked position. The malfunctioning canopy latch system suggested potential maintenance (rigging) issues.*
