**LIMITED OCCURRENCE INVESTIGATION REPORT – FINAL**

<b>Reference Number</b>	CA18/2/3/10428						
<b>Classification</b>	Accident	<b>Date</b>	2 March 2024		<b>Time</b>	1335Z	
<b>Type of Operation</b>	Private (Part 94)						
<b>Location</b>							
<b>Place of Departure</b>	Klerksdorp Airfield (FAKD), North West Province		<b>Place of Intended Landing</b>		Bona-Bona Game Lodge Airfield, North West Province		
<b>Place of Occurrence</b>	Runway 17 at Bona-Bona Airfield						
<b>GPS Co-ordinates</b>	<b>Latitude</b>	27°01'06.03" S	<b>Longitude</b>	26°13'16.66" E	<b>Elevation</b>	4 605 ft	
<b>Aircraft Information</b>							
<b>Registration</b>	ZU-FNS						
<b>Make; Model; S/N</b>	Shadow Lite CC; Jabiru J430 (Serial Number: 791)						
<b>Damage to Aircraft</b>	Substantial			<b>Total Airframe Hours</b>	492.3		
<b>Pilot-in-command</b>							
<b>Licence Type</b>	Private Pilot Licence (PPL)		<b>Gender</b>	Male		<b>Age</b>	65
<b>Licence Valid</b>	Yes	<b>Total Hours</b>	199.24		<b>Total Hours on Type</b>	53.0

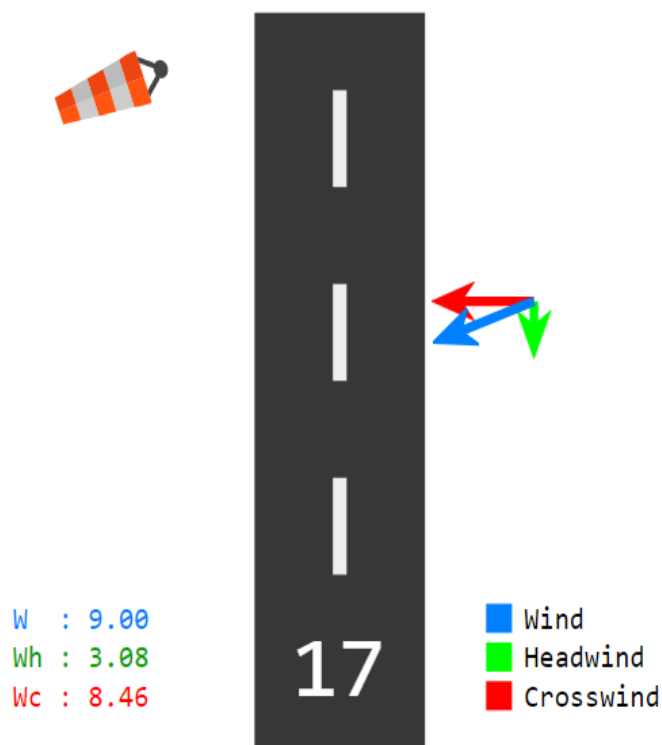
The crosswind component at the time of the flight was calculated at 8.46 knots from the right. A Jabiru J430 aircraft has a maximum crosswind velocity of 14 knots demonstrated at full (40°) flaps setting.

**Figure 4:** The calculated wind component.

- 2.5 The pilot would have had no challenges maintaining the runway centreline during the 8.46 knots crosswind as the aircraft is certified to operate in conditions of up to 14 knots crosswind without difficulty.
