LIMITED OCCURRENCE INVESTIGATION REPORT – FINAL

Reference Number	CA18/2/3/10432					
Classification	Accident	Date	18 March 2024	Time	0930Z	
Type of Operation	Private (Part 94)					
Location						
Place of Departure	Karoo Gateway Aerodrome (FABW), Beaufort West, Western Cape Province		Place of Intended Landing	New Tempe Aerodrome (FATP), Bloemfontein, Free State Province		
Place of Occurrence	Karoo Gateway Aerodrome (FABW)					
GPS Co-ordinates	Latitude	32°18'6.12" S	Longitude	022°39'54.36" E	Elevation	2932 ft
Aircraft Information						
Registration	ZU-DSH					
Make; Model; S/N	Yakovlev; Yak 55 (Serial Number: 880501)					
Damage to Aircraft	Substantial		Total Aircraft Hours	370.5		
Pilot-in-command						
Licence Type	Commercial Pilot Licence		Gender	Male		Age 24
Licence Valid	Yes	Total Hours	860		Total Hours on Type	35
Total Hours 30 Days	24		Total Flying on Type Past 90 Days	20		
People On-board	0	Injuries	0	Fatalities	0	Other (on ground) 0
What Happened

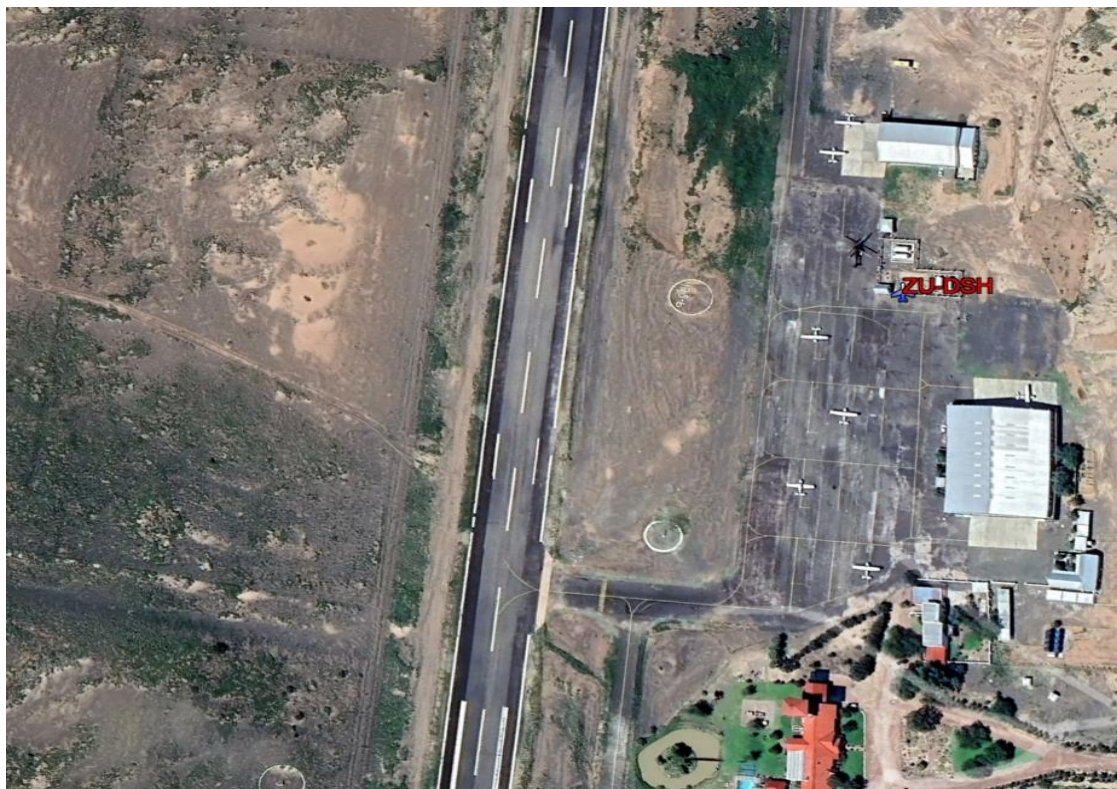
The accident occurred during start-up at the apron at FABW at Global Positioning System (GPS) coordinates determined to be S 32°18'6.12" E 022°39'54.36", at a field elevation of 2932 ft.

Figure 1: Aerial view of FABW and the accident site. (Source: Google Earth)
