LIMITED OCCURRENCE INVESTIGATION REPORT – FINAL

Reference Number	CA18/2/3/10438					
Classification	Accident	Date	2 April 2024		Time	0515Z
Type of Operation	Private (Part 91)					
Location						
Place of Departure	Groutville Airfield KwaZulu-Natal Province		Place of Intended Landing		New Tempe Airfield (FATP), Free State Province	
Place of Occurrence	On Runway 05 at Grootville Airfield in Ballito, KwaZulu-Natal Province					
GPS Co-ordinates	Latitude	29°24'36.5"S	Longitude	31°16'46.0" E	Elevation	235 ft
Aircraft Information						
Registration	ZS-ZZZ					
Make; Model; S/N	Cirrus Design Corporation; SR22 (Serial Number: 4602)					
Damage to Aircraft	Destroyed		Total Aircraft Hours	663.2		
Pilot-in-command						
Licence Type	Private Pilot Licence (PPL)		Gender	Male	Age	55
Licence Valid	Yes	Total Hours	1305.6	Total Hours on Type	1147.34	
Total Hours 30 Days	6.8		Total Flying on Type Past 90 Days		33.8	
People On-board	1+3	Injuries	0	Fatalities	0	Other (on the ground) 0

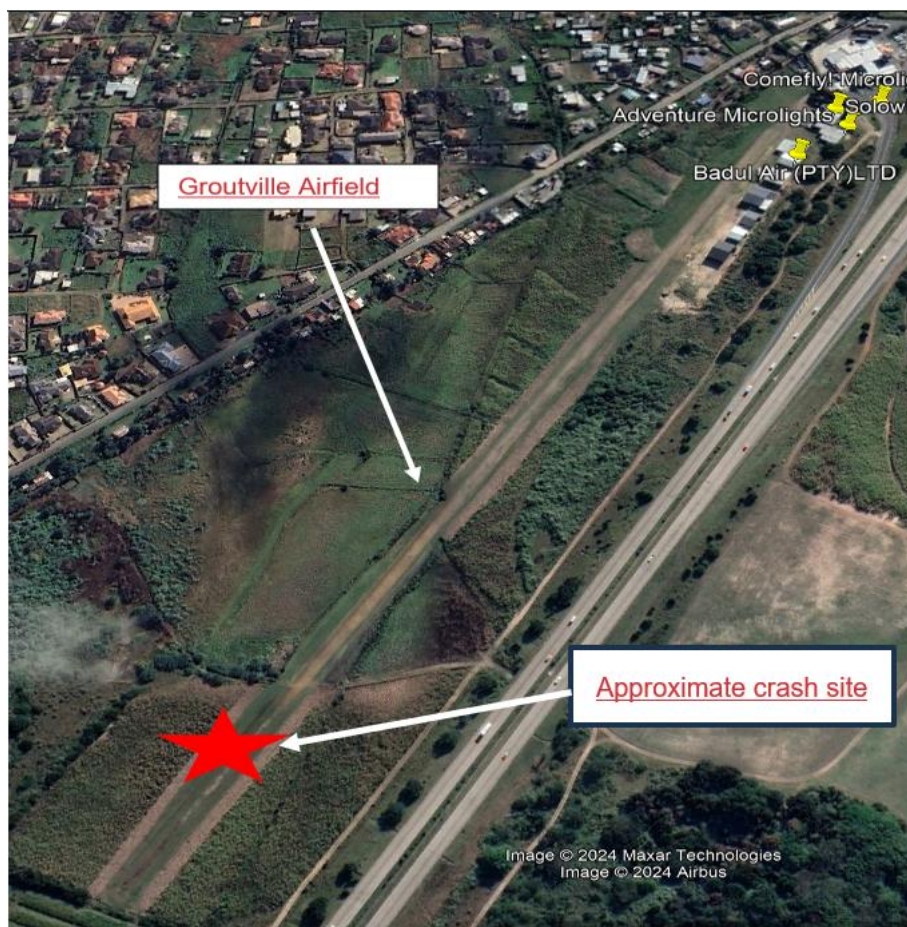
Figure 1: Aerial view of Groutville Airfield and the approximate area where the aircraft had stopped.
(Source: Google Earth)
