LIMITED OCCURRENCE INVESTIGATION REPORT – FINAL

Reference Number	CA18/2/3/10440						
Classification	Accident	Date	26 March 2024	Time	0645Z		
Type of Operation	Training (Part 141)						
Location							
Place of Departure	Grand Central Aerodrome (FAGC), Gauteng Province		Place of Intended Landing	Grand Central Aerodrome (FAGC), Gauteng Province			
Place of Occurrence	Runway 35 at Grand Central Aerodrome (FAGC), Gauteng Province						
GPS Co-ordinates	Latitude	25° 58'55.88" S	Longitude	028° 08'16.41" E	Elevation	5 268 ft	
Aircraft Information							
Registration	ZS-IOI						
Make; Model; S/N	Cessna 172L (Serial Number: 172-60301)						
Damage to Aircraft	Substantial		Total Aircraft Hours	15 521.80			
Pilot-in-command							
Licence Type	Student Pilot Licence (SPL)		Gender	Female		Age	18
Licence Valid	Yes	Total Hours	21.3		Total Hours on Type	21.3	
Total Hours 30 Days	8.5		Total Flying on Type Past 90 Days	11.5			
People on-board	1+0	Injuries	0	Fatalities	0	Other (on ground)	0

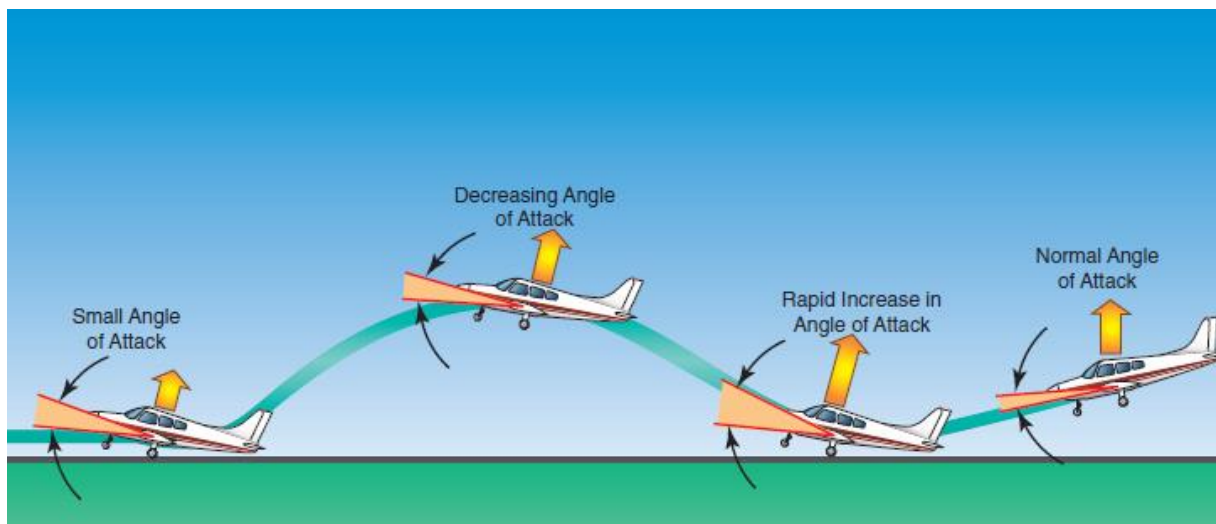
When the aeroplane contacts the ground with a sharp impact as the result of an improper attitude or an excessive rate of sink, it tends to bounce back into the air. Though the airplane's tires and shock struts provide some springing action, the airplane does not bounce like a rubber ball. Instead, it rebounds into the air because the wing's angle of attack was abruptly increased, producing a sudden addition of lift. [Figure 4] The abrupt change in angle of attack is the result of inertia instantly forcing the airplane's tail downward when the main wheels contact the ground sharply. The severity of the bounce depends on the airspeed at the moment of contact and the degree to which the angle of attack or pitch attitude was increased. Since a bounce occurs when the airplane makes contact with the ground before the proper touchdown attitude is attained, it is almost invariably accompanied by the application of excessive back-elevator pressure.

Illustration 1: A depiction of how the bounce occurs.

is to EXECUTE A GO-AROUND IMMEDIATELY. No attempt to salvage the landing should be made. Full power should be applied while simultaneously maintaining directional control and lowering the nose to a safe climb attitude. The go-around procedure should be continued even though the airplane may descend, and another bounce may be encountered. It would be extremely foolish to attempt a landing from a bad bounce since airspeed diminishes very rapidly in the nose-high attitude, and a stall may occur before a subsequent touchdown could be made.
