AIRCRAFT ACCIDENT REPORT AND EXECUTIVE SUMMARY

Reference:		CA18/2/3/10442	
Aircraft Registration	ZU-EFA	Date of Accident	17 April 2024		Time of Accident	1050Z	
Type of Aircraft	Bushbaby 500		Type of Operation		Private (Part 94)		
Pilot-in-command Licence Type	Private Pilot Licence (PPL)		Age	41	Licence Valid	Yes	
Pilot-in-command Flying Experience	Total Flying Hours		142.9	Hours on Type	35.2		
Last Point of Departure	Oudtshoorn Aerodrome (FAOH), Western Cape Province						
Next Point of Intended Landing	Joubertina Private Airstrip, 20nm north-east of Plettenberg Bay Aerodrome (FAPG), Western Cape Province						
Damage to Aircraft	Substantial						
Location of the accident site with reference to easily defined geographical points (GPS readings if possible)							
Hillandale Hideaway at Global Positioning System (GPS) determined to be 33°58'55.16"S 023°26'56.44"E, at an elevation of 672 feet							
Meteorological Information	Wind velocity: 350° at 6KT; Temperature: 32°C; Dew Point: 14°C; Visibility: ≥10 km; Cloud: CAVOK; QNH: 1013 hPa

Reference Number : CA18/2/3/10442
Occurrence Category : Accident (Category 1)
Type of Operation : Private (Part 94)
Name of Operator : GJ De Villiers

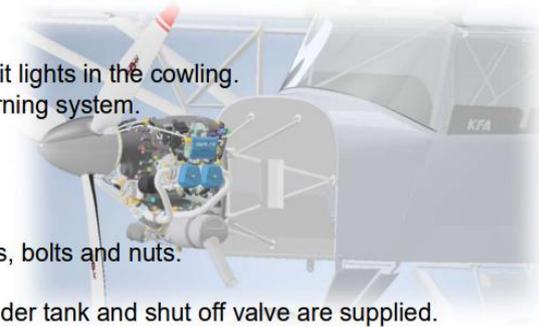
Figure 7: The KFA engine installation guide. (Source:

1.16.1. The aircraft was recovered and transported by road to an approved person (AP). Upon inspection, the AP noticed that the coolant radiator lacked good airflow because of the manner in which it was installed by the original builder. The crank runout test and the inspection of the reduction gearbox were in good shape and were within limits. The engine run, oil pressure and oil temperature were put on the test bed and were found to be normal; moreover, the coolant temperature was also functioning optimally. The engine reached its full power.

2.2.3. The purpose of the flight was to ferry the aircraft for its 100-hour periodic check. According to the records, the aircraft was maintained in accordance with the Regulations. The aircraft was airworthy at the time of the flight. However, according to the AP observations, the engine cooling system was not installed in accordance with the aircraft manufacturer (KFA) standard installation factory instructions. This led to a restriction in the cooling system which caused a

3.4.1. Improper installation of the engine cooling system.
