AIRCRAFT ACCIDENT REPORT AND EXECUTIVE SUMMARY

Reference:		CA18/2/3/10450	
Aircraft Registration	ZU-COB	Date of Accident	8 May 2024		Time of Accident	1445Z	
Type of Aircraft	Orion Cub		Type of Operation		Private (Part 94)		
Pilot-in-command Licence Type	National Pilot Licence (NPL)		Age	65	Licence Valid	Yes	
Pilot-in-command Flying Experience	Total Flying Hours		6 820		Hours on Type	200	
Last Point of Departure	Krugersdorp Aerodrome (FAKR), Gauteng Province						
Next Point of Intended Landing	Krugersdorp Aerodrome (FAKR), Gauteng Province						
Damage to Aircraft	Substantial						
Location of the accident site with reference to easily defined geographical points (GPS readings if possible)							
Approximately 2 kilometres (km) north of FAKR at Global Positioning System (GPS) co-ordinates determined to be 26°4'14.23" South 27°43'22.90" East, at 5 400 feet (ft) AMSL							
Meteorological Information	Wind direction: 180°; Wind speed: 03kts; Temperature: 21°C; Dew Point: 16°C; Cloud Cover: Nil; Cloud Base: Nil; Visibility: CAVOK; QNH: 1015hPa

Synopsis

Reference Number : CA18/2/3/10450
Occurrence Category : Category 2
Type of Operation : Private (Part 94)
Name of Operator : Avroy Sh

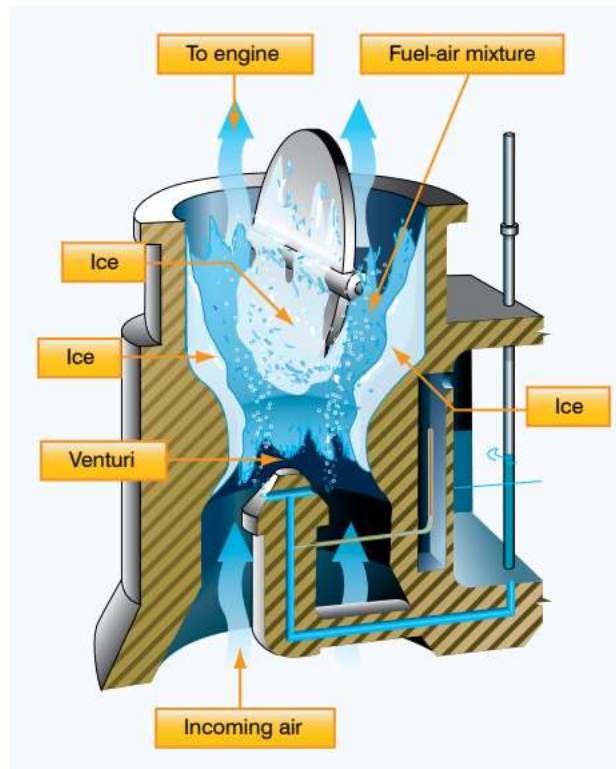
One disadvantage of the float-type carburettor is its icing tendency. Carburettor ice occurs due to the effects of fuel vaporisation and the decrease in air pressure in the venturi, which causes a sharp temperature drop in the carburettor. If water vapour in the air condenses when the carburettor temperature is at or below freezing, ice may form on the internal surfaces of the carburettor, including the throttle valve. The reduced air pressure, as well as the vaporisation of fuel contributes to the temperature decrease in the carburettor. Ice generally forms in the vicinity of the throttle valve and the venturi throat. This restricts the flow of the fuel-air mixture and reduces power. If enough ice builds up, the engine may cease to operate. Carburettor ice is most likely to occur when temperatures are below 70 degrees Fahrenheit (°F) or 21 degrees Celsius (°C) and the relative humidity is above 80 percent. Due to the sudden cooling that takes place in the carburettor, icing can occur even in outside air temperatures as high as 100 °F (38 °C) and humidity as low as 50 percent. This temperature drop can be as much as 60 to 70 absolute (versus relative) Fahrenheit degrees ($70 \times 100/180 = 38.89$

Illustration 1. Carburettor icing in an engine. (Source:
