LIMITED OCCURRENCE INVESTIGATION REPORT – DRAFT

Reference Number	CA18/2/3/10460						
Classification	Accident	Date	08 June 2024		Time	0740Z	
Type of Operation	Private (Part 94)						
Location							
Place of Departure	Stellenbosch Aerodrome (FASH), Western Cape Province		Place of Intended Landing		Caledon Airfield (FACG), Western Cape Province		
Place of Occurrence	Strawberry farm, approximately 500 metres (m) from the threshold of Stellenbosch Aerodrome (FASH) Runway 19						
GPS Co-ordinates	Latitude	33°59.1476' S	Longitude	018°49.4180' E	Elevation	337 ft	
Aircraft Information							
Registration	ZU-DWK						
Make; Model; S/N	Jabiru; J160C (Serial Number: 018)						
Damage to Aircraft	Substantial			Total Aircraft Hours	2 540.8		
Pilot-in-command							
Licence Type	Commercial Pilot Licence (CPL) Aeroplane		Gender	Male		Age	40
Licence Valid	Yes	Total Hours	1 265		Total Hours on Type	274	
Total Hours 30 Days	2.5		Total Hours on Type Past 90 Days		78

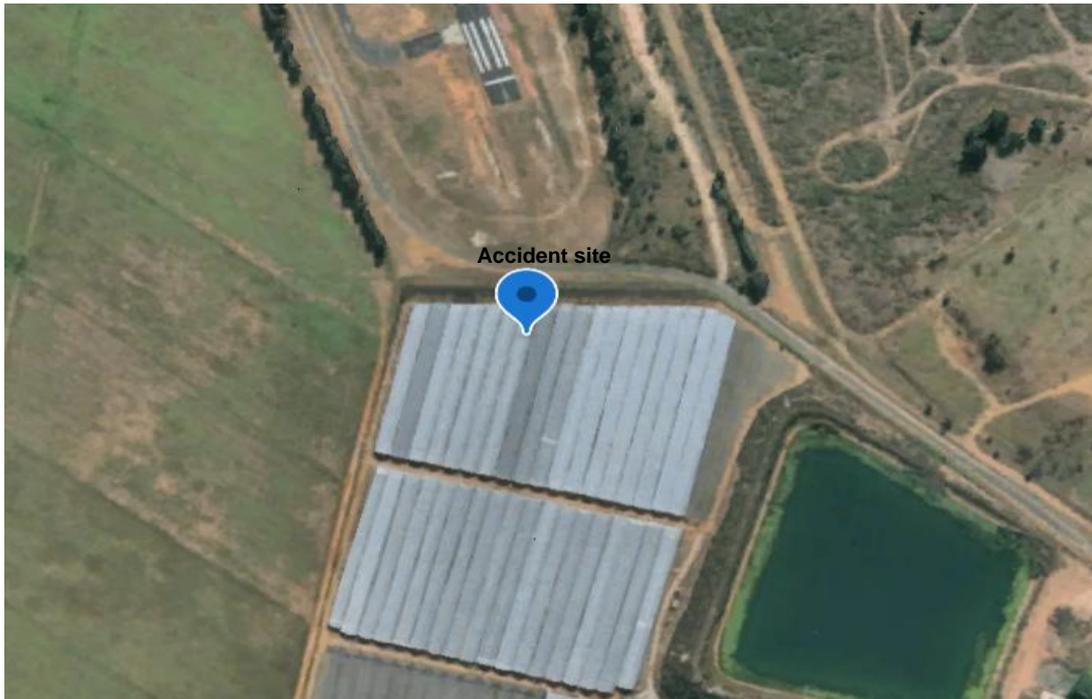
The accident occurred during daylight at a strawberry farm, approximately 500m from the threshold of FASH Runway 19, at Global Positioning System (GPS) co-ordinates determined to be 33°59.1476' South, 018°49.4180' East, and at an elevation of 337 feet (ft).

Figure 1: Aerial view of the accident site. (Source: Google Earth)
