AIRCRAFT ACCIDENT REPORT AND EXECUTIVE SUMMARY

Reference:		CA18/2/3/10461	
Aircraft Registration	ZS-URO	Date of Accident	11 June 2024		Time of Accident	0635Z	
Type of Aircraft	Cessna 182T Skylane			Type of Operation	Private (Part 91)		
Pilot-in-command Licence Type	Commercial Pilot Licence (CPL)		Age	48	Licence Valid	Yes	
Pilot-in-command Flying Experience	Total Flying Hours		6 279.8		Hours on Type	1 202.0	
Last Point of Departure	Mooketsi Airstrip near Tzaneen, Limpopo Province						
Next Point of Intended Landing	Esme 4 Farm Airstrip, Limpopo Province						
Damage to the Aircraft	Substantial						
Location of the accident site with reference to easily defined geographical points (GPS readings if possible)							
Approximately 19 nautical miles (nm) from Mooketsi Airstrip on public road D3732 near Tzaneen, Limpopo province (GPS position: 23°34'00" South 030°09' 00" East), at an elevation of 2 300 feet (ft)							
Meteorological Information	Temperature: 13.3°C; Dew point: 9.7°C; Cloud: Broken stratocumulus

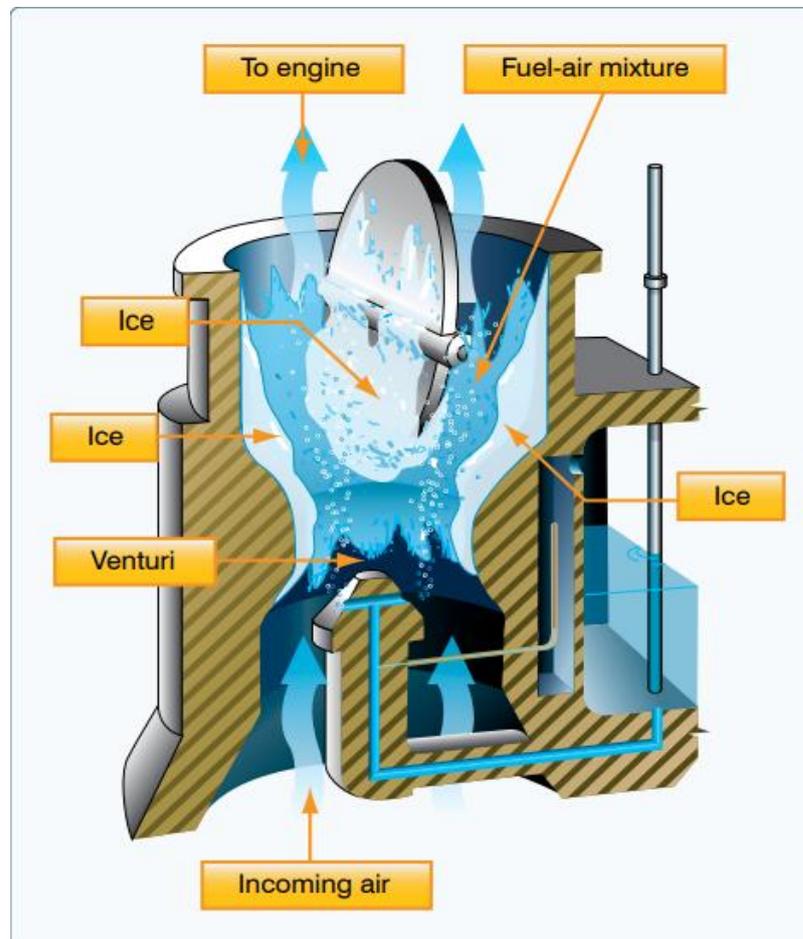
Diagram 1: Typical carburettor ice build-up.

Carburettor icing during descent can significantly affect an aircraft's performance by restricting or blocking airflow to the engine due to ice forming inside the carburettor. This occurs because of the cooling effect caused by fuel vaporisation and pressure drop within

the carburettor, especially when engine power is reduced during descent. The result can be a gradual or sudden loss of engine power, rough running or even engine failure if not promptly addressed. This poses a serious risk during the approach and landing phases where altitude and time to recover are limited. During severe cases of carburettor icing, the throttle valve can become stuck due to ice build-up.

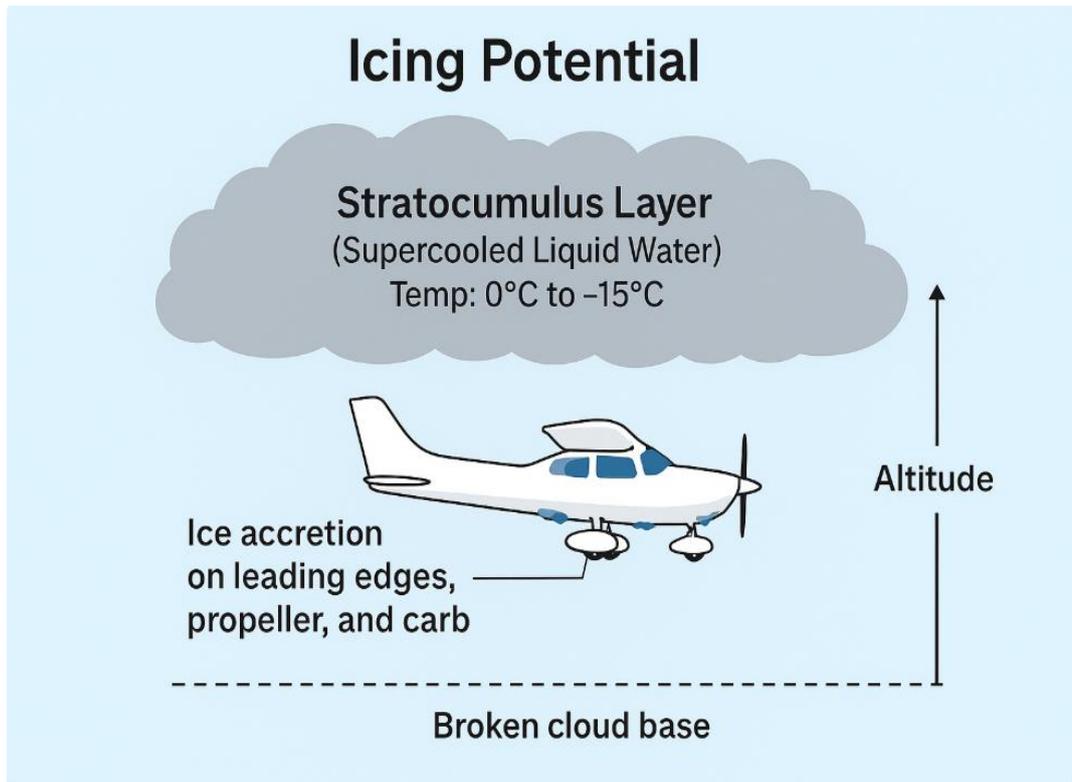
Diagram 2: Diagrammatic illustration of icing potential.

1.7.3. According to the information derived from 1.7.2, the approximate dew point temperature was 9.7°C. The calculated dew point depression (3.6°C) suggested that the weather conditions

at the time of the accident were conducive for the formation of serious carburettor icing at any power setting. Therefore, these conditions increased the likelihood of carburettor icing (as indicated by the black solid line, along with the black dot, in Figure 7).

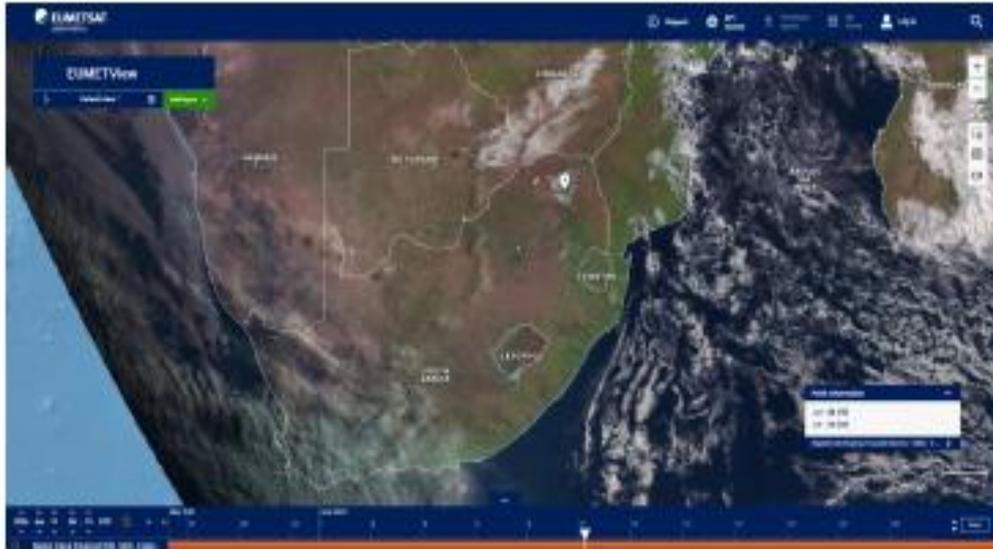
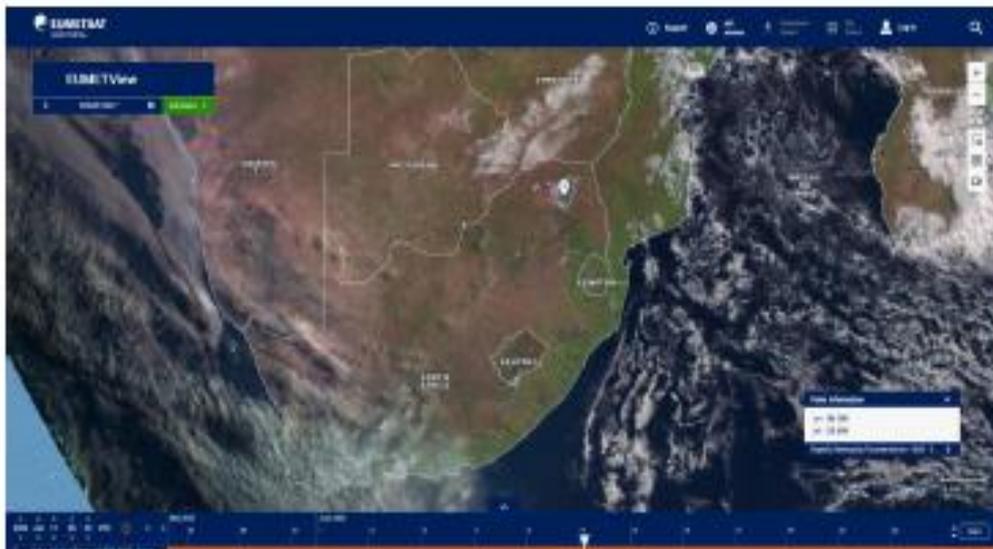
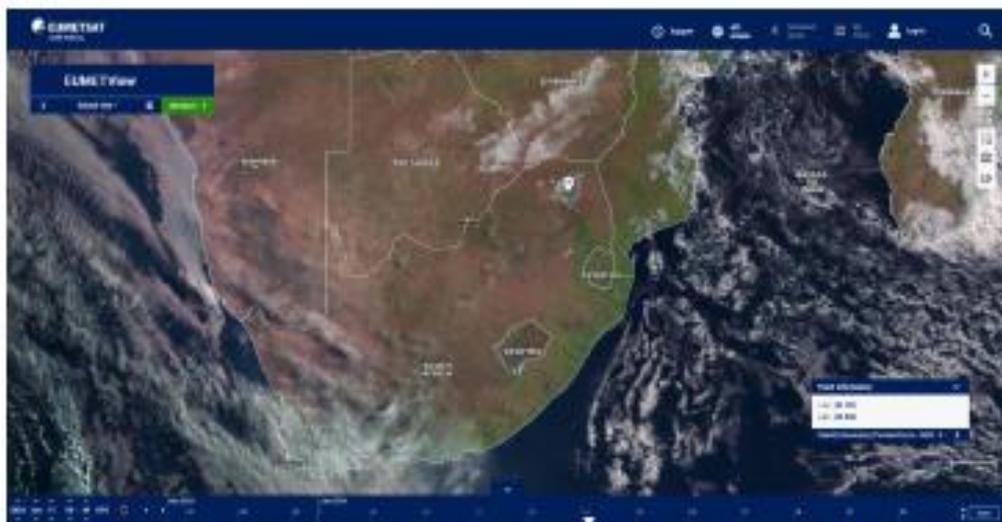
The Day Natural Colour RGB (DNC) satellite images of the MeteoSat Second Generation (MSG) shows a presence of localised stratocumulus cloud in the vicinity of the accident region (See white location pin in images) prior (figure 1 at 0615Z), during the incident (figure 2 at 0630Z) and post the time of incident (figure 3 at 0645Z).

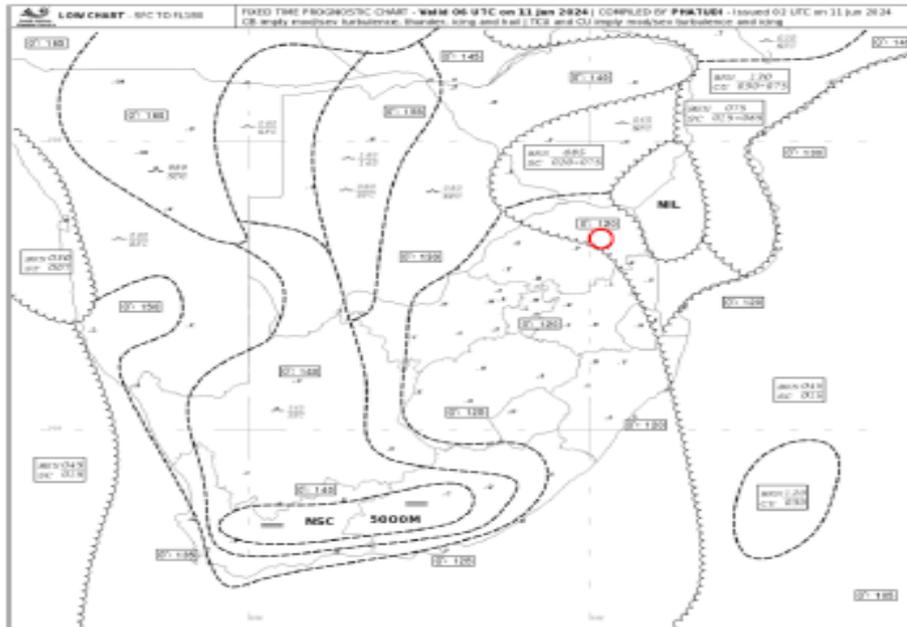
Figure 4: Low level significant weather chart valid for 0600Z (Accident area demarcated in red).

Figure 4 is the low-level chart valid for 0600Z on 27 October 2024. Although it is valid for 6Z, forecasters accommodate forecasts for a few hours before and after validity period. According to the forecast in figure 4, broken stratocumulus clouds were forecasted, otherwise no other significant weather was forecasted. This broken stratocumulus forecast coincides with the stratocumulus clouds observed in the satellite images.
