LIMITED OCCURRENCE INVESTIGATION REPORT – FINAL

Reference Number		CA18/2/3/10465					
Classification	Accident	Date	18 June 2024			Time	1545Z
Type of Operation	Private 94						
Location							
Place of Departure	New Tempe Aerodrome (FATP) Free State Province		Place of Intended Landing	New Tempe Aerodrome (FATP) Free State Province			
Place of Occurrence	On Runway 01 during landing at New Tempe Aerodrome (FATP)						
GPS Co-ordinates	Latitude	29° 2' 22.15" S	Longitude	026° 9' 33.01" E	Elevation	4 526ft	
Aircraft Information							
Registration	ZU-CUD						
Make; Model; S/N	Urban Air S.R.O; Samba UFM-10 (Serial Number: 29/10/2002)						
Damage to Aircraft	Substantial			Total Aircraft Hours	865.3		
Pilot-in-command							
Licence Type	National Pilot Licence (NPL)		Gender	Male		Age	82
Licence Valid	Yes	Total Hours	604.5		Total Hours on Type	62.5	
Total Hours 30 Days	2.6		Total Flying on Type Past 90 Days			2.6	
People On-board	1+0	Injuries	0	Fatalities	0	Other (on ground)	0

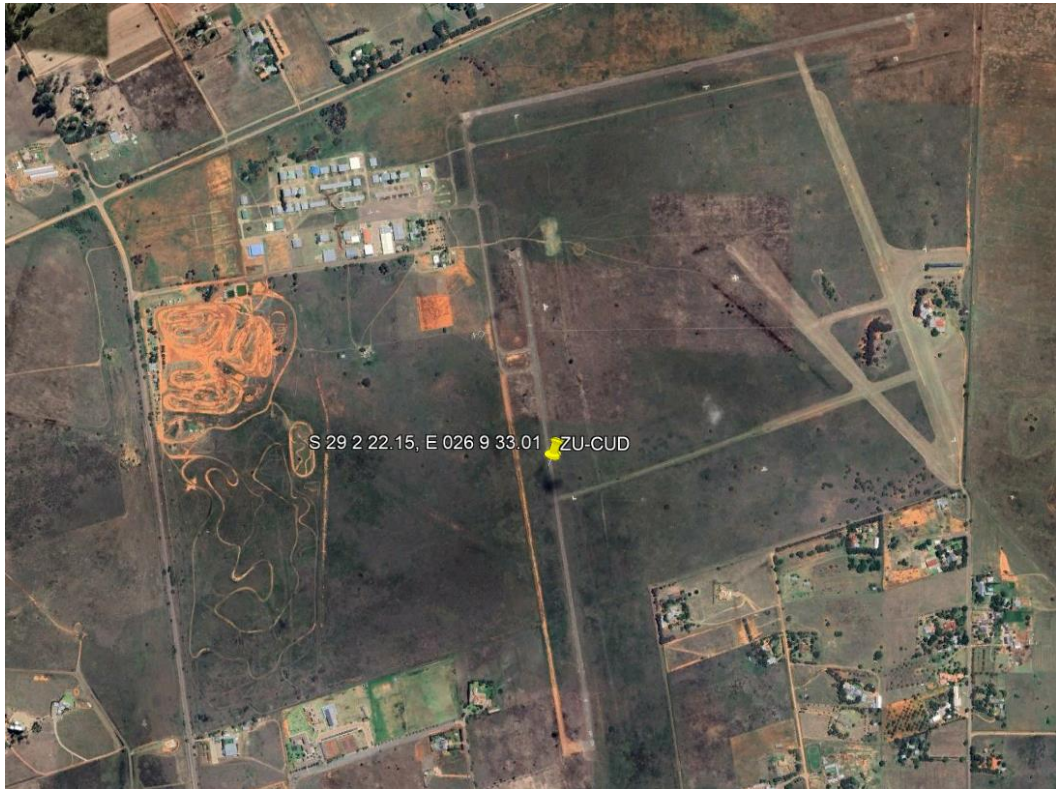
The accident occurred during daylight after landing on RWY 01 at Global Positioning System (GPS) coordinates determined to be S 29 2 22.15 E 026 9 33.01, at a field elevation of 4526 feet.

Figure 1: A view of the accident site. (Source: Google Earth Maps)
