AIRCRAFT ACCIDENT REPORT AND EXECUTIVE SUMMARY

Reference:		CA18/2/3/10471	
Aircraft Registration	ZU-IEZ	Date of Accident	15 July 2024		Time of Accident	0700Z	
Type of Aircraft	Bat Hawk			Type of Operation	Private (Part 94)		
Pilot-in-command Licence Type	National Pilot Licence (NPL)		Age	65	Licence Valid	Yes	
Pilot-in-command Flying Experience	Total Flying Hours			101.2	Hours on Type	10.3	
Last Point of Departure	Bundu Inn Airfield, Gauteng Province						
Next Point of Intended Landing	Wonderboom Aerodrome (FAWB), Gauteng Province						
Damage to Aircraft	Substantial						
Location of the accident site with reference to easily defined geographical points (GPS readings if possible)							
At GPS co-ordinates: 25°39'02.9" South 028°02' 48.7" East, at an elevation of 4 265 feet (ft)							
Meteorological Information	Surface wind:180° 5 kts; temperature: 08°C; dew point: -2°C; CAVOK						
Number of People On-board	1 + 1	Number of People Injured	1	Number of People Killed	0	Other (On Ground)	0

Probable Cause/s and/or Contributory Factors							
It is probable that the engine stoppage in-flight was caused by serious carburettor icing conditions.							
SRP Date	8 April 2025		Publication

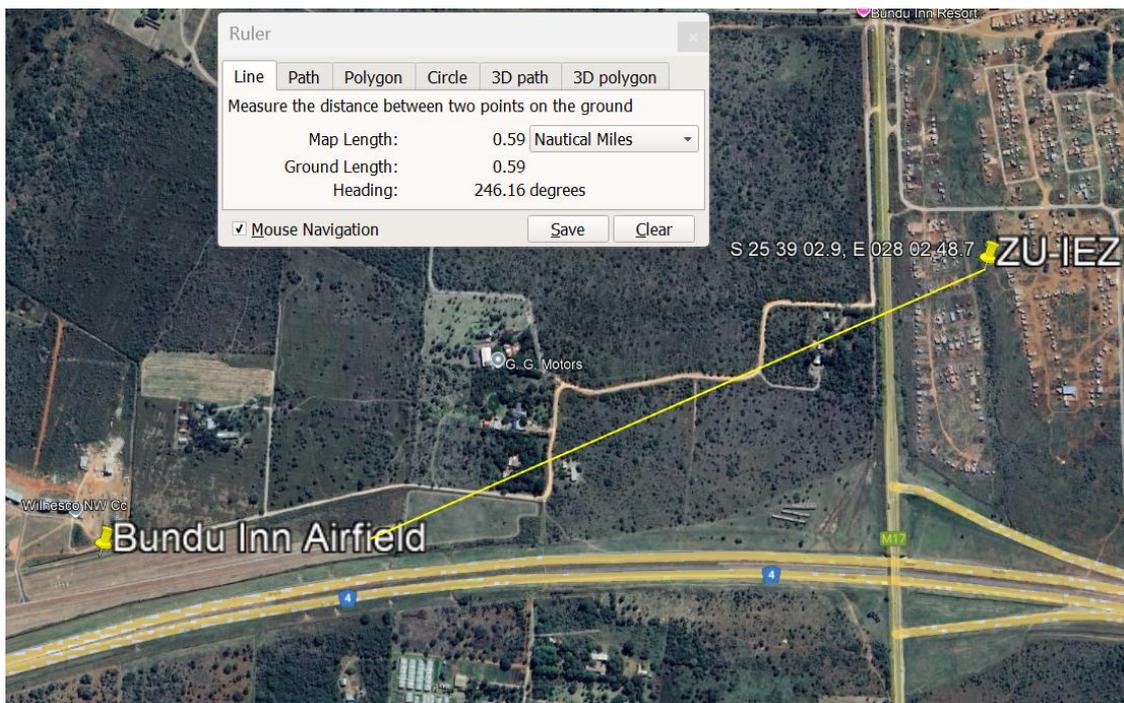
1.1.3 The accident occurred approximately 0.6 nautical miles (nm) west of Bundu Inn Airfield at Global Positioning System (GPS) co-ordinates determined to be 25°39'02.9" South 028°02'48.7" East, at an elevation of 4 265 feet (ft).

Figure 1: Aerial view of the accident site and the threshold of Runway 27. (Source: Google Earth)
