LIMITED OCCURRENCE INVESTIGATION REPORT

Reference Number	CA18/2/3/10475				
Classification	Accident	Date	6 August 2024	Time	0730Z
Type of Operation	Training (Part 141)				
Location					
Place of Departure	Cape Winelands Aerodrome, (FAWN) Western Cape Province	Place of Intended Landing	Cape Winelands Aerodrome, (FAWN) Western Cape Province		
Place of Occurrence	On Runway 05 at Cape Winelands Aerodrome, Western Cape Province				
GPS Co-ordinates	Latitude	33°46'18.70" S	Longitude	018°44'23.34" E	Elevation 414 ft
Aircraft Information					
Registration	ZS-PUW				
Make; Model; S/N	Cessna 150 (Serial Number: 150-59992)				
Damage to Helicopter	Substantial	Total Aircraft Hours	4882.46		
Pilot-in-command					
Licence Type	Student Pilot Licence (SPL)	Gender	Male	Age	26
Licence Valid	Yes	Total Hours	44.2	Total Hours on Type	44.2
Total Hours Past 30 Days	3.4		Total Flying Hours on Type Past 90 Days	29.1	
People On-board	1 + 0	Injuries	0	Fatalities	0
				Other (on ground)	0

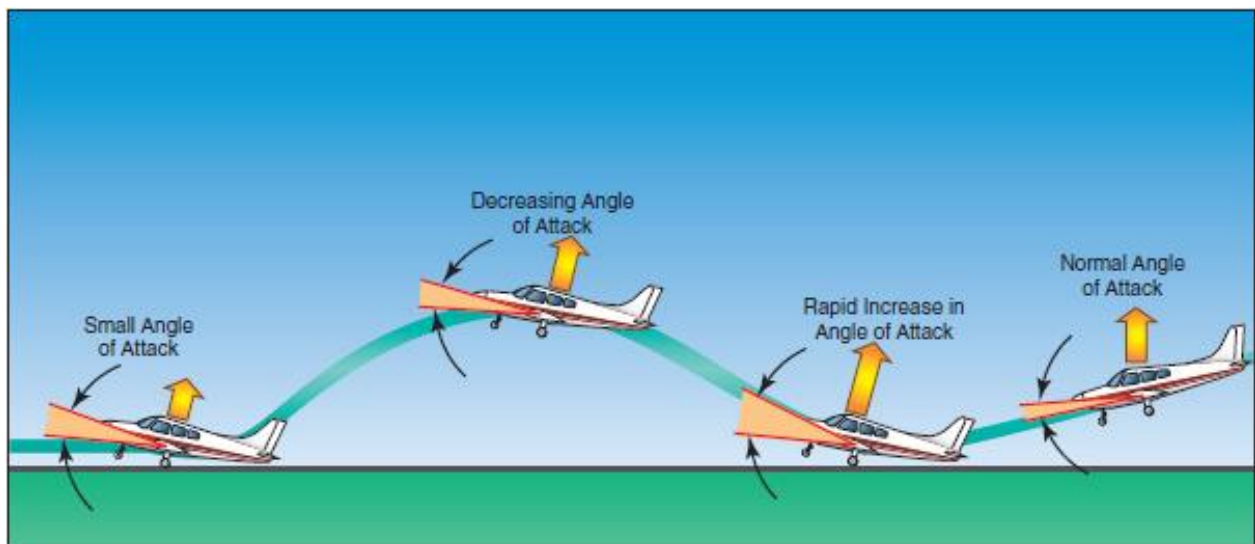
In a bounced landing that is improperly recovered, the airplane comes in nose first, initiating a series of motions imitating the jumps and dives of a porpoise (Figure 3). The improper airplane attitude at touchdown may be caused by inattention, not knowing where the ground is, miss-trimming, or forcing the airplane onto the runway.

Figure 3: Illustration of the bounce landing.

Ground effect decreases elevator control effectiveness and increases the effort required to raise the nose. Not enough elevator or stabilator trim can result in a nose low contact with the runway and a porpoise develops.
