LIMITED OCCURRENCE INVESTIGATION REPORT – FINAL

Reference Number	CA18/2/3/10482						
Classification	Accident	Date	23 August 2024	Time	0820Z		
Type of Operation	Training (Part 141)						
Location							
Place of Departure	Rhino Park Airfield, Gauteng Province		Place of Intended Landing	Rhino Park Airfield, Gauteng Province			
Place of Occurrence	During the take-off roll on Runway 09 at Rhino Park Airfield						
GPS Co-ordinates	Latitude	25° 50' 03.0" S	Longitude	028° 32' 22.0" E	Elevation	4770 ft	
Aircraft Information							
Registration	ZU-SEL						
Make; Model; S/N	Shadow Lite CC; Jabiru J230 (Serial Number: 828)						
Damage to Aircraft	Substantial			Total Aircraft Hours	431.1		
Pilot-in-command							
Licence Type	Student Pilot Licence (SPL)		Gender	Male	Age	44	
Licence Valid	Yes	Total Hours	70		Total Hours on Type	68.2	
Total Hours 30 Days	14.2		Total Flying on Type Past 90 Days		24.2		
People On-board	1+0	Injuries	0	Fatalities	0	Other (on ground)	0

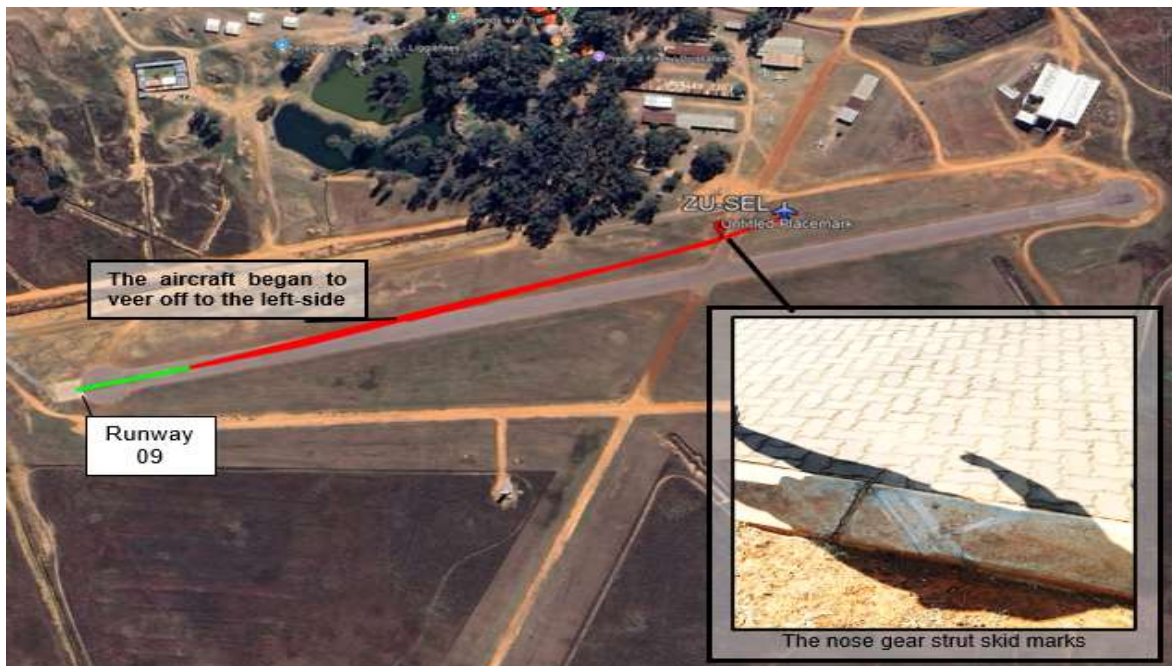
The accident occurred at Rhino Park Airfield at Global Positioning System (GPS) co-ordinates determined to be 25°49'57.95"South 028°32'28.97"East, at a field elevation of 3189 feet (ft).

Figure 1: Aerial view of the accident site (Source: Google Earth Maps)

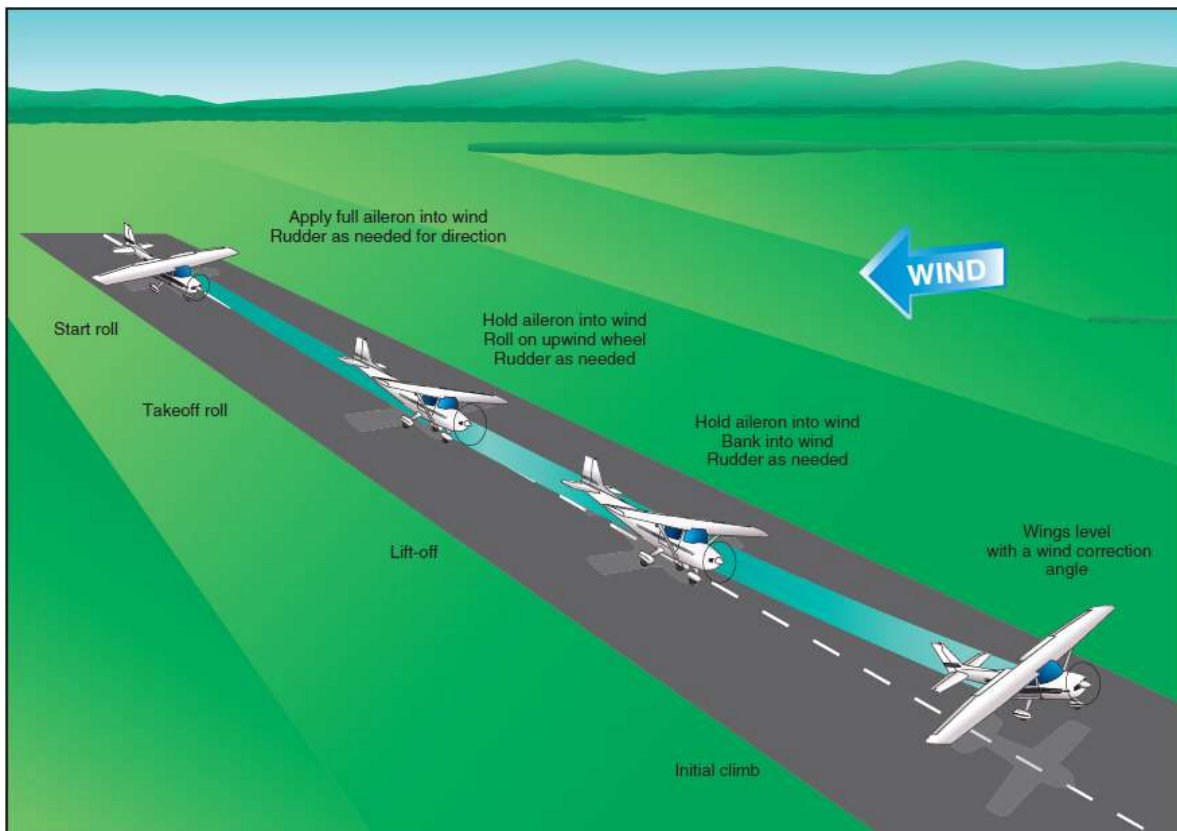
Figure 5: Illustration of crosswind take-off. (Source: FAA-H-8083-3a-3of7)
