<b>LIMITED OCCURRENCE INVESTIGATION REPORT</b>
--

<b>Reference Number</b>	CA18/2/3/10483						
<b>Classification</b>	Accident	<b>Date</b>	29 August 2024	<b>Time</b>	1000Z		
<b>Type of Operation</b>	Private (Part 94)						
<b>Location</b>							
Place of Departure	Stellenbosch Airfield (FASH), Western Cape Province		Place of Intended Landing	Stellenbosch Airfield (FASH), Western Cape Province			
Place of Occurrence	During approach for landing on Runway 19 at Stellenbosch Airfield (FASH)						
GPS Co-ordinates	Latitude	33°58'45.70" S	Longitude	18°49'19.20" E	Elevation	290 ft	
<b>Aircraft Information</b>							
Registration	ZU-MAP						
Make; Model; S/N	Aeroprakt (Serial Number: 076)						
Damage to Aircraft	Substantial		Total Aircraft Hours	2484.7			
<b>Pilot-in-command</b>							
Licence Type	Private Pilot Licence (PPL)		Gender	Male		Age	44
Licence Valid	Yes	Total Hours	129.3		Total Hours on Type	47.5	
Total Hours Past 30 Days	1.8		Total Flying Hours on Type Past 90 Days	15.5

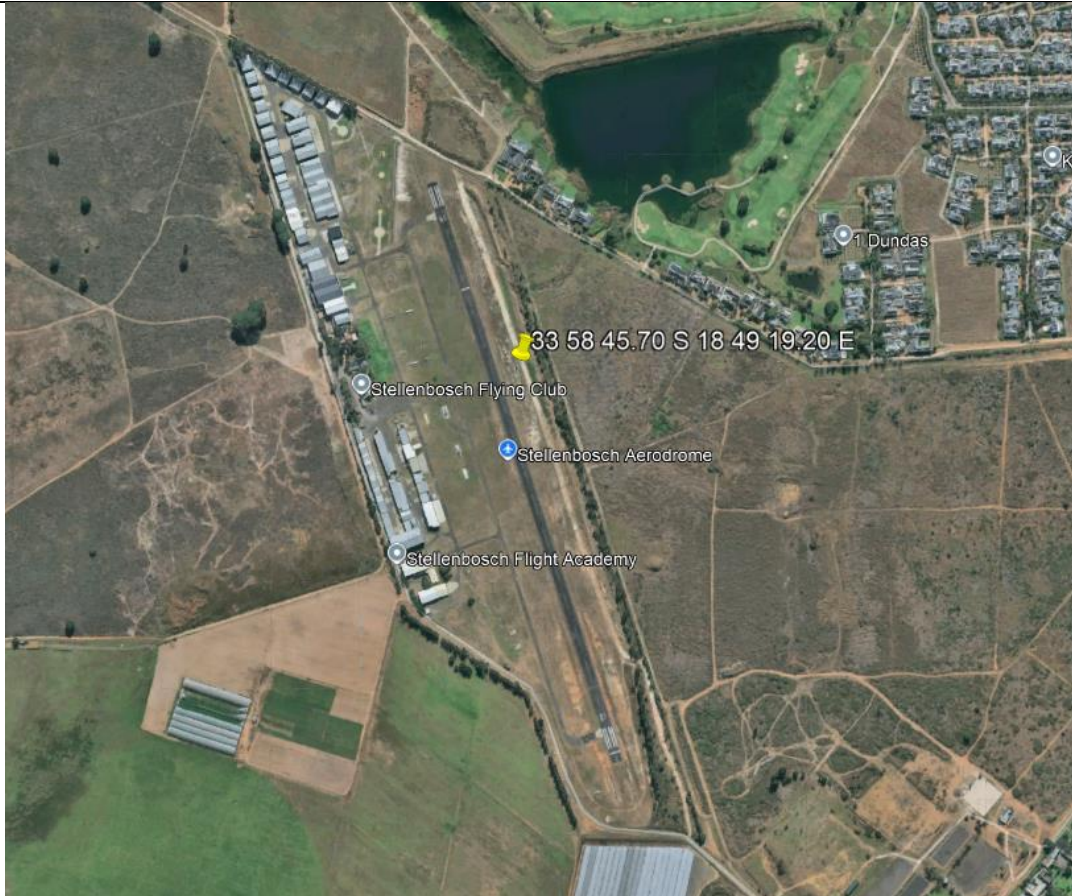
**Figure 1:** Aerial view of the accident site. (Source: Google Earth)

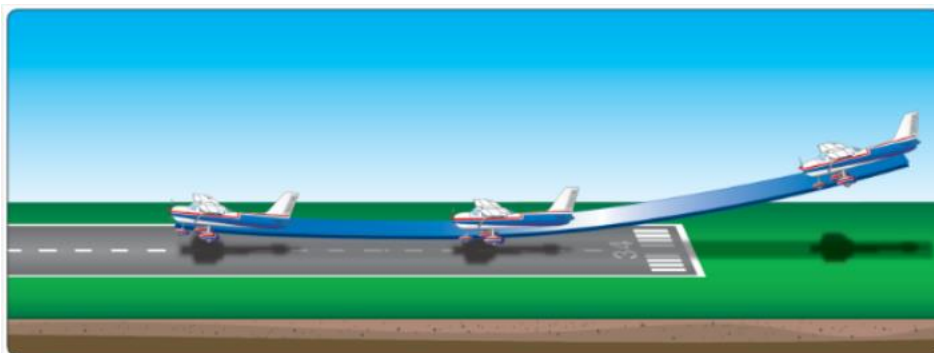
A ballooned landing is an aerodynamically induced vertical departure (climb) away from the runway usually caused by a pilot attempting to land with excess air speed. At higher airspeeds, a longer period of time is required to “wash off” the airspeed (float) which increases the risk for the aircraft to climb away or lift off again from the runway.

**Illustration 1:** Excess airspeed and floating.

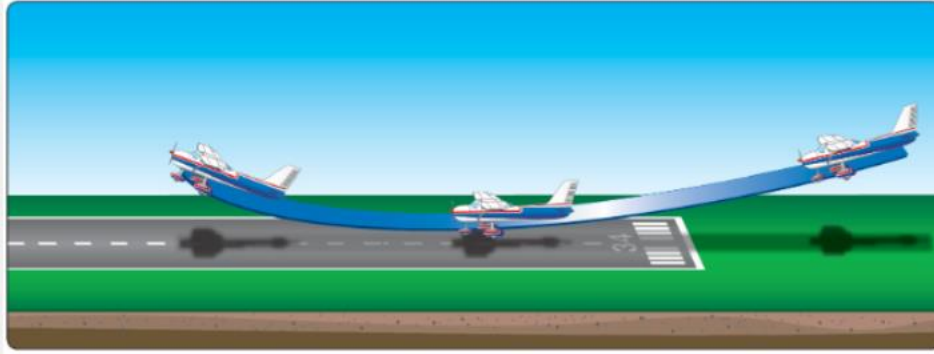
*During the ballooning, climb airspeed is lost, the lift decreases, and the aircraft may enter a state where there is insufficient air speed to effectively maintain control of the aircraft’s descent back to the runway, resulting in a hard landing. Attempting to control the balloon with the elevator may lead to the pilot “overcontrolling” and causing the aircraft to nose into the runway or into a series of swoops and dives called Pilot Induced Oscillation (PIO).*

*Managing a ballooned landing requires perfectly timed and precise control inputs. The safest option is to go-around because an incorrectly managed balloon could lead to a hard, bounced or porpoise landing.*

**Illustration 2:** Balloon landing.  
(Source: FAA-H-8083-3C)
