**LIMITED OCCURRENCE INVESTIGATION REPORT – FINAL**

| <b>Reference Number</b> | CA18/2/3/10494 | | | | | | |
| Registration | ZU-FBG | | | | | | |
| Make; Model; S/N | B & F Technik Polaris; FK14 B2 (Serial Number: B2-081) | | | | | | |

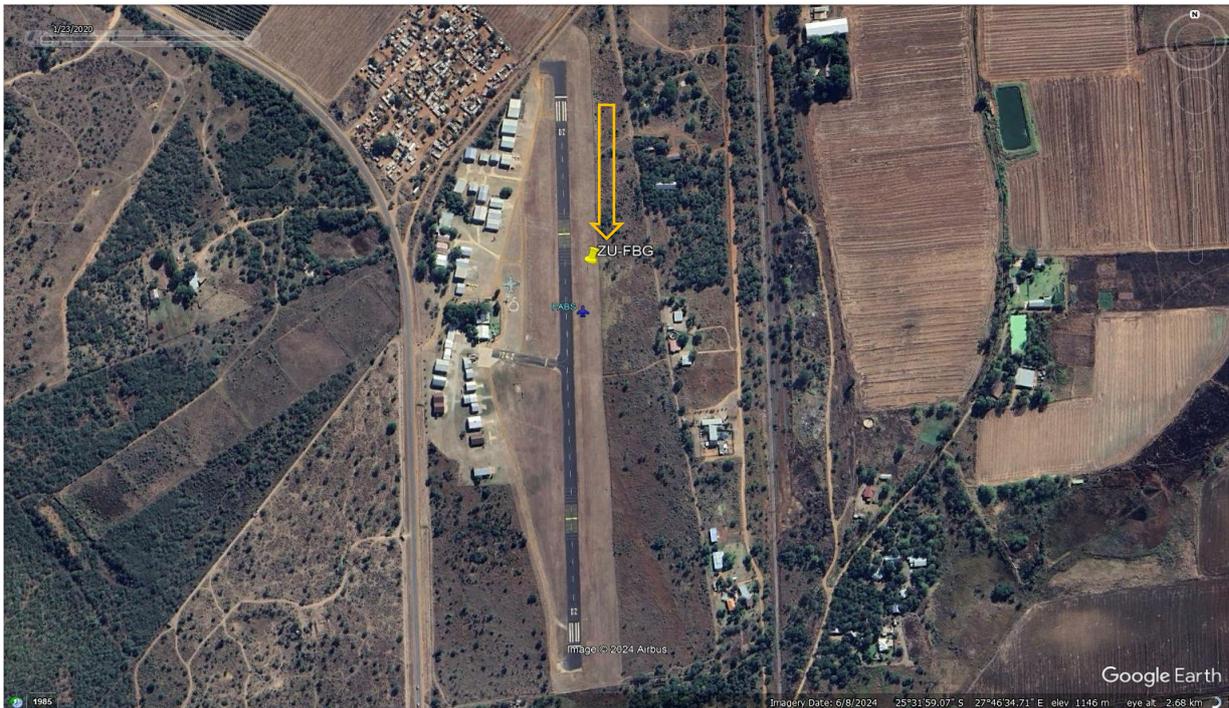
**Figure 1:** The accident site. The yellow arrow indicates the direction of landing. (Source: Google Earth)

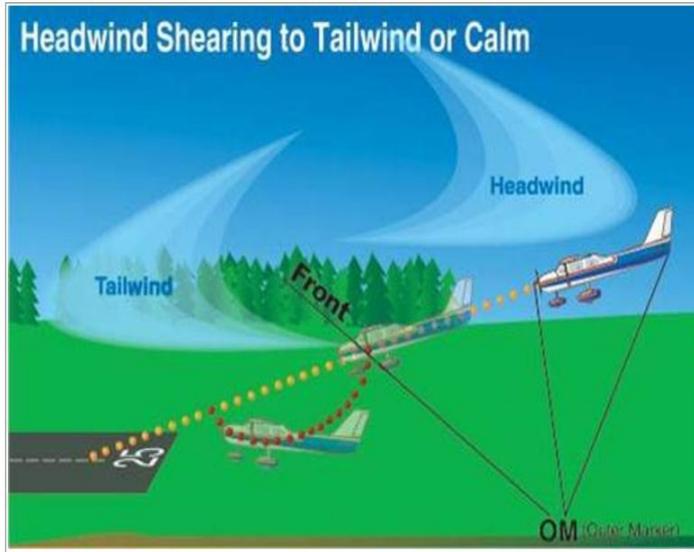
While an aircraft is on approach, a shear from a headwind to a tailwind (or calm) causes:

- The airspeed to decrease;
- The nose to pitch down;
- The aircraft to drop below the glide slope.

If the pilot pulls the nose up to compensate, airspeed will be reduced even further.

The pilot will typically compensate by increasing power, but if the engines don't spool up fast enough, the airplane may land short, slow, and hard and could lead to a crash.

**Figure 5:** Illustration of wind shear. (Source: [https://www.weather.gov/zme/safety\\_llws](https://www.weather.gov/zme/safety_llws))

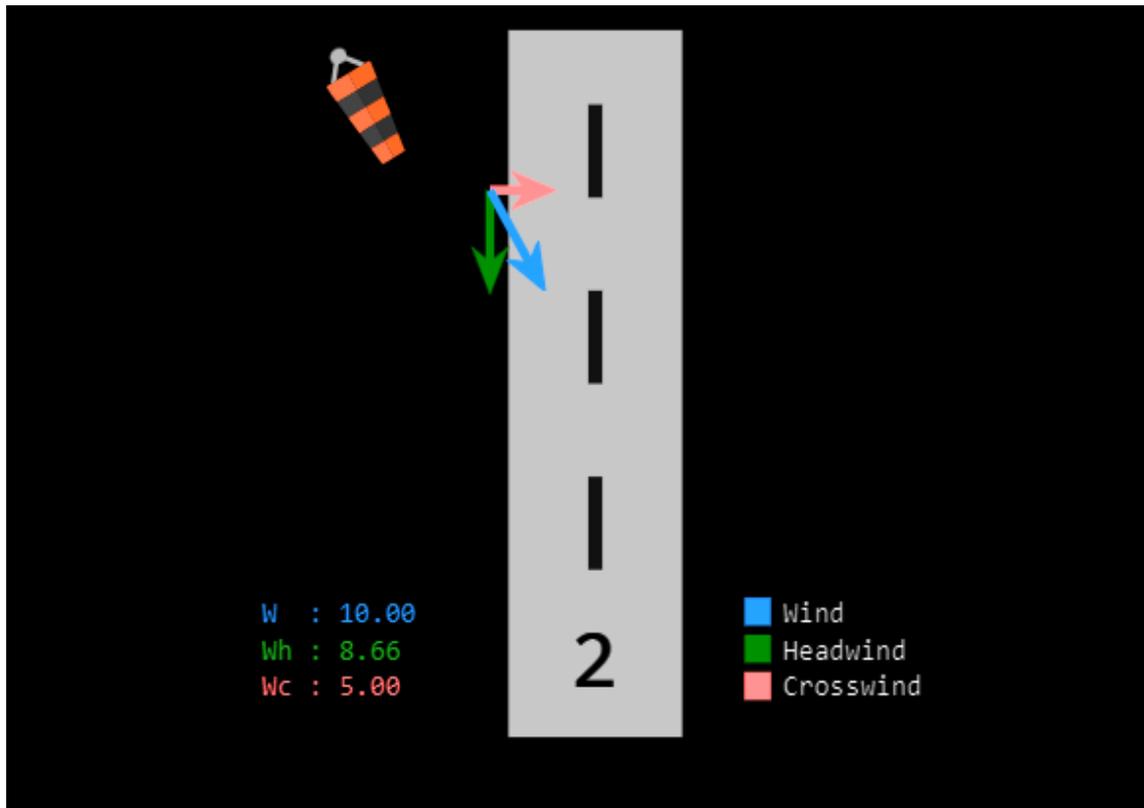
The meteorological aerodrome report (METAR) below was obtained from the South African Weather Service (SAWS) report that was issued for Lanseria International Airport (FALA) on 14 September 2024 at 1000Z. FALA is located 25.7 nautical miles (nm) south-east of FABS. According to the weather report, the surface wind velocity was variable between 20 and 320 degrees which could result in wind shear.

**Figure 6:** The average wind component of the day. (Source: e6bx.com)

3.1. According to the weather report, the prevailing wind conditions were susceptible to inducing wind shear and were considered a factor that contributed to the accident.
