LIMITED OCCURRENCE INVESTIGATION REPORT – FINAL

Reference Number	CA18/2/3/10497							
Classification	Accident			Date	6 May 2024		Time	0700Z
Type of Operation	Private (Part 94)							
Location								
Place of Departure	Pietermaritzburg Airport (FAPM), KwaZulu-Natal Province			Place of Intended Landing	Pietermaritzburg Airport (FAPM), KwaZulu-Natal Province			
Place of Occurrence	Runway 16 at Pietermaritzburg Airport (FAPM)							
GPS Co-ordinates	Latitude	29°38'42.63"S	Longitude	30°23'43.85"E	Elevation	2 423ft		
Aircraft Information								
Registration	ZU-WES							
Make; Model; S/N	Sling Aircraft Factory, Sling 2 LSA (Serial Number: 061)							
Damage to Aircraft	Minor			Total Aircraft Hours	2 444.0			
Pilot-in-command								
Licence Type	Private Pilot Licence (PPL)			Gender	Male		Age	25
Licence Valid	Yes	Total Hours	90.6		Total Hours on Type	4.2		
Total Hours 30 Days	1.6			Total Flying on Type Past 90 Days	4.2			
People On-board	1+1	Injuries	0	Fatalities	0	Other (on the ground)	0

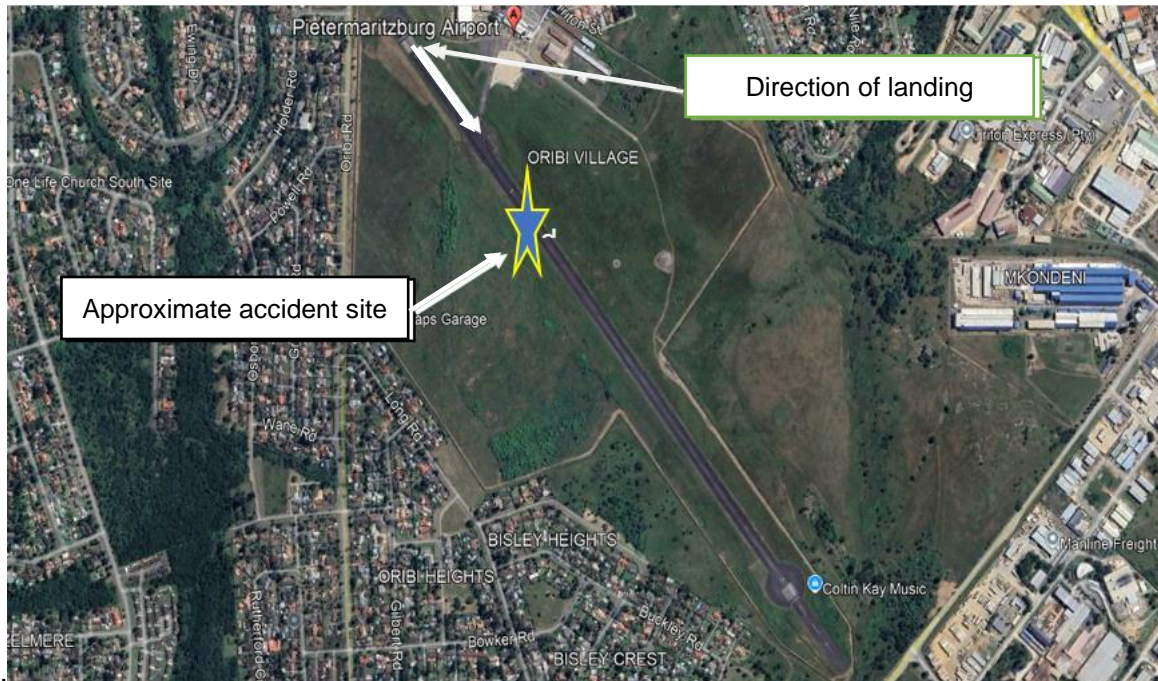
The accident occurred during daylight at Global Positioning System (GPS) co-ordinates determined to be 29°38'42.63"South 30°23'43.85"East, at an elevation of 2 423 feet (ft).

Figure 1: Aerial view of FAPM, the landing direction, and the accident site. (Source: Google Earth)
